MEMORANDUM

To:	Steve Lederer, Director of Public Works Leigh Sears, Concessions Manager	From:	Chris Silke, Engineering Manager, P.E.
Date:	October 27, 2023	Re:	Steele Park Drainage Culvert Failure

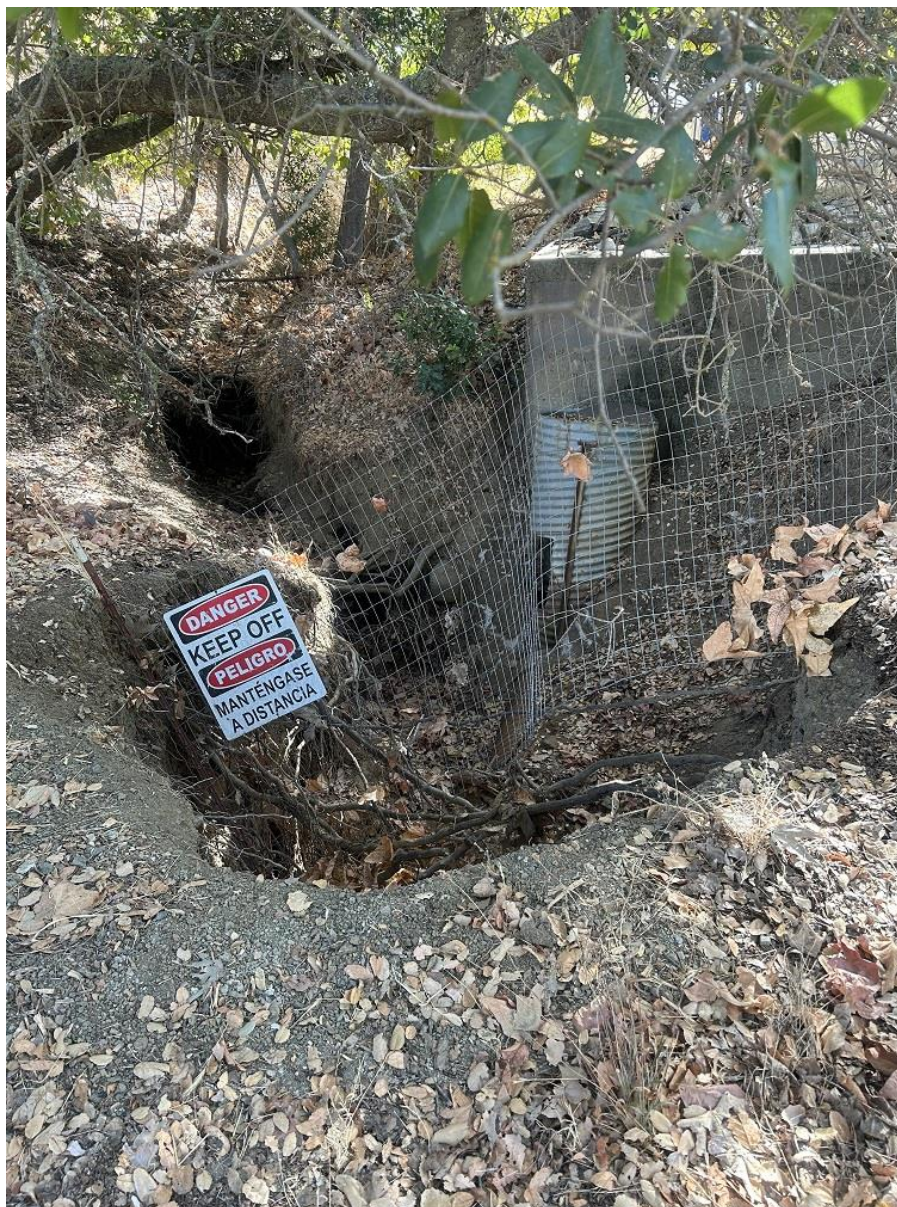
Site Key A – Culvert Inlet Pool

Figure 1 is a Locus Map of Steele Park showing the culvert drainage inspection points listed in the Site Key. The culvert inlet pool at Site Key A has sustained bank scour with several feet of tree and shrub root exposure. Annular space between the inlet corrugated vertical tee and horizontal pipe placed underneath the paved access drive is plugged with vegetative debris. Gravel has infilled approximately half of the 36 inch culvert pipe due to slow entry velocities. The Resort Park Manager reported seeing the culvert surcharged at the inlet with water flowing over the access road during moderate to major AR storm events in 2023. An 8 foot diameter by 12 foot deep sinkhole has emerged at Site Key B due to the pipe collapsing from corrosion. A photo of the storm drain outfall in Site Key C illustrates the extent to which the corrugated metal pipe properties have deteriorated within the wetted perimeter. Uniformity of iron corrosion on the pipe interior is indicative of lake level at full pond elevation (440 ft) and prolonged submergence.

soil material. Reshape geometry of inlet pool banks to be slope compatible for geofabric placement and rip rap armoring. Estimated construction cost - \$119,014.

Option No. 2 is recommended to rehabilitate the drainage facility addressing the immediate safety and economic loss risks.
