Clover Flat Landfill Site Inspection

Inspection Report Date: January 14, 2026

Inspection Date: January 13, 2026

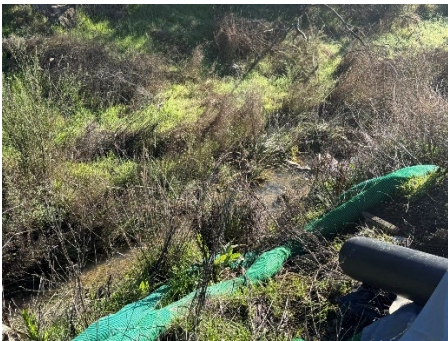
The creek was flowing well and was free of foam and excess sediment. The stormwater outfall pipe had ponding and fine sediment around it leading to the creek. While the BMPs in place helped drop out most of the fine sediment, the area needs to be cleared and ensure that stormwater is flowing through the channelized area only and not spreading across the ground uncontrolled.

Creek, looking SE

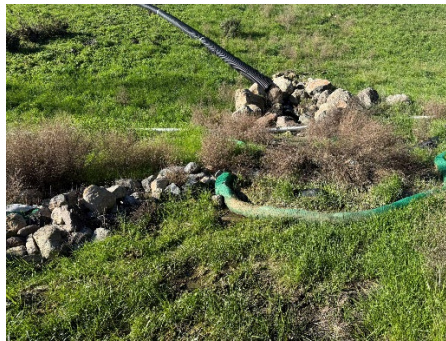
Stormwater conveyance outlet

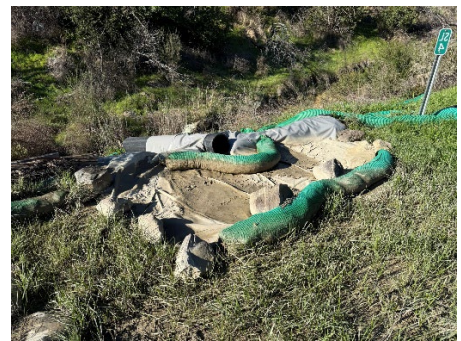
Fine sediment accumulation near creek

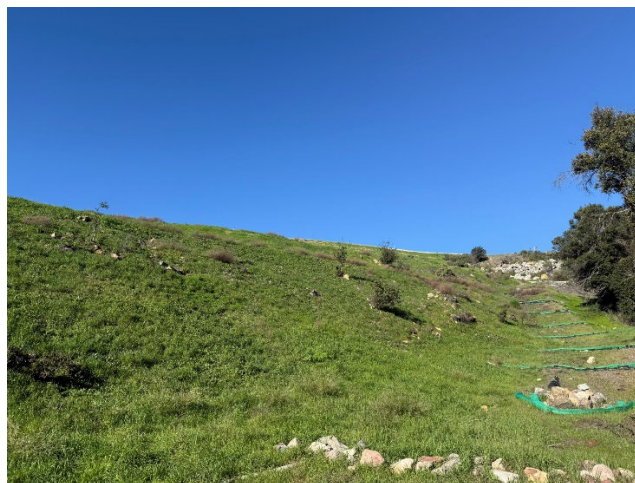
The lowest closed portion of the landfill, Module 1A, has tree growth reappearing in the final cover post-Glass Fire (2020) burn of the previous growth. I informed Waste Connections to remove any deep-rooted growth that could potentially impact the final cover, they agreed to get that work done this week.

Small trees starting to regrow on Module 1A, looking NW

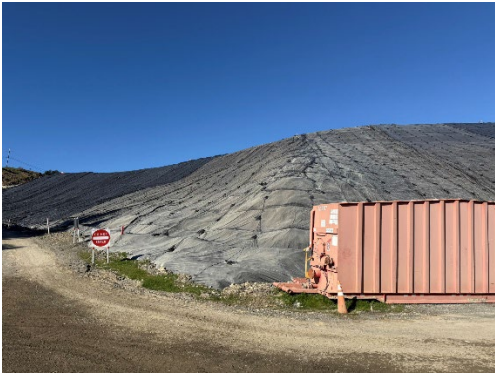
Module 3 and 1

The scrim placed on Modules 3, 1, 1B, and 2B held up well in the storms and successfully kept stormwater from infiltrating the waste and leachate seeps from surfacing. The berm placed across the access road from Module 5B was covered in scrim as well, after an inspection in the Fall of 2024 noted the berm material was low-pH soil and orange staining was present after a rainstorm.

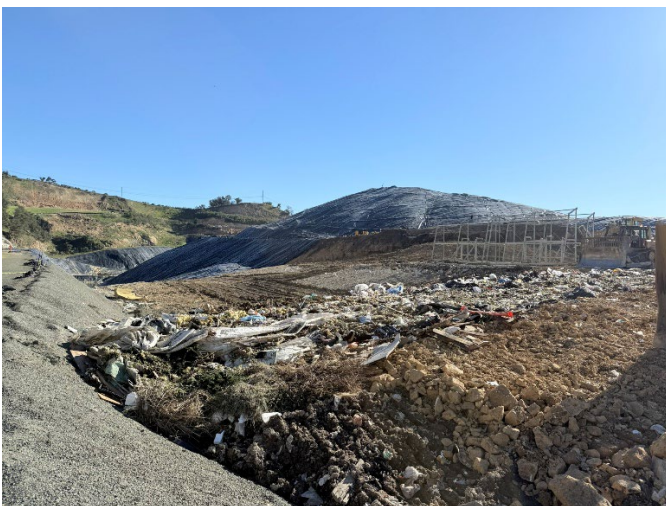
Module 5B is being filled incrementally, with the western half still used as stormwater collection until this summer when another portion of 5B is expected to be filled with waste. Low-pH water coming down the bench from the northern soil borrow area is still being treated with lime pellets prior to discharging into the stormdrain and ultimately the creek. Some areas of Posi shell have failed on the slope above Module 5B and should be repaired.

Module 5B- active filling area

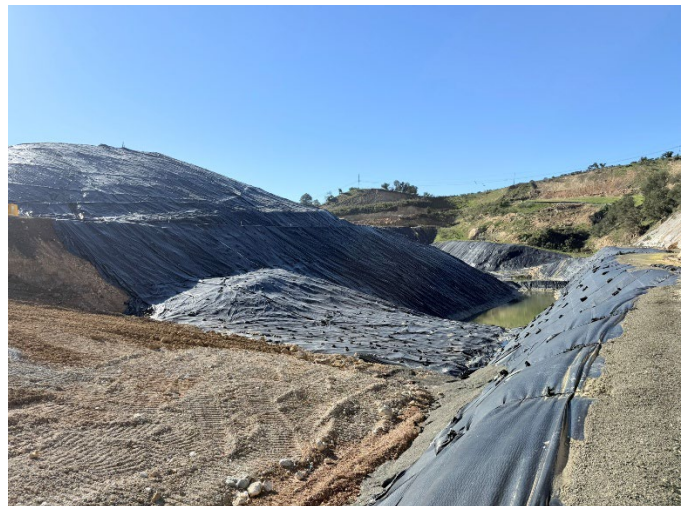
Module 5B- end of filled area with cover, and stormwater pond

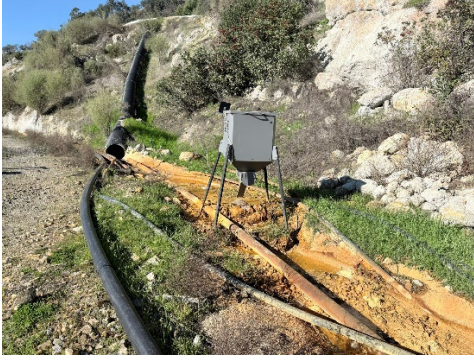
Low-pH water treatment dispenser

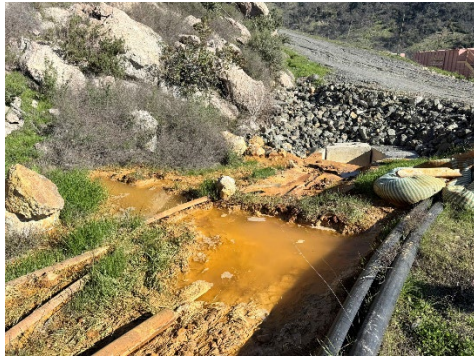
Stormwater holding prior to discharge

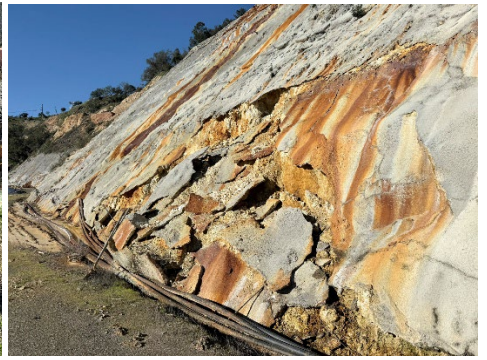
Posi shell damage above Module 5B

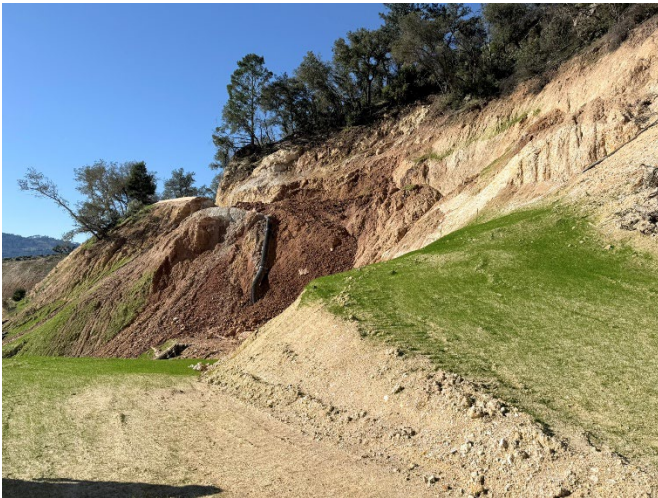
The small landslide present in the northern area of the site was stabilized, with large boulders removed and grading performed from mid October 2025 through early November 2025. The slide was partially activated by the heavy rainfall on December 30, 2025, with soil material falling downslope, but not making it as far as the newly graded bench below. The area will be repaired in the coming week(s) of dry weather by removing excess soil, cleaning out the drain at the base of the slide, and clearing debris from the stormwater conveyance pipe and drain below the toe of the slide.

Landslide area, looking west

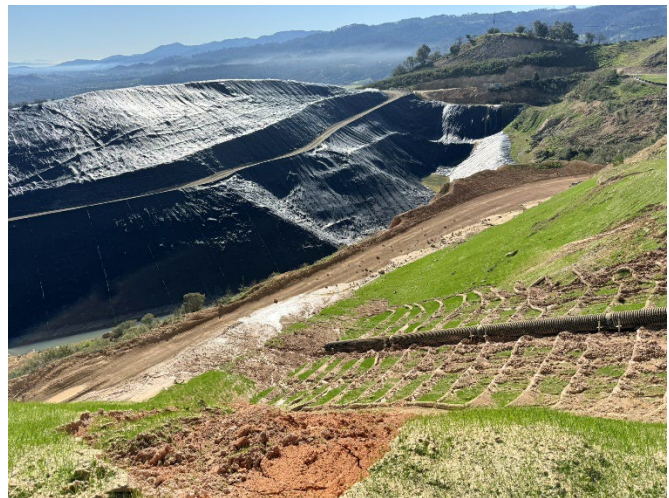
Toe of landslide, looking southwest

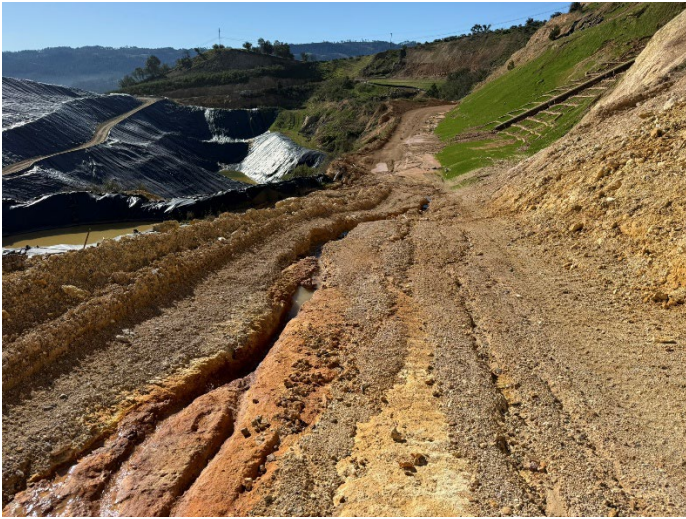
Roadway below landslide, rilling from runoff (looking W)

The newly graded road below the landslide needs minor repairs after excess stormwater runoff created rills and erosion channels. The stormwater drain at the toe of the landslide should be cleared and a stormwater dissipator added, and a culvert or drainage channel should be added along the northern side of the road leading to the drain at the toe of the slide to prevent erosion of the road during future storm events.

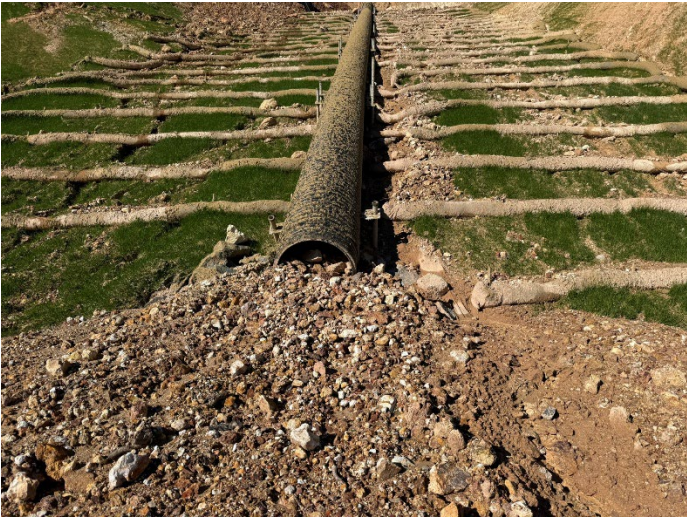
Stormwater pip below toe of landslide, filled with sediment
