GEOLOGIC HAZARD REPORT

**HOWELL MOUNTAIN CEMETERY
1225 HOWELL MOUNTAIN ROAD
ANGWIN, CALIFORNIA**

7775.01.01.2

October 25, 2023

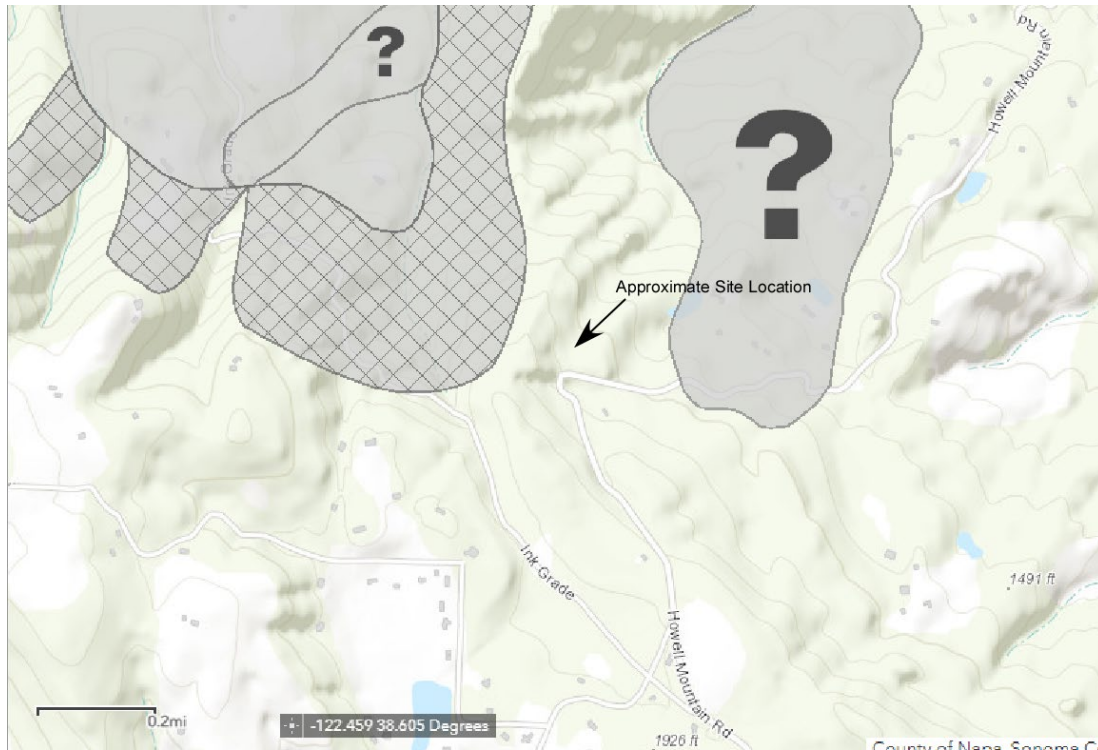
The California Landslide Inventory (CGS, 2023) does not indicate large-scale slope instability at the portion of the site to be developed. However, large-scale landslides are mapped downslope of the project site and on the opposite side of the ridge to the northwest of the development area (see below). Although not shown on the CGS map, the scarp of the landslide downslope of the project site extends upwards toward the project site. The scarp of this large-scale feature exposes undisturbed lithic tuff bedrock. The observed landslide scarp is mapped on Plate 2.

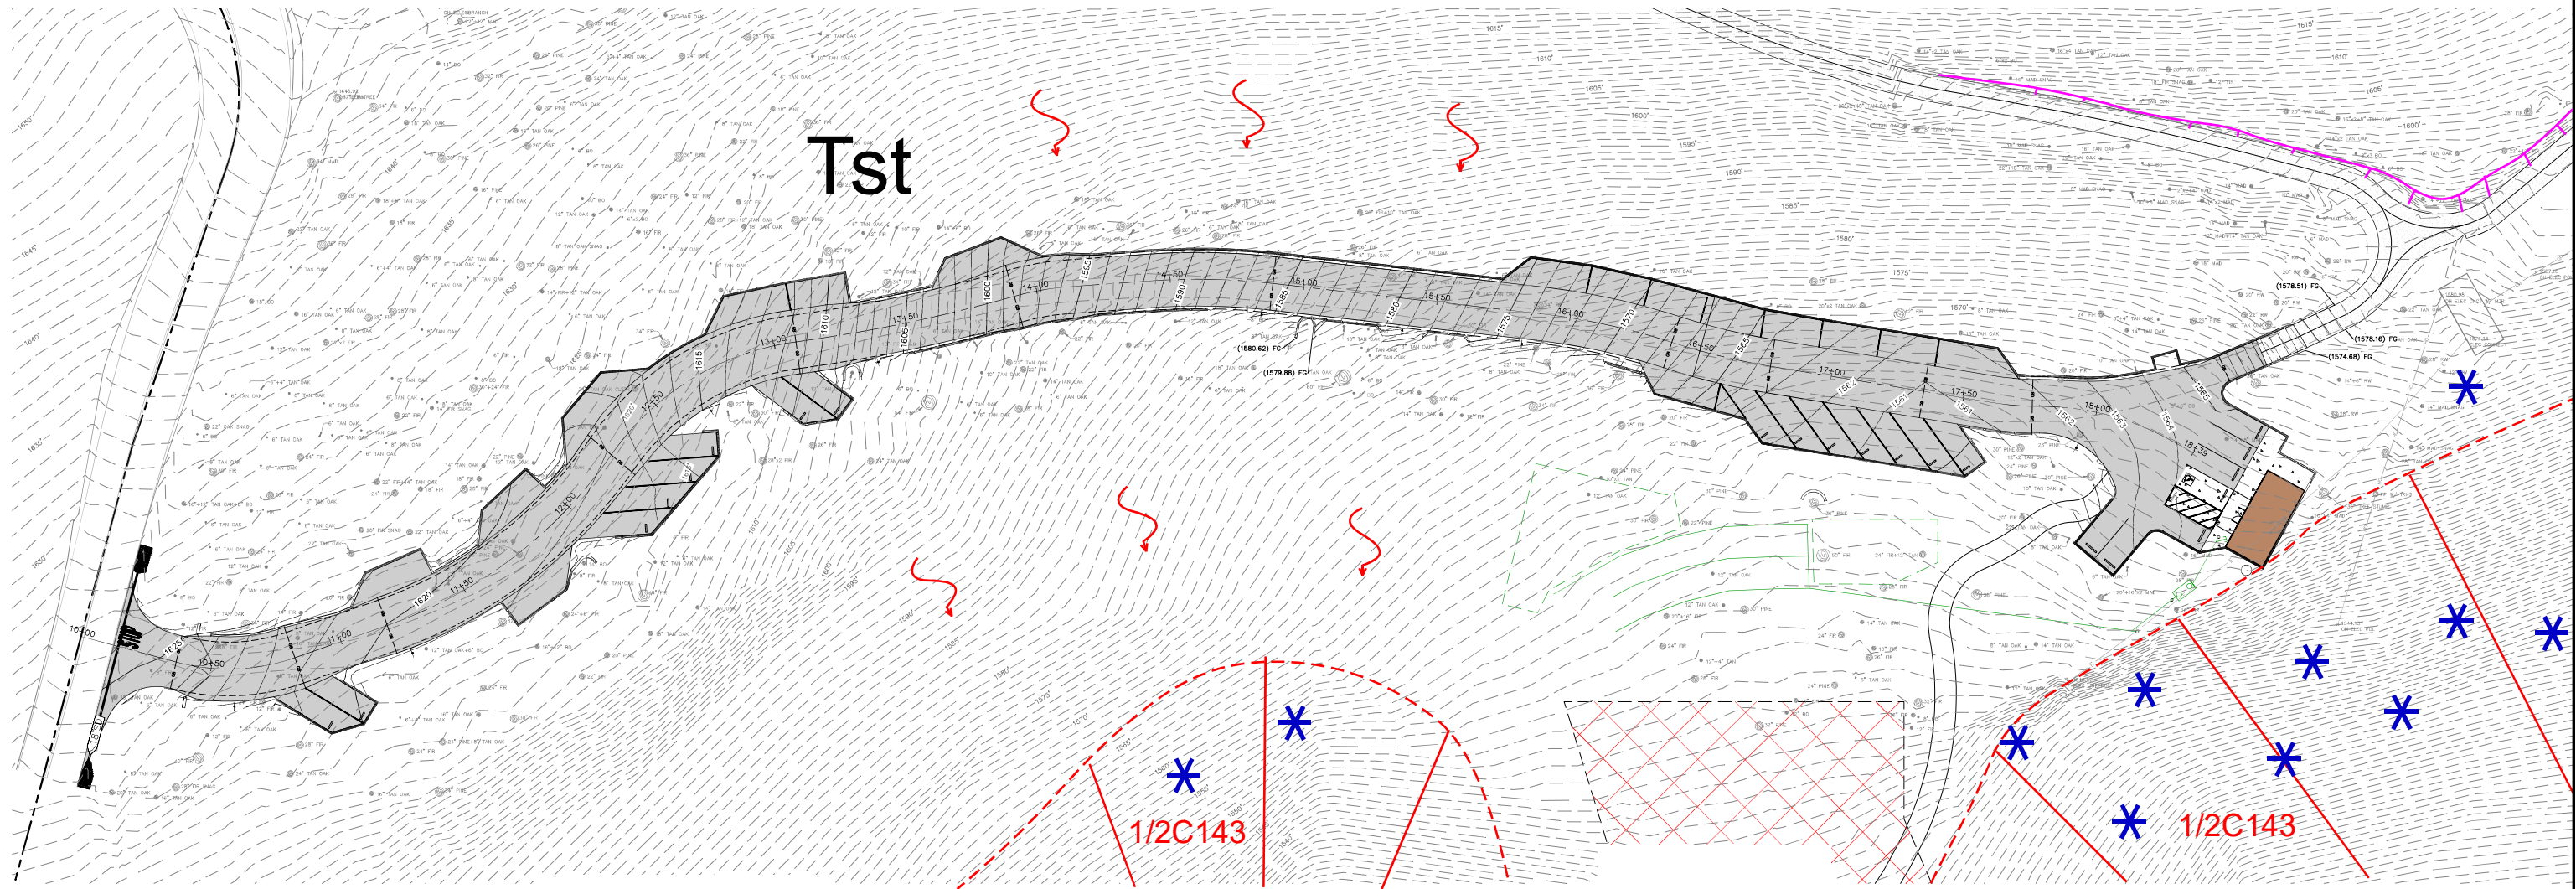
SITE RECONNAISSANCE PLAN Howell Mountain Cemetery 1225 Howell Mountain Road Angwin, California	PLATE 2
	Job No: 7775.01.01.2 Date: OCT 2023

As discussed previously, the scarp of a large scale landslide feature was mapped and observed at the project site. The observed landslide features are mapped on Plate 2. We understand that the planned development will not encroach into the landslide features, but the welcome center will be constructed adjacent to the scarp of a large landslide feature. We did observe undisturbed bedrock outcrops exposed in the scarp feature. The welcome center planned adjacent to the scarp feature should gain support in undisturbed bedrock and should have adequate lateral confinement based on the slope geometry and bedrock joint and/or bedding orientations should be considered in the foundation construction. The final geotechnical study should address these issues in detail.

The proposed building envelope for the welcome center must be located outside unstable areas and steep slopes in order to reduce the risks associated with slope instability. The location of the building envelope in relation to such areas is shown on Plate 2. A site-specific study should finalize recommended structural set back and foundation design for the welcome center.
