## Bat Habitat Assessment

Ladera Vineyards Winery  
Minor Modification P21-00294-MOD and Viewshed P22-00109  
Planning Commission Hearing June 7, 2023

**Subject: Bat habitat assessment results for Ladera Winery, Calistoga, Napa County, California**

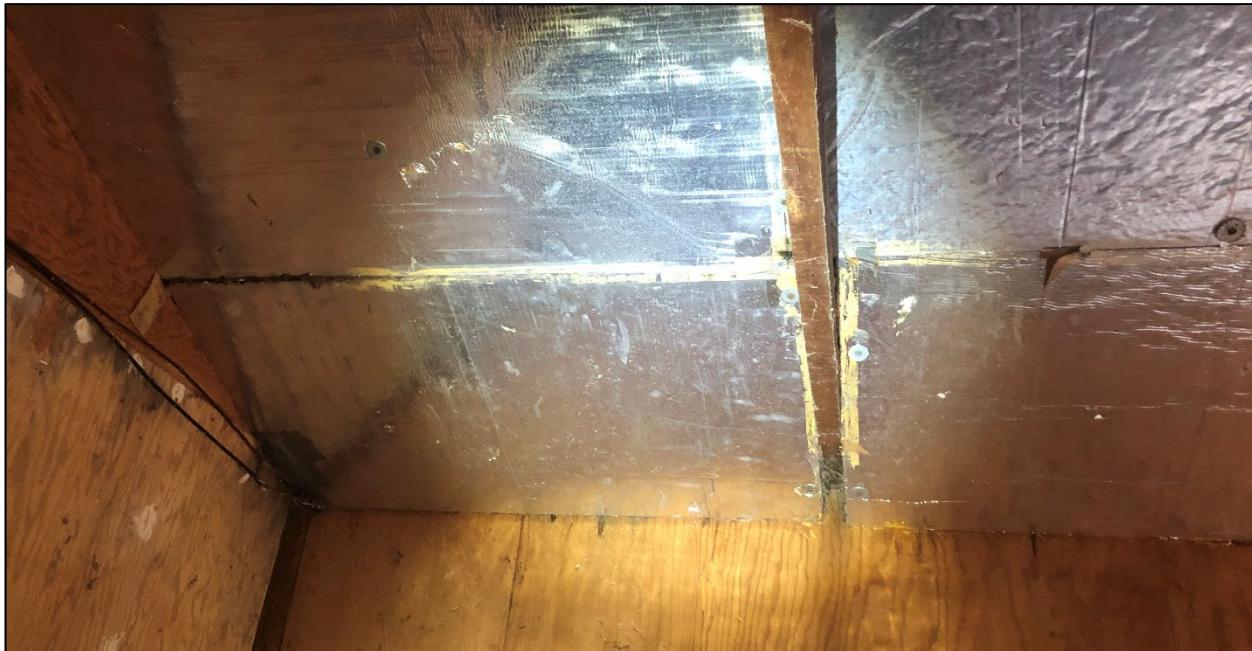
Photo 1: Looking at a typical section of roof inside the workshop. Insulation is held tight against the roof, eliminating interstitial spaces that might be occupied by bats. The workshop is also open with barn doors on either end that let in ample light and the area is regularly disturbed by workers.

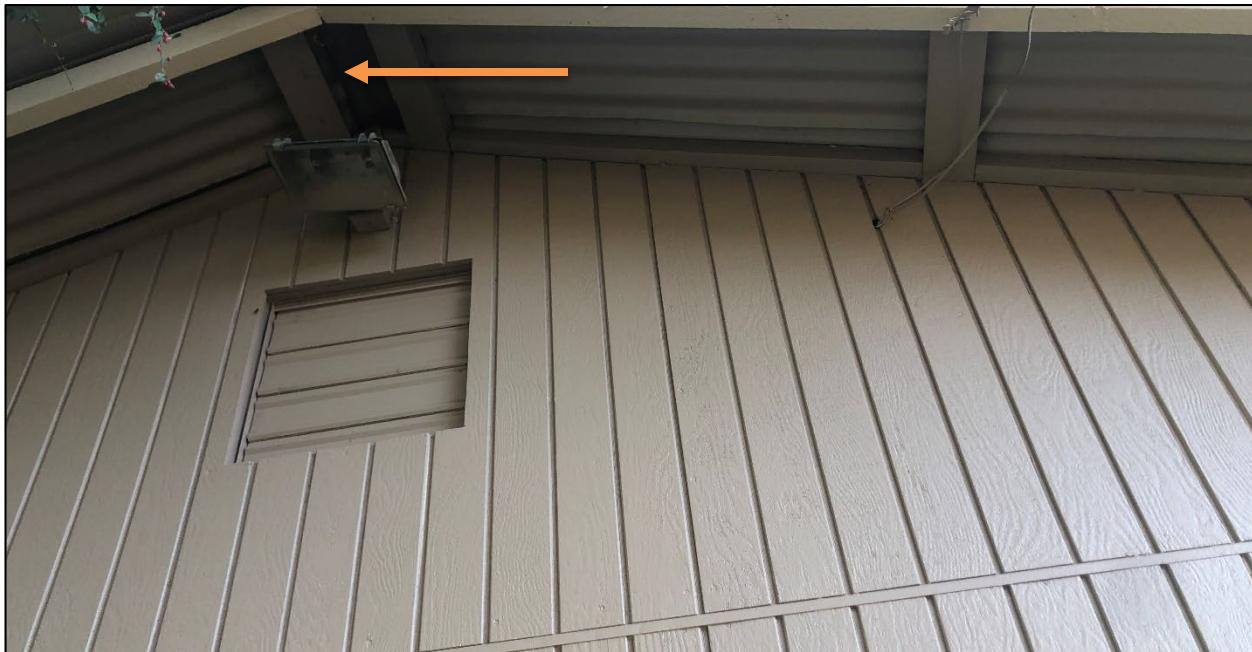
Photo 2: External roof and siding of the wine tasting/wine storage building. The metal roof is vented (see example marked by arrow) which eliminates any stable air traps that are necessary for bat roosting. The building is also sealed and regularly maintained for hygienic conditions to serve and store wine.

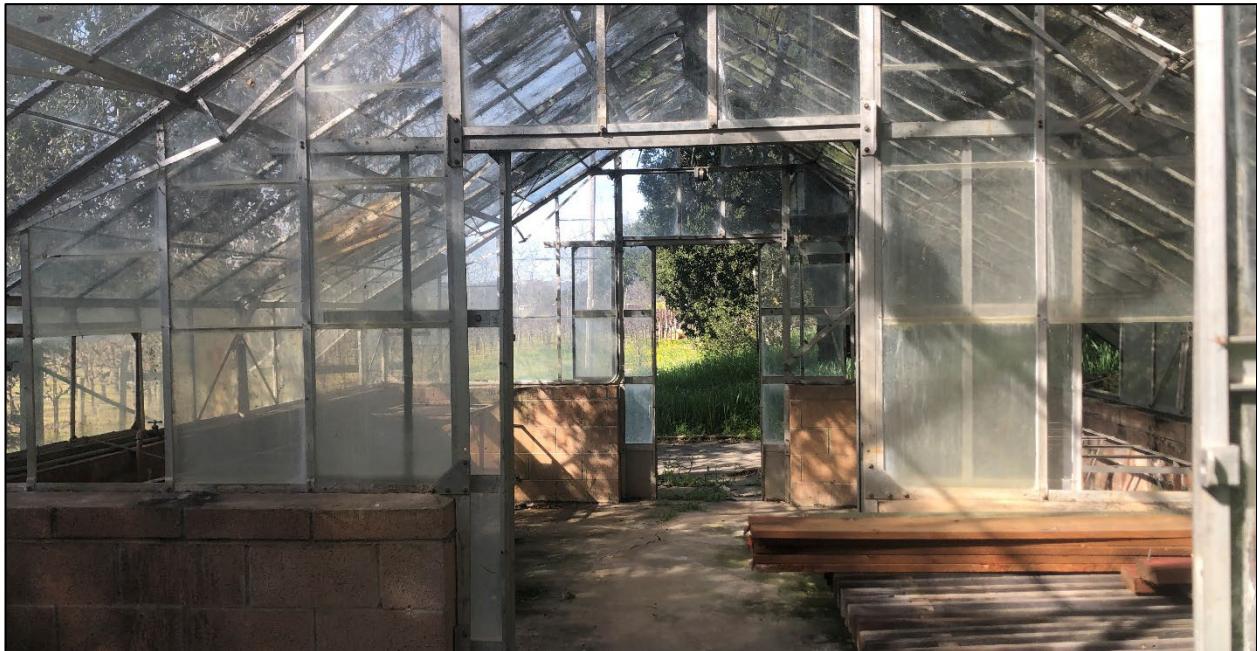
Photo 3: The greenhouse has no secluded and dark areas that may be used by bats.

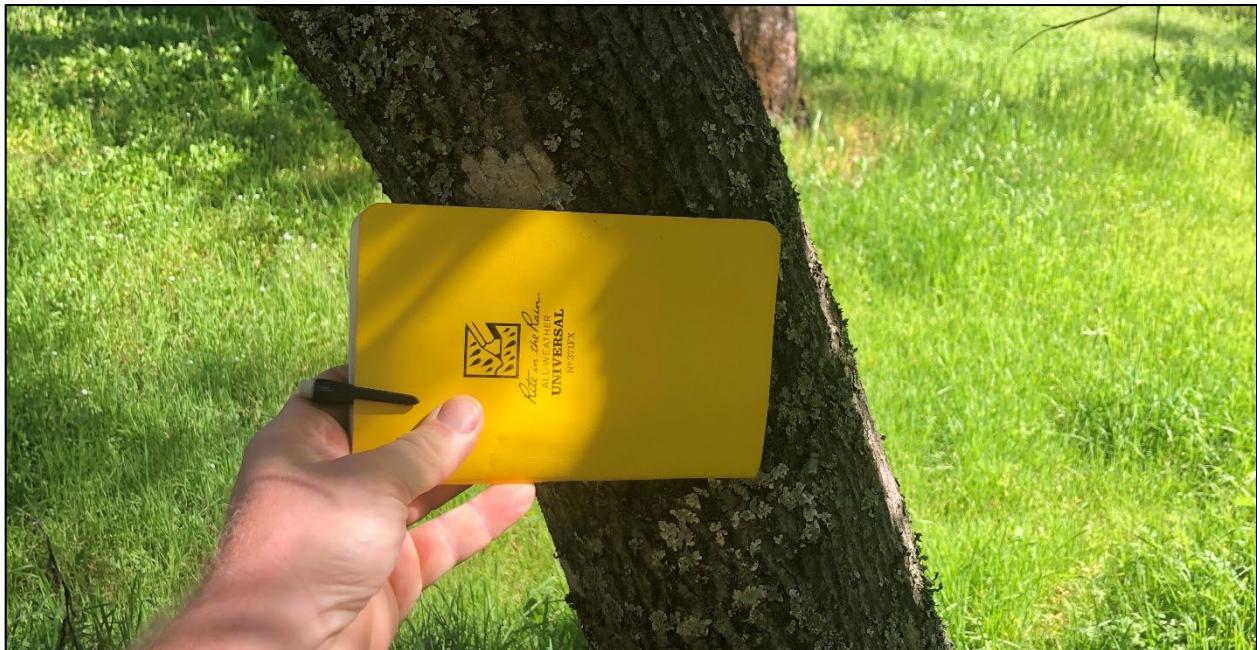
Photo 4: A typically-sized oak tree in the vicinity of the tasting room. Such trees are too small to support interstitial spaces for bat roosting.

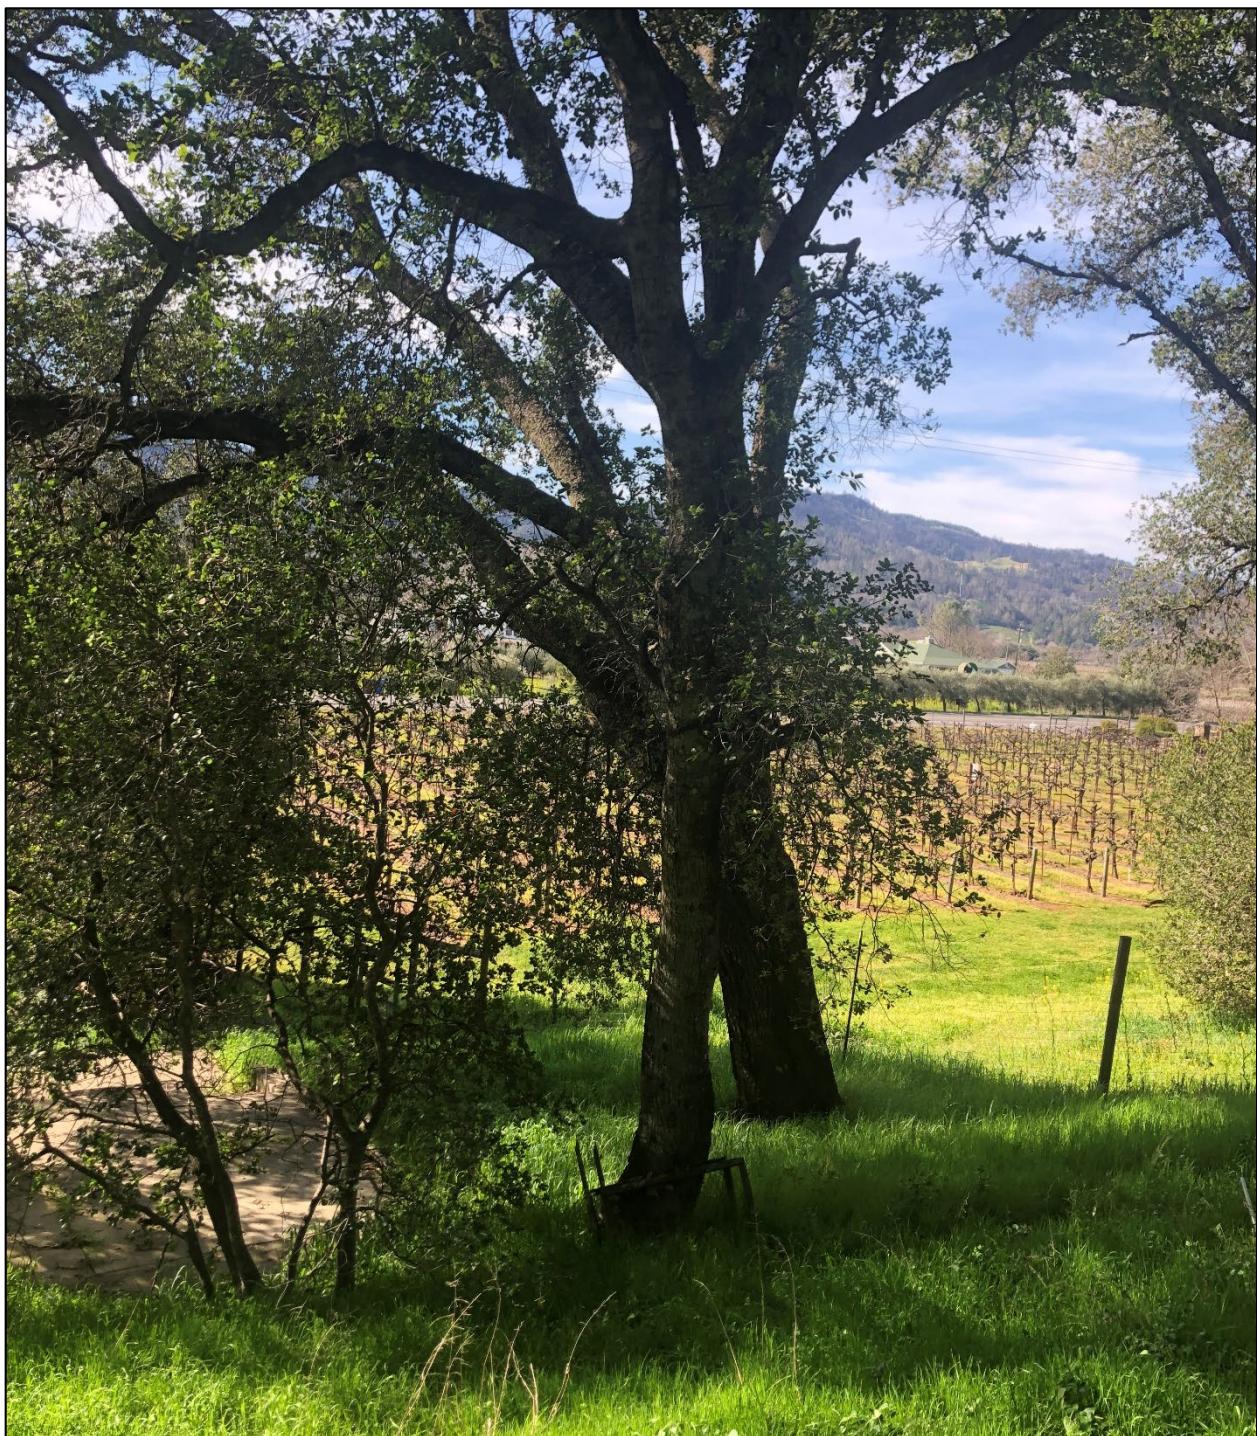
Photo 5: Larger trees like the oak shown here appeared to be healthy and showed no signs of rot. Those that showed signs of fire damage did not appear severely burned to the point at which fire might have created internal cavities.

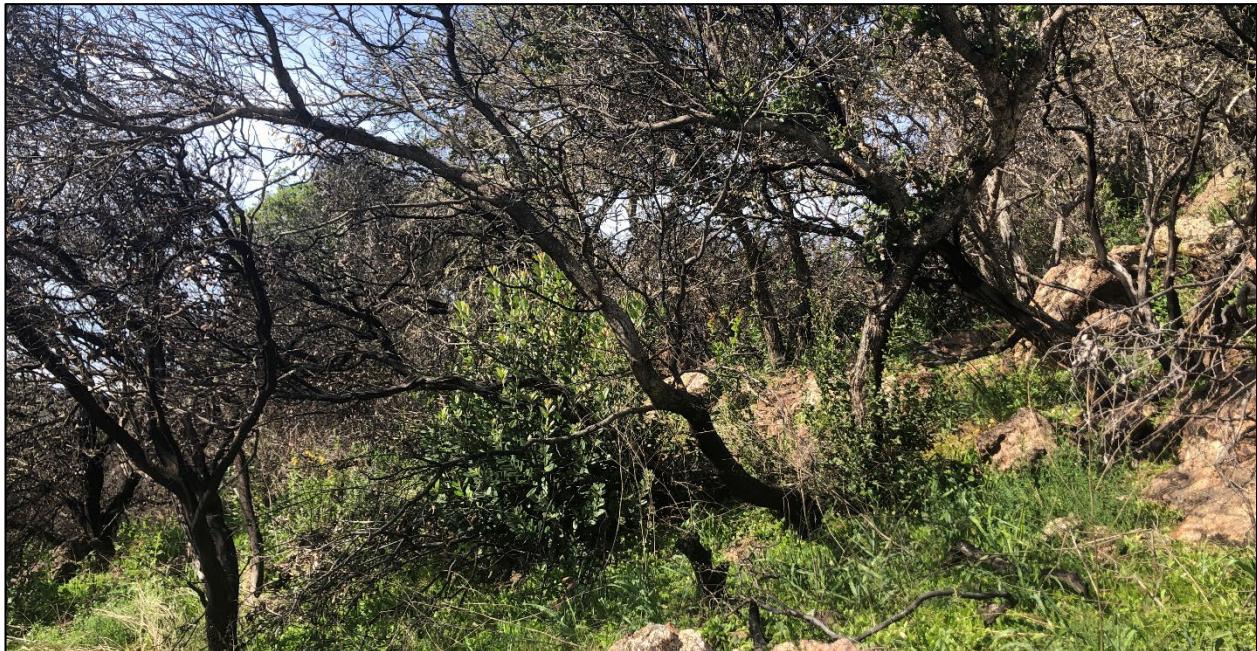
Photo 6: Area surrounding the proposed location of the new water tanks. Most of the vegetation consists of previously burned shrubs and small oaks. Rocks on the hillslope showed no signs of crevices or large vertical cracks that might be occupied by bats.

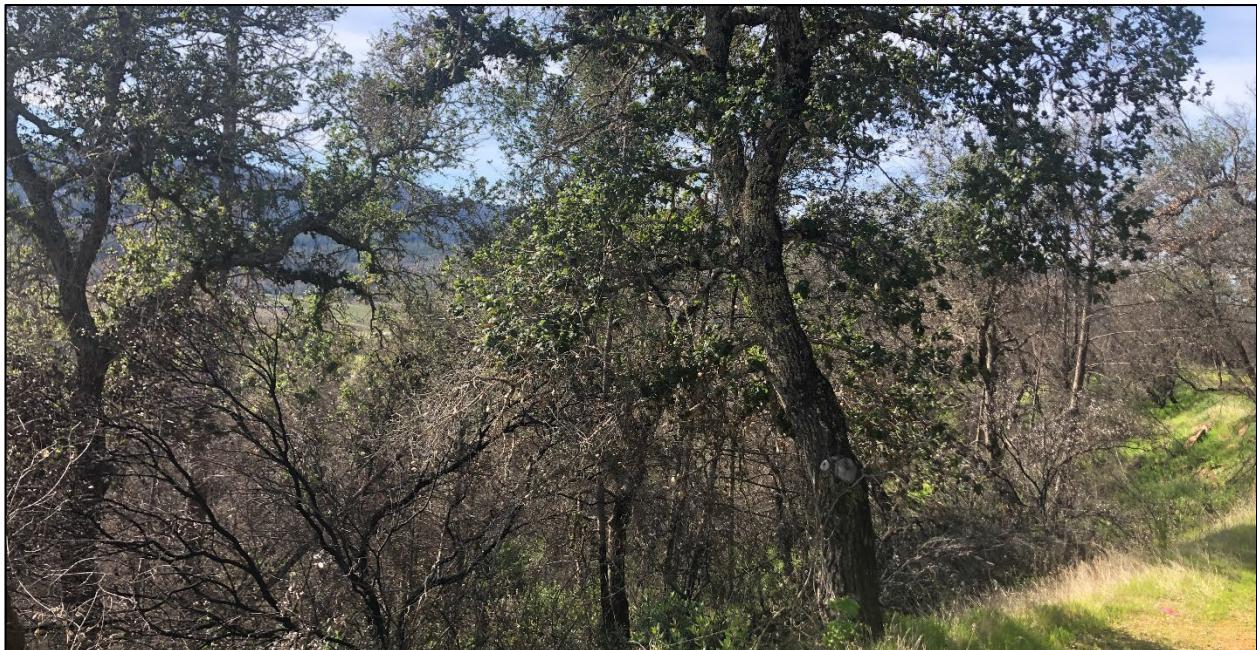
Photo 7: Area surrounding the proposed location of the new water tanks. Oaks and other trees in the vicinity of the water tank site are mostly burned, but not large enough to provide hollows/cavities suitable for bat roosting.
