# Bat Habitat Assessment

Ladera Vineyards Winery  
Minor Modification P21-00294-MOD and Viewshed P22-00109  
Planning Commission Hearing June 7, 2023

**Subject: Bat habitat assessment results for Ladera Winery, Calistoga, Napa County, California**

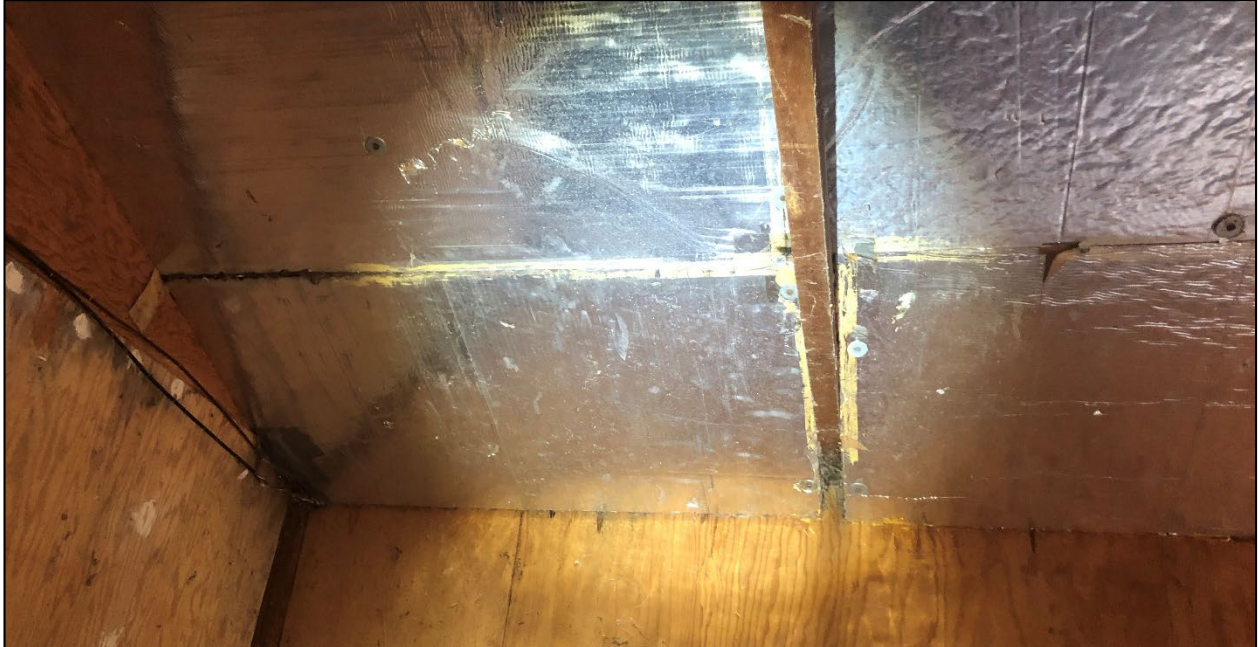
Photo 1: Looking at a typical section of roof inside the workshop. Insulation is held tight against the roof, eliminating interstitial spaces that might be occupied by bats. The workshop is also open with barn doors on either end that let in ample light and the area is regularly disturbed by workers.

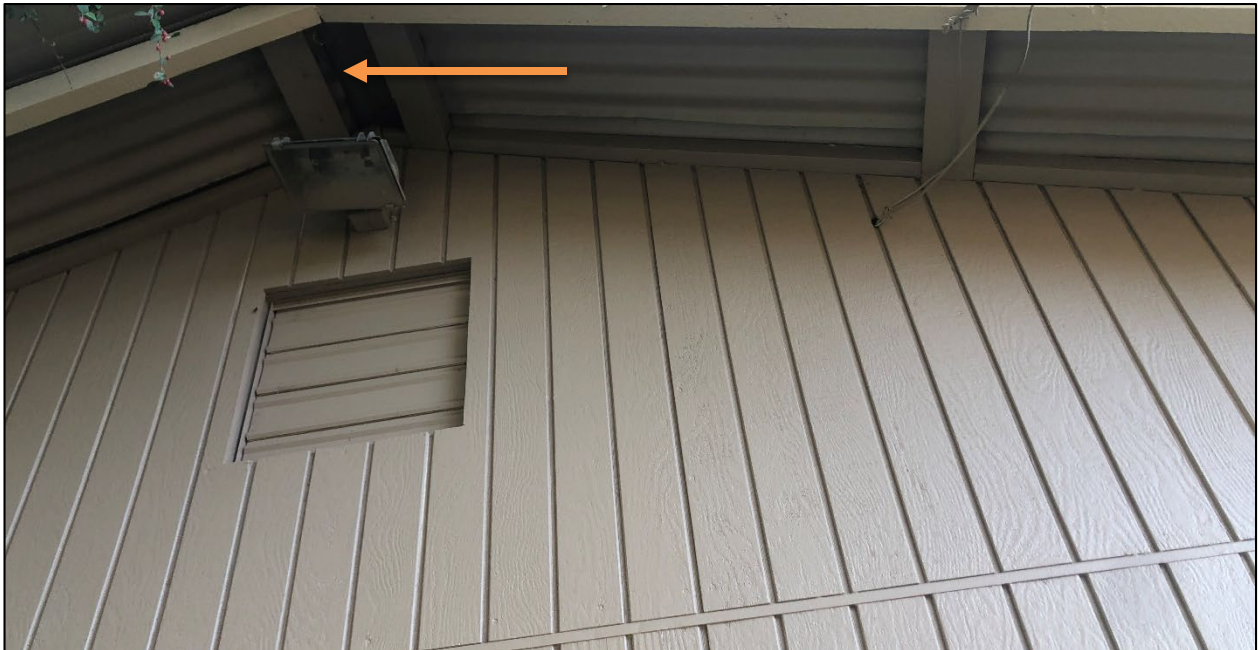
Photo 2: External roof and siding of the wine tasting/wine storage building. The metal roof is vented (see example marked by arrow) which eliminates any stable air traps that are necessary for bat roosting. The building is also sealed and regularly maintained for hygienic conditions to serve and store wine.

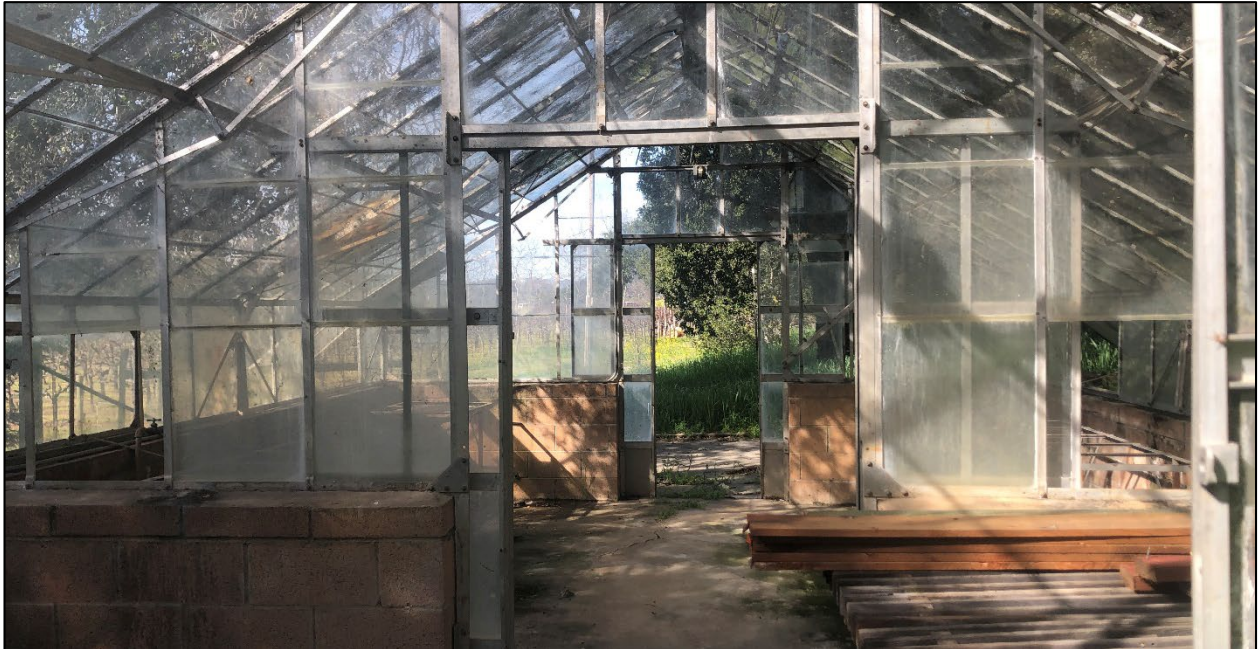
Photo 3: The greenhouse has no secluded and dark areas that may be used by bats.

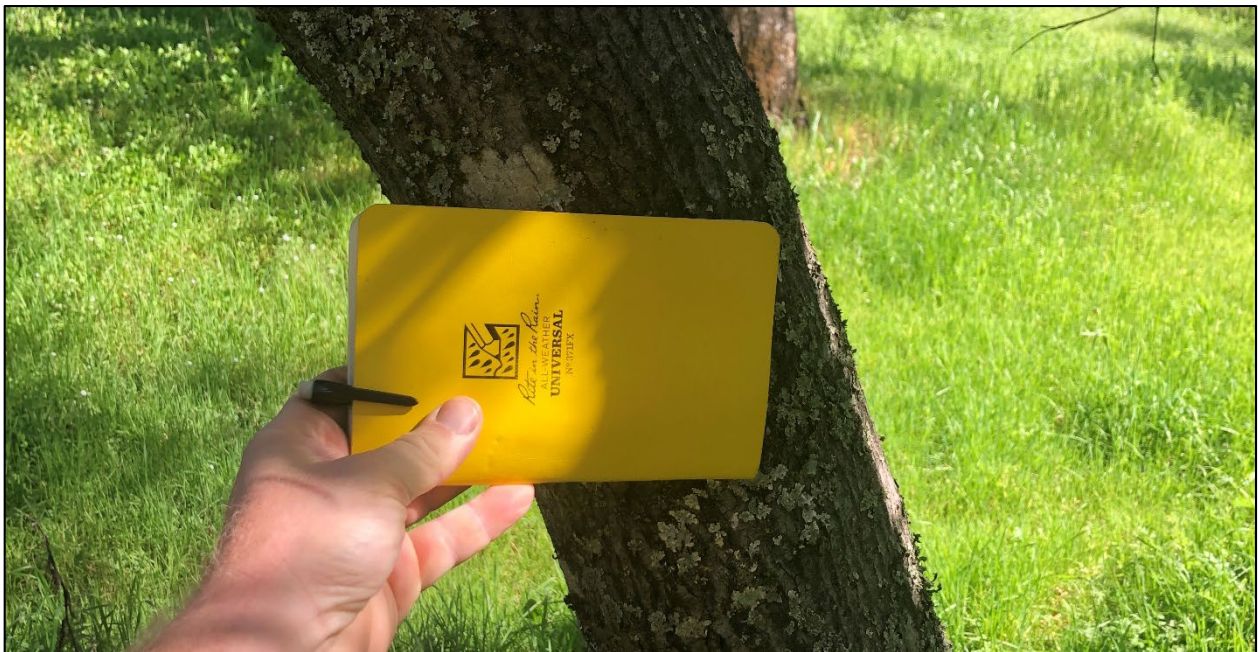
Photo 4: A typically-sized oak tree in the vicinity of the tasting room. Such trees are too small to support interstitial spaces for bat roosting.

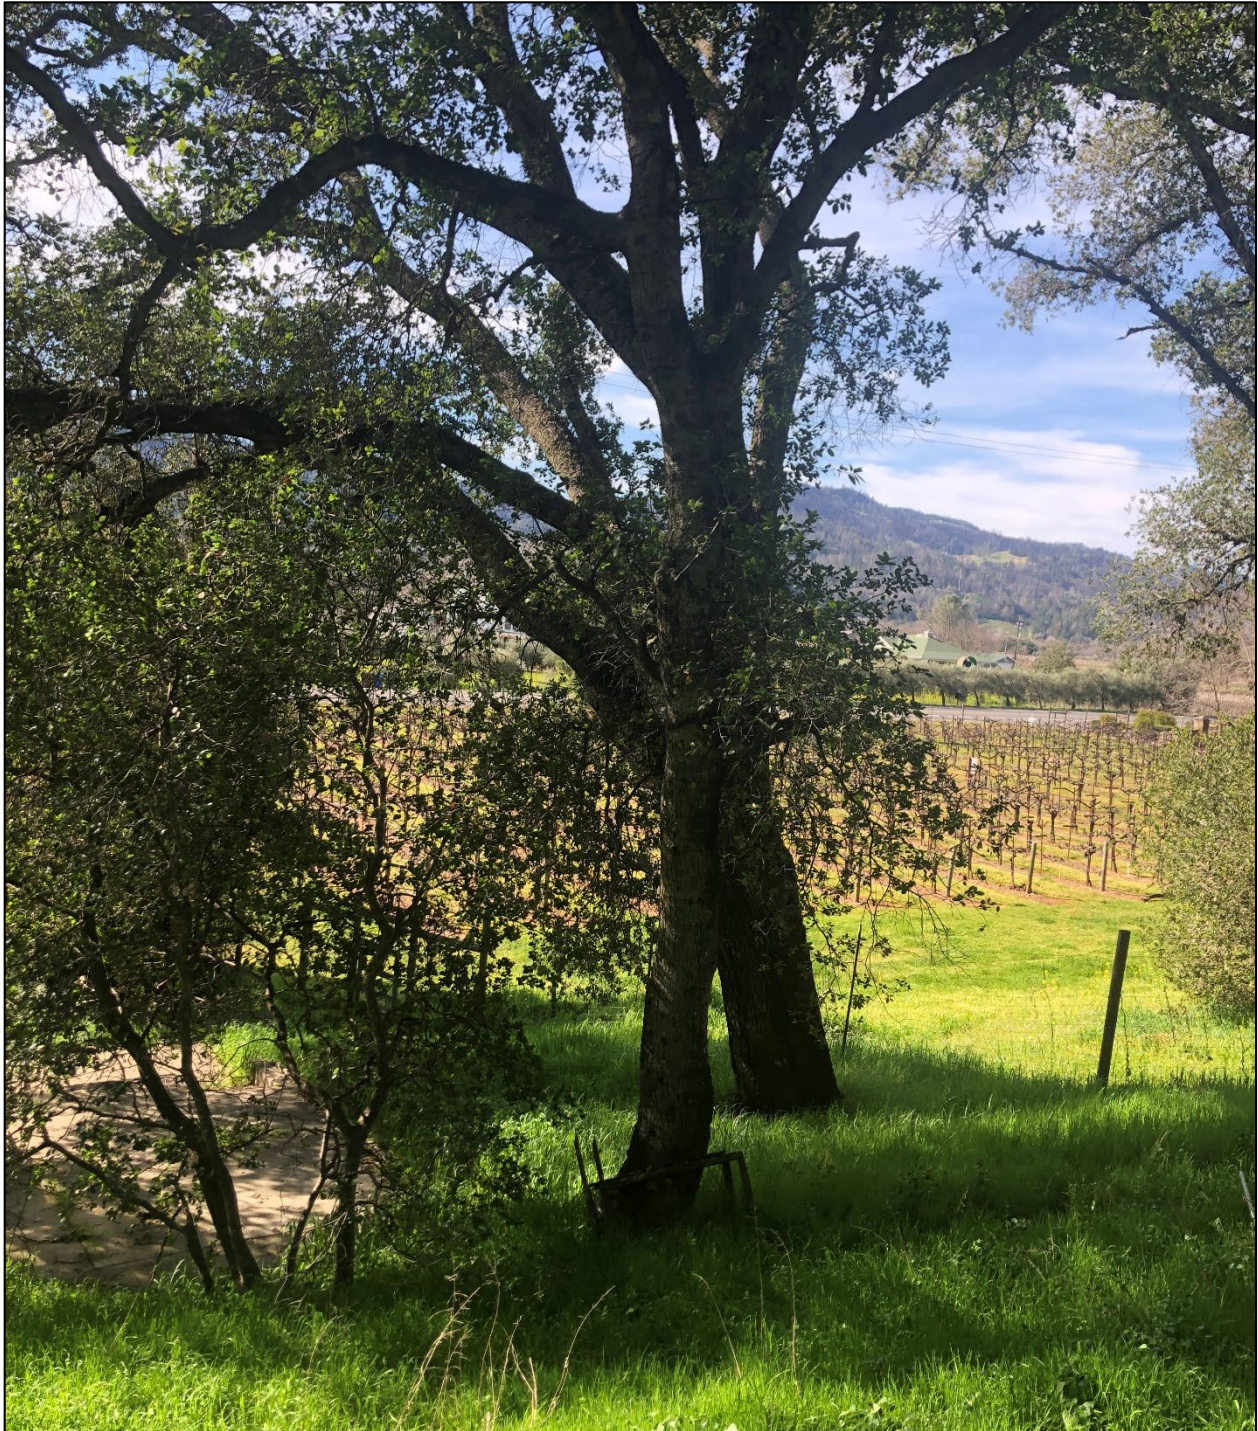
Photo 5: Larger trees like the oak shown here appeared to be healthy and showed no signs of rot. Those that showed signs of fire damage did not appear severely burned to the point at which fire might have created internal cavities.

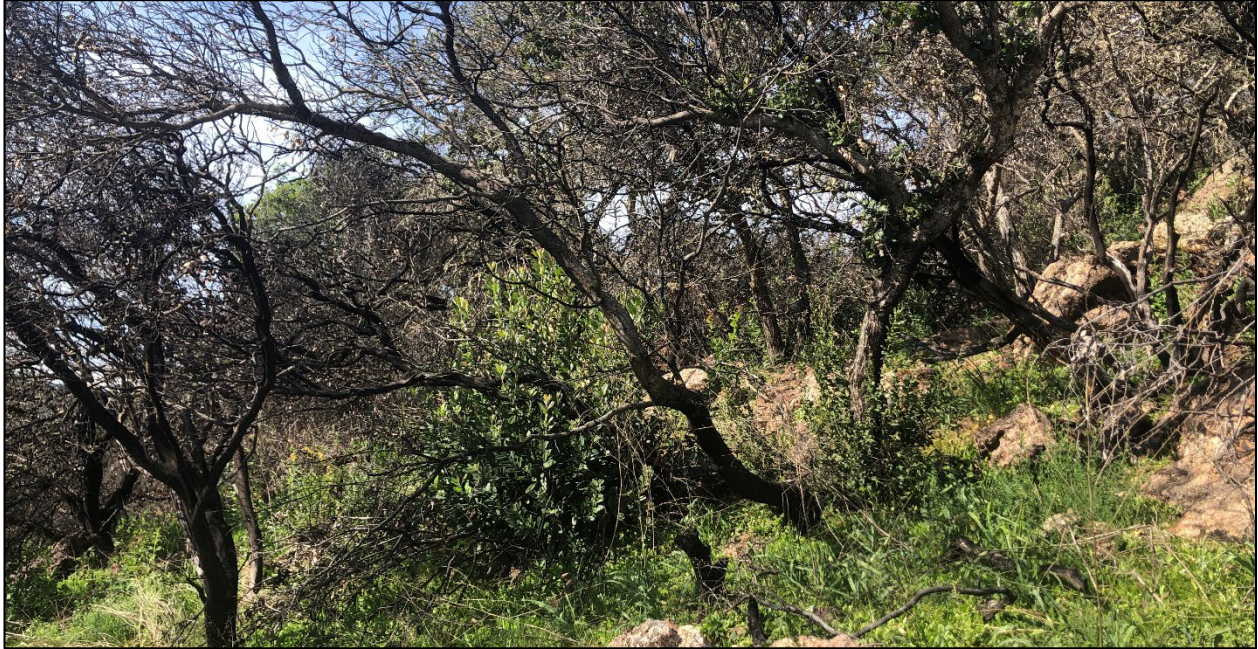
Photo 6: Area surrounding the proposed location of the new water tanks. Most of the vegetation consists of previously burned shrubs and small oaks. Rocks on the hillslope showed no signs of crevices or large vertical cracks that might be occupied by bats.

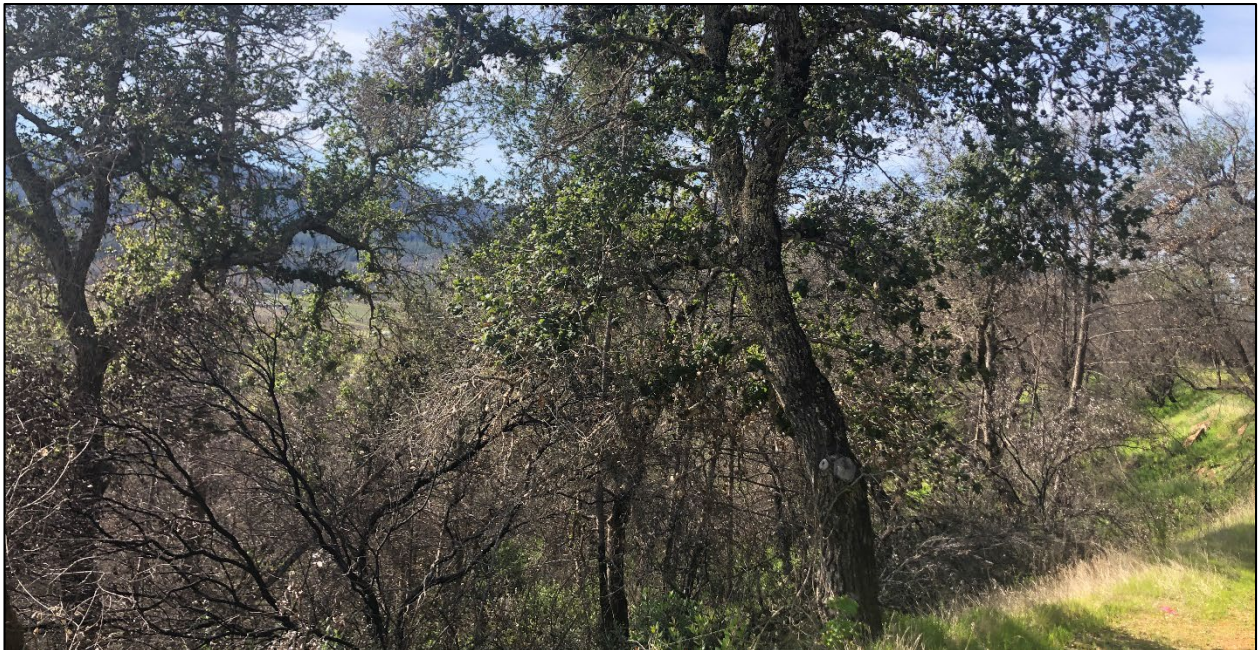
Photo 7: Area surrounding the proposed location of the new water tanks. Oaks and other trees in the vicinity of the water tank site are mostly burned, but not large enough to provide hollows/cavities suitable for bat roosting.
