Bat Habitat Assessment

Ladera Vineyards Winery
Minor Modification P21-00294-MOD and Viewshed P22-00109
Planning Commission Hearing May 3, 2023

Subject: Bat habitat assessment results for Ladera Winery, Calistoga, Napa County, California

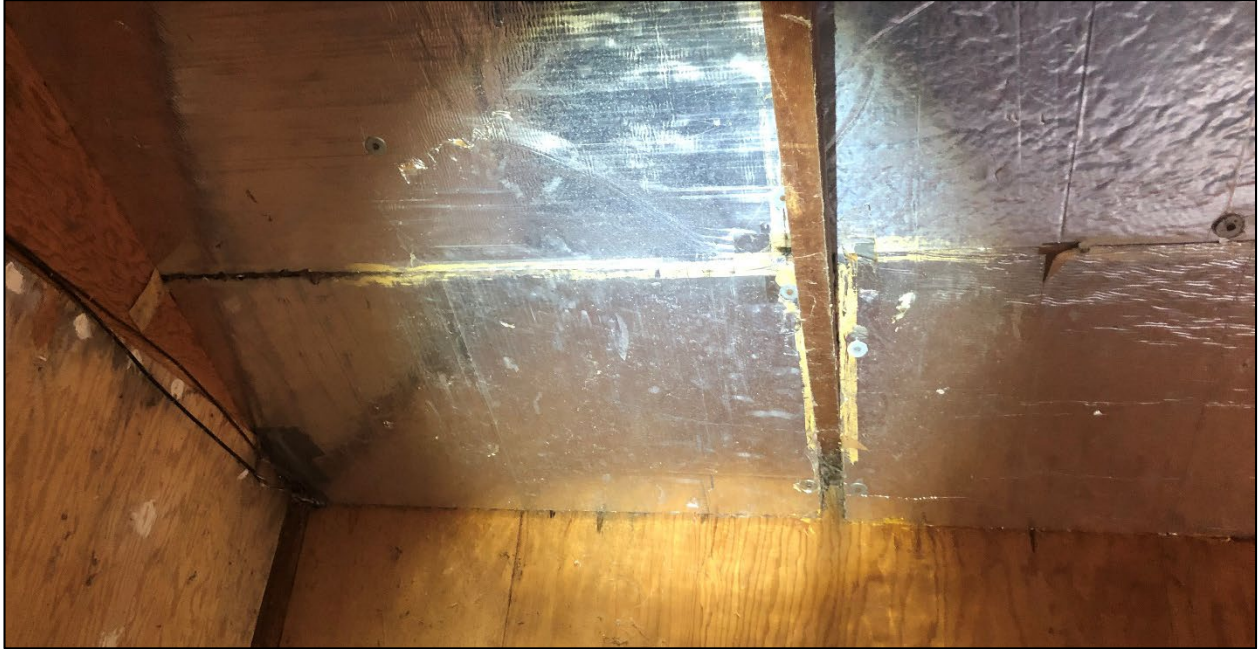
Photo 1: Looking at a typical section of roof inside the workshop. Insulation is held tight against the roof, eliminating interstitial spaces that might be occupied by bats. The workshop is also open with barn doors on either end that let in ample light and the area is regularly disturbed by workers.

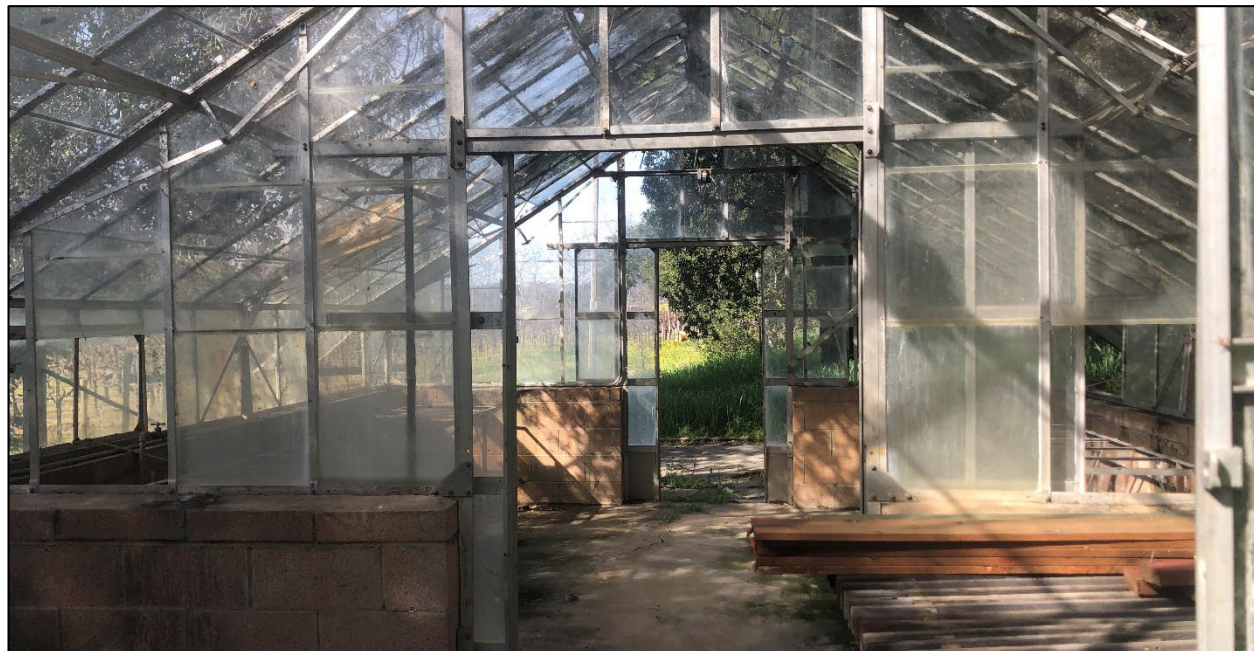
Photo 3: The greenhouse has no secluded and dark areas that may be used by bats.

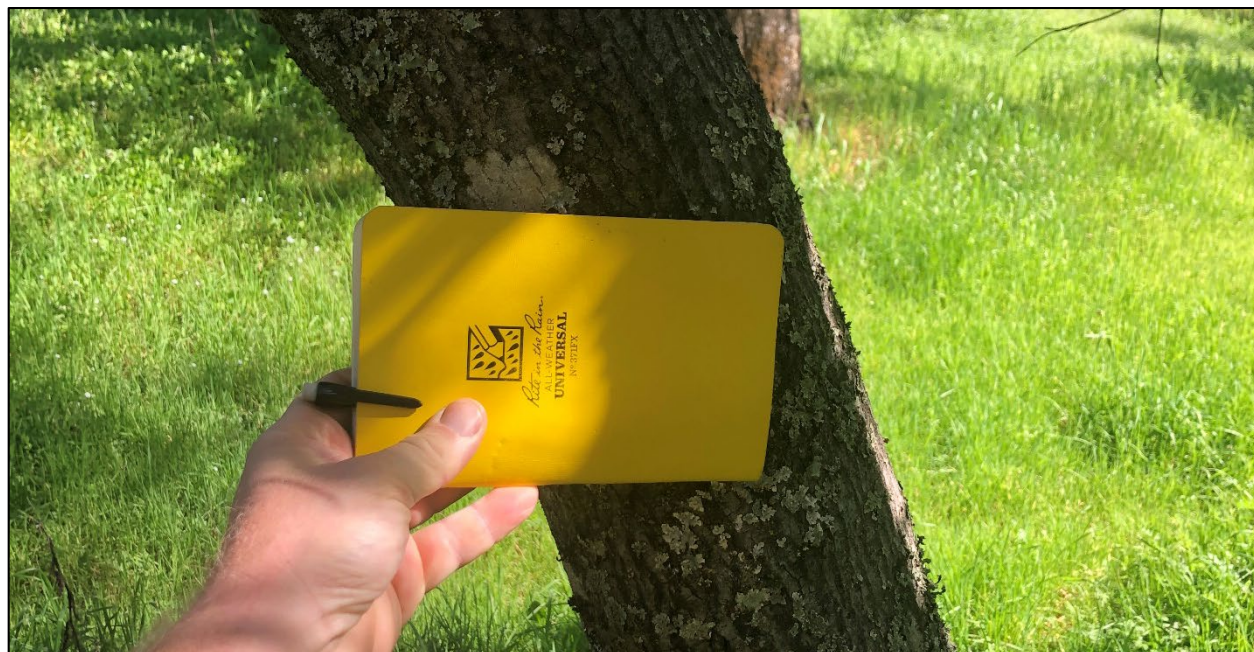
Photo 4: A typically-sized oak tree in the vicinity of the tasting room. Such trees are too small to support interstitial spaces for bat roosting.

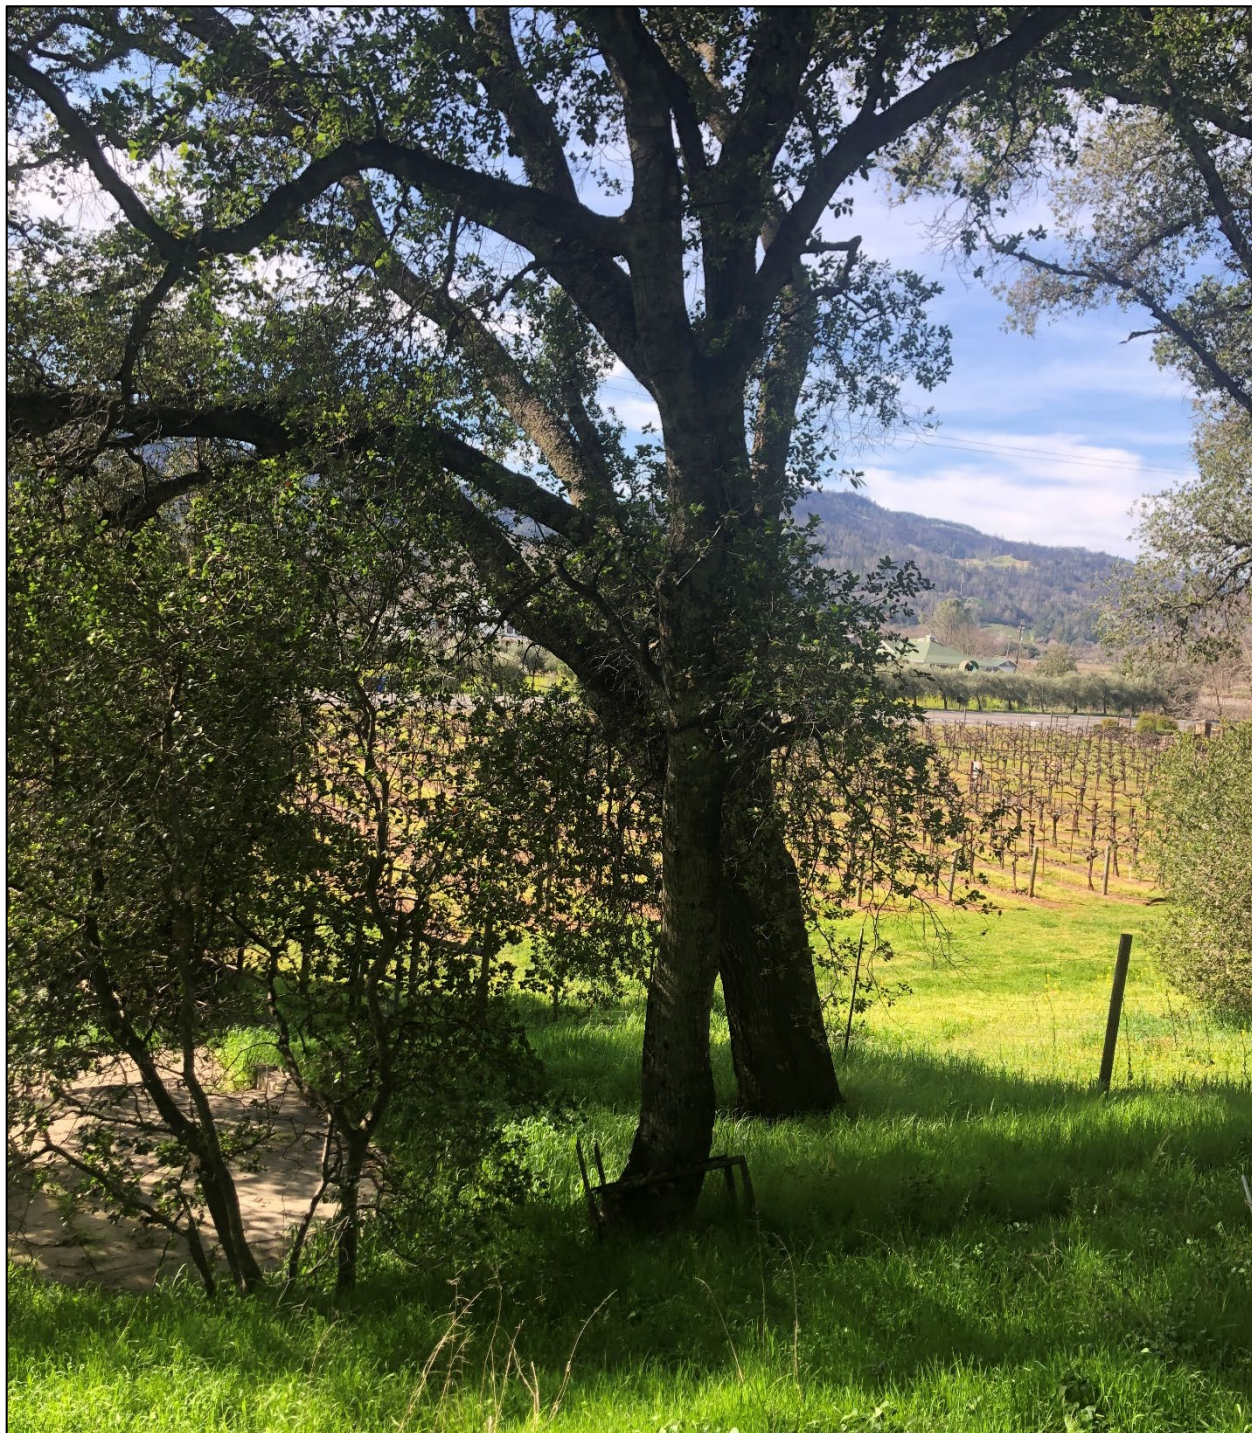
Photo 5: Larger trees like the oak shown here appeared to be healthy and showed no signs of rot. Those that showed signs of fire damage did not appear severely burned to the point at which fire might have created internal cavities.
