Historical Resource Evaluation

Stewart Ranch Micro Winery Use Permit P23-00178-UP Zoning Administrator Hearing - June 25, 2025

HISTORIC RESOURCE EVALUATION AND SECRETARY OF INTERIOR'S STANDARDS FOR THE TREATMENT OF HISTORIC PROPERTIES REVIEW OF THE PROPERTY AT 2195 GOLDEN GATE DRIVE, IN UNINCORPORATED NAPA COUNTY, CALIFORNIA

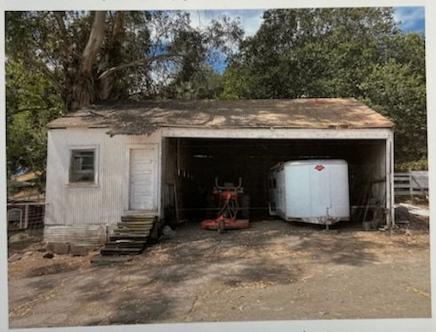
Figure 57. Northeast elevation, facing southwest.

The ca. 1940 garage is a Vernacular form, consisting of a side-facing gable building with a rectangular footprint, where only the southern third of the building is enclosed. The wood-framed building is clad with corrugated metal on the walls and roof. The enclosed section of the building is on a raised pier foundation, while the open section has an asphalt floor that follows the natural slope of the hill. On the northeast elevation, the enclosed section consists of a one-over-one wood window to the south of a wood-paneled door (Figure 57). The door is accessed via a wood stair of seven steps. While only a third of the northeast elevation is enclosed, the remaining section is exposed as a covered parking area for farm equipment. The southeast elevation consists of two one-over-one wood windows (Figure 58). Neither the northwest nor northeast elevations have any fenestration (Figure 59).
