Bridge Condition Review

RE: Bridge Conditions Review
ZFA Job No.: 21695

Diamond Creek - Stone Arch Bridge Review

RE: Diamond Creek Bridge Review and Recommendations

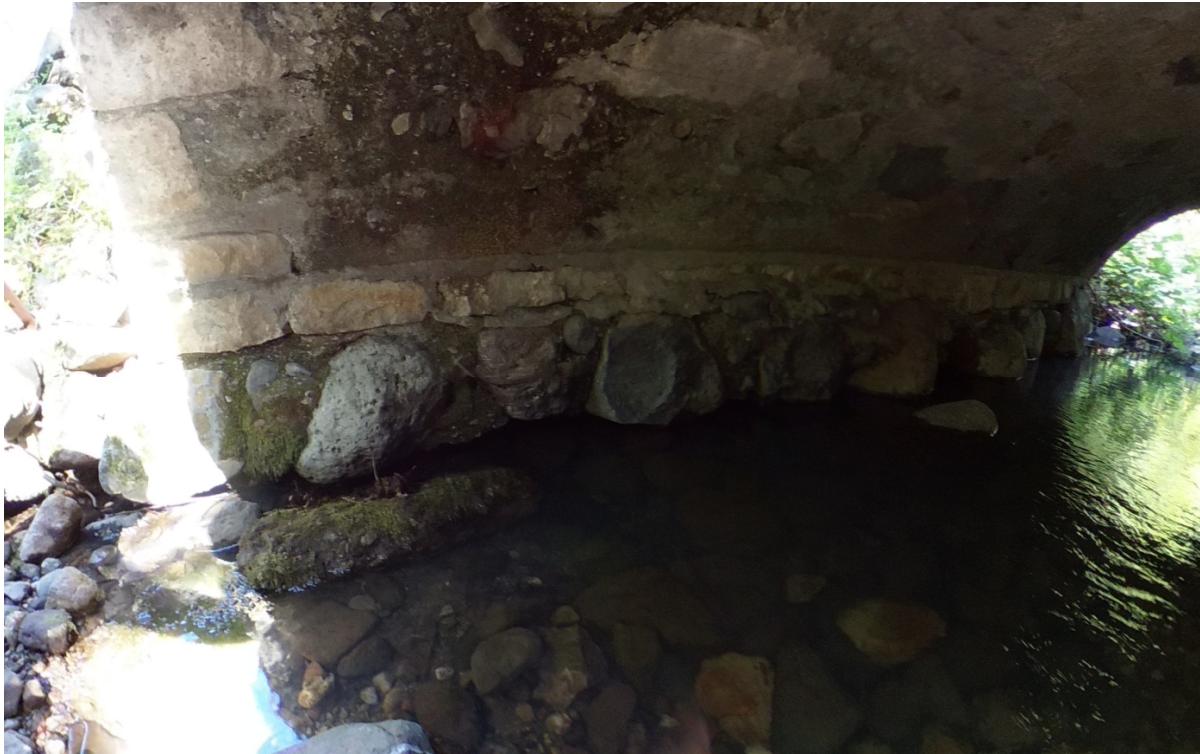
Photo 1: West arch foundation

1. The erosion undermining the west arch foundation has worsened since the original report, with measurements up to 27-inches horizontally perpendicularly underneath the stone arch foundation. This undermining could lead to loss of soil support of the bridge structure.

ZFA recommends that the undermined arch foundations be repaired to regain their full soil bearing support and protected from future erosion/scour. This repair could be conducted by structurally and completely filling the void under the undermined foundation walls with a concrete or soil slurry and covering the repair with rubble rock to reduce the risk of repeated erosion.

Any repair should be coordinated with the appropriate state and local jurisdictions. ZFA recommends these repairs to be commenced as soon as possible and completed prior to next winter's rainy season. Until this repair is in place, we recommend that the foundations and bridge be reviewed during each month from November to March to review for further erosion or signs of structural distress.

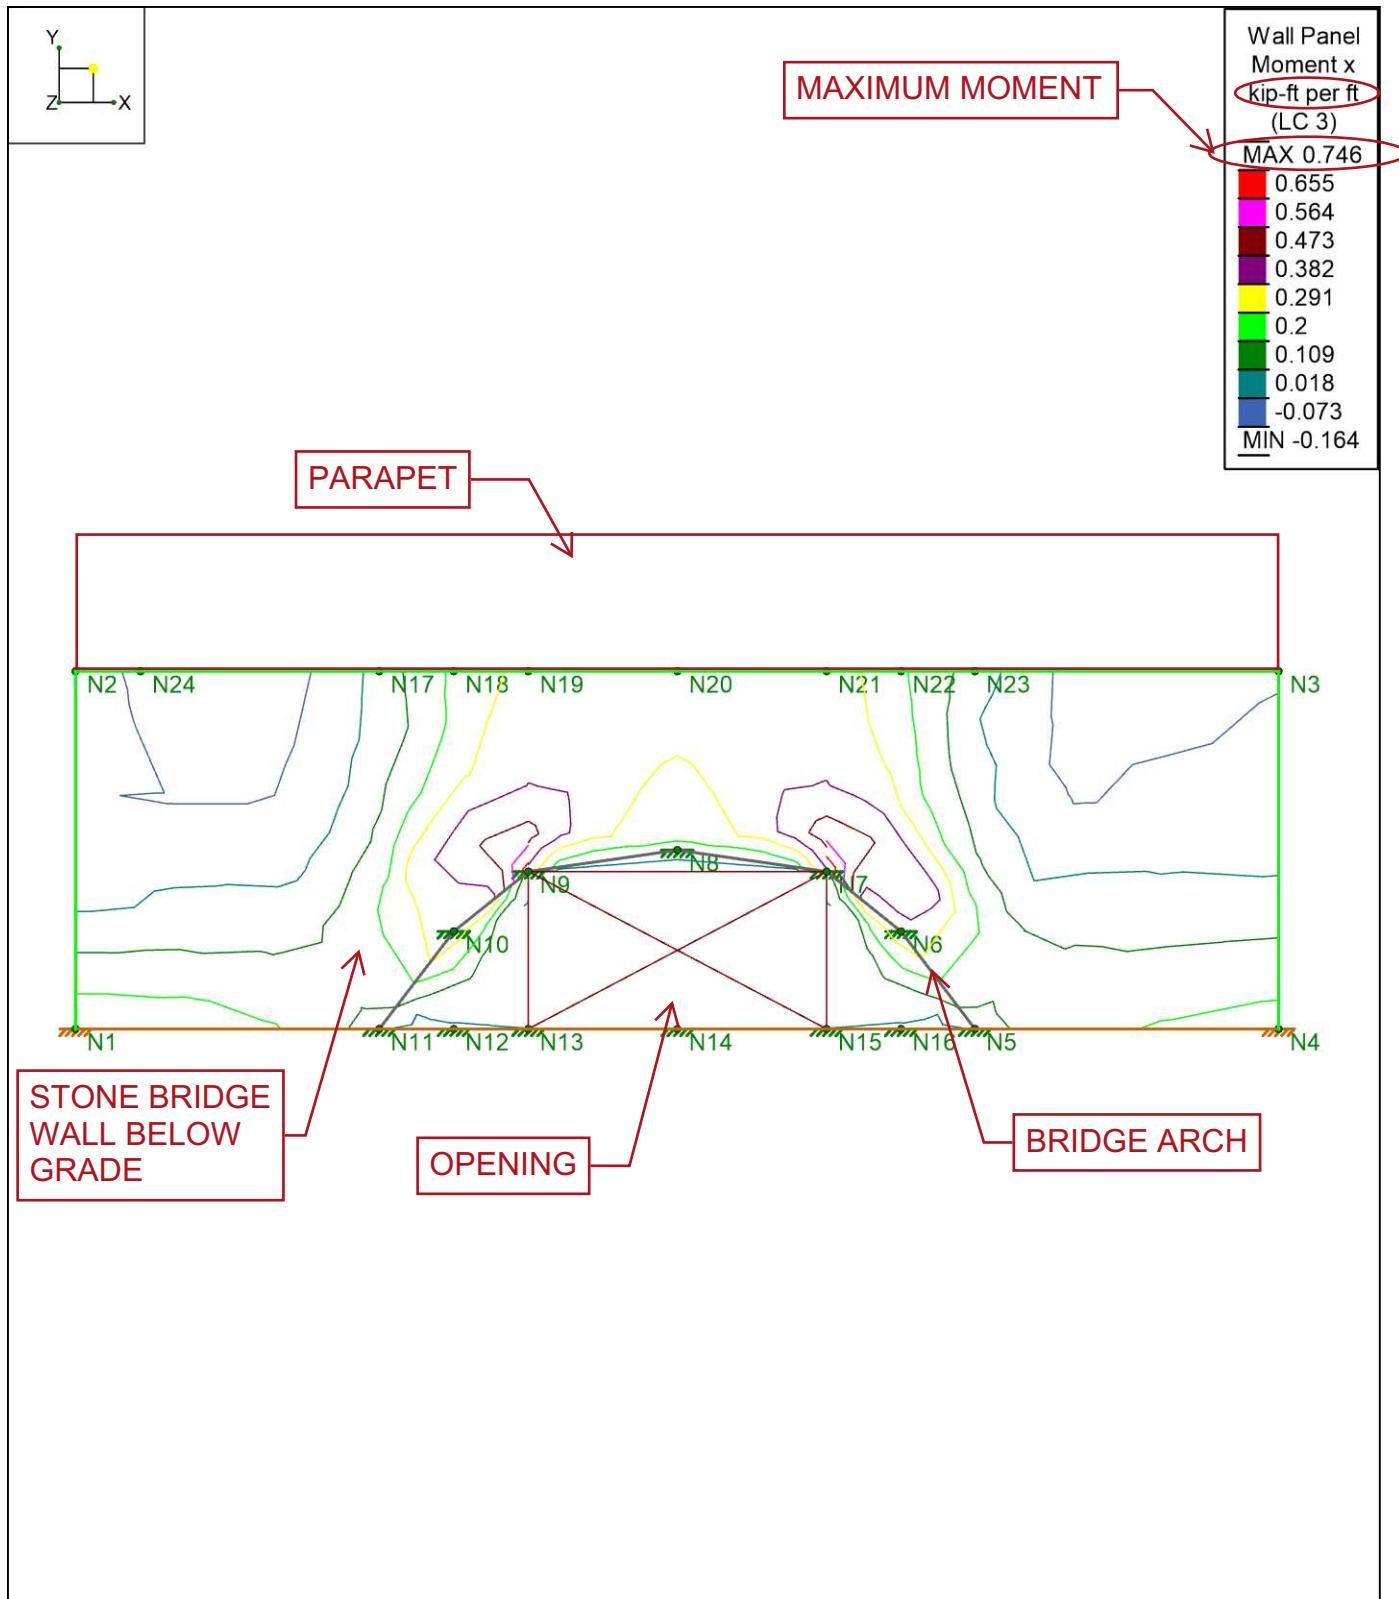
SK-1

Results for LC 3, Horizontal Only

RETAINED SOIL PRESSURE

SURCHARGE LOAD FROM VEHICLE = 2'x SOIL PRESSURE

The Napa County comments also requested to update the previously provided load rating to include the entire bridge, including the unreinforced masonry (URM) head walls. Although the end wall thicknesses could not be directly observed or measured in the field, the wall thickness was assumed to be uniform to the parapet portion of the wall.

The wall was analyzed using an assume active loading of 40 pounds per cubic foot, and a soil surcharge load equivalent to an additional 2' of retained soil height was analyzed placed on the wall per AASHTO Table 3.11.6.4.2. The analysis concluded that the stress on the mortar was less than the allowable default lower-bound tensile strength per the ASCE 41-17 / Table 11-2a,

concluding that the head walls are adequate to support the vehicular surcharge loading and retained soil.

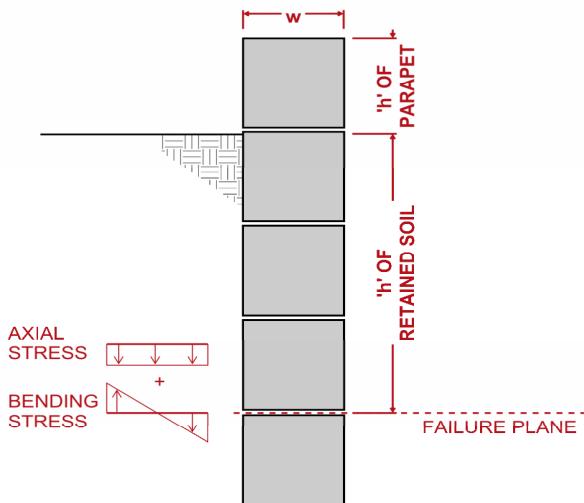
Spandrel Walls as Gravity Retaining Walls

Find 'h' max such that the tension caused by bending minus the axial compression is equal to the rupture stress of grout

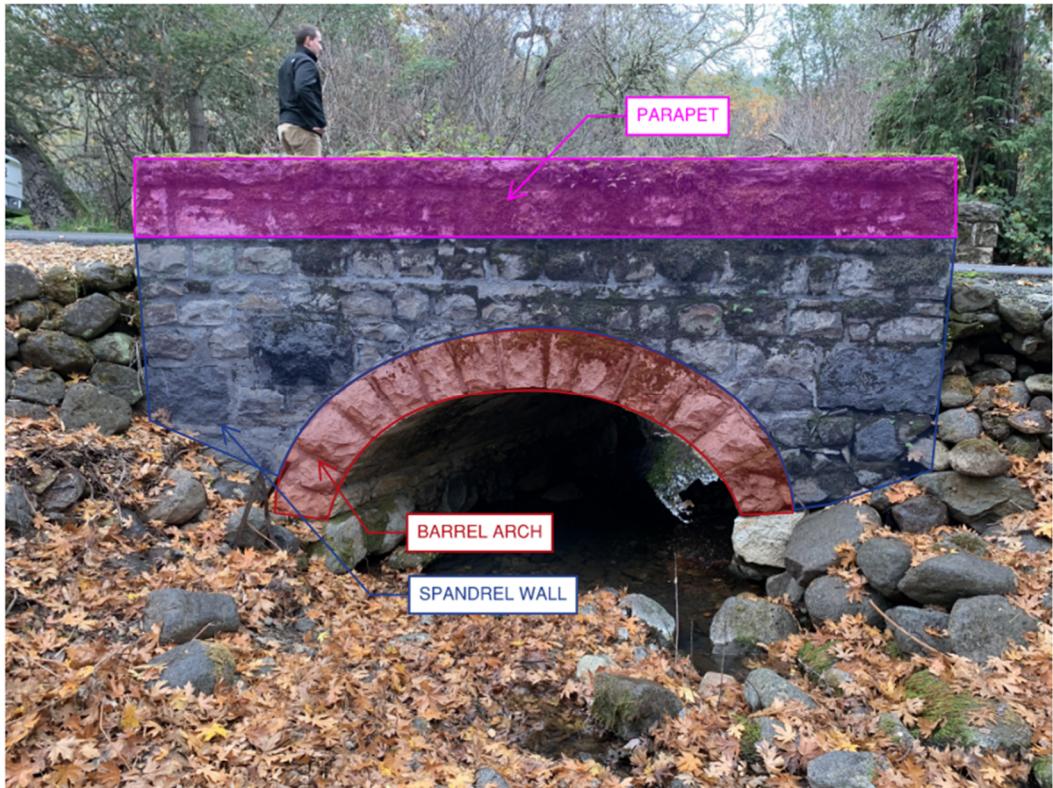
Photo 1: Labeled Elevation View

On December 6th, ZFA visited the project site to review and document the historic masonry bridge structure. The bridge structure is comprised of a stone masonry barrel arch and spandrel walls with an engraving indicating the structure was constructed in 1885. The barrel arch spans approximately 9'-2" with a rise at the crown of approximately 4'-0", see Appendix B photos of the existing bridge. The masonry arch soffit has what appears to be the original lime-based mortar, but portions of the spandrel walls appear to have been repointed with a cement-based mortar.

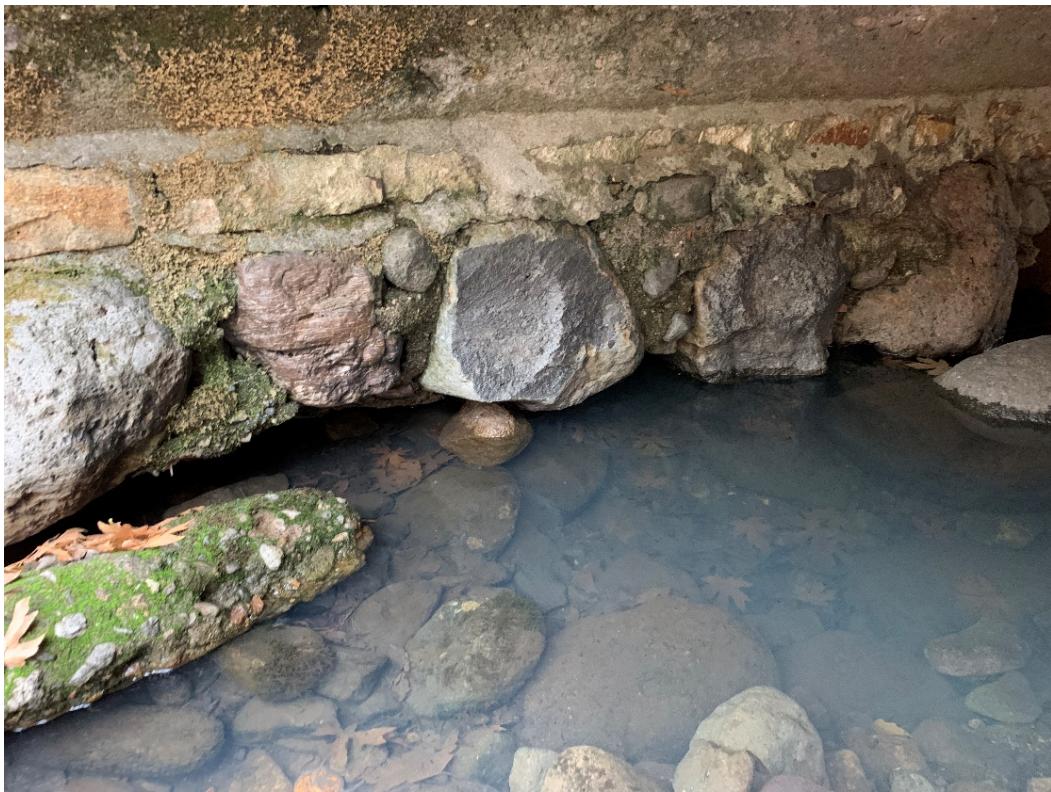
Photo 5: Partially Undermined Foundation at West Wall

1. Erosion has removed soil support from under sections of the arch at each side of the bridge, partially undermining its support (Photo 5 & 6). No significant signs of distress were observed in the masonry bridge itself, but if erosion remains or is allowed to progress it could lead to progressive failure.

- ZFA recommends that the undermined foundations be repaired to regain their full soil bearing support. This repair could be conducted by structurally filling the void under the undermined foundation walls with a concrete and covering the repair with rock to reduce the risk of repeated erosion. The base of the headwall should be repaired similarly. Any repair should be coordinated with the appropriate state and local jurisdictions including the County of Napa and the California Fish and Wildlife. While not an immediate danger, ZFA recommends these repairs to be engaged as soon as possible and that a civil or environmental engineer be engaged to coordinate this scope of work with the pertinent jurisdictions. Until this repair is in place we recommend that the foundations be reviewed after each significant storm event to review for further erosion under the arches.

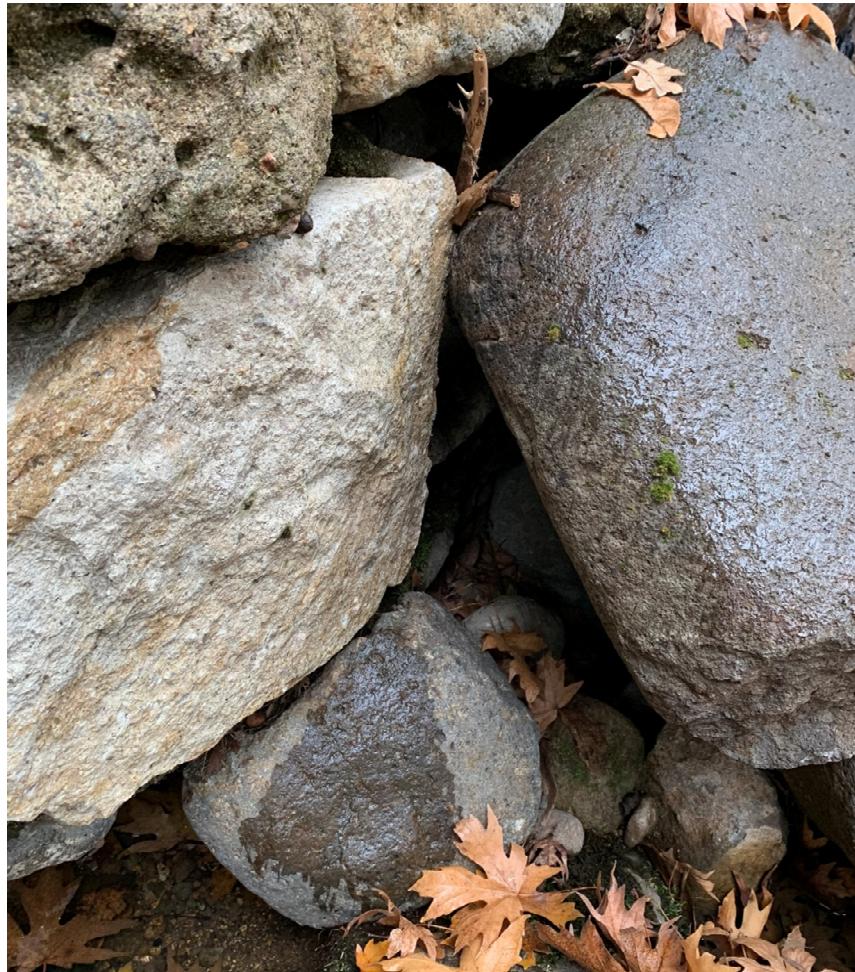
Photo 7: Missing Mortar and Loose Masonry

2. The mortar between many of the stones is highly weathered. At one location the mortar was completely missing so that the stones were loose to the touch (Photos 7 & 8).

- ZFA recommends that the entirety of the bridge be repointed with mortar. See Appendix D for masonry repair specifications. Furthermore, we recommend that the masonry structure be reviewed annually for weathering, movement, cracking, and deterioration. After the above repairs have been completed and three years

without additional required maintenance, this recommended review interval can be increased to once every three years.
