MEMORANDUM

To:	Steve Lederer, Director of Public Works Leigh Sears, Concessions Manager	From:	Chris Silke, Engineering Manager, P.E.
Date:	October 27, 2023	Re:	Steele Park Drainage Culvert Failure

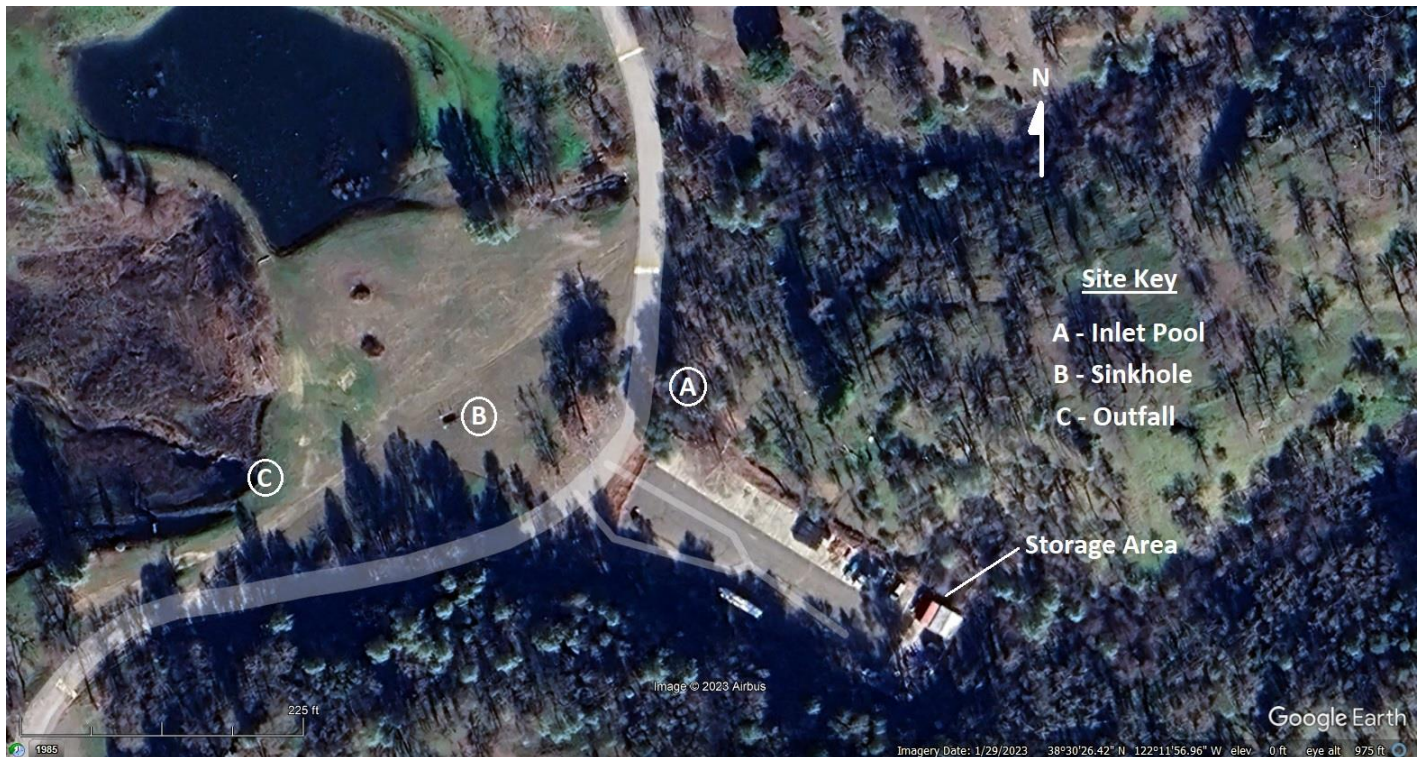
Figure 1 – Steele Park Drainage Assessment Map

Figure 1 is a Locus Map of Steele Park showing the culvert drainage inspection points listed in the Site Key. The culvert inlet pool at Site Key A has sustained bank scour with several feet of tree and shrub root exposure. Annular space between the inlet corrugated vertical tee and horizontal pipe placed underneath the paved access drive is plugged with vegetative debris. Gravel has infilled approximately half of the 36 inch culvert pipe due to slow entry velocities. The Resort Park Manager reported seeing the culvert surcharged at the inlet with water flowing over the access road during moderate to major AR storm events in 2023. An 8 foot diameter by 12 foot deep sinkhole has emerged at Site Key B due to the pipe collapsing from corrosion. A photo of the storm drain outfall in Site Key C illustrates the extent to which the corrugated metal pipe properties have deteriorated within the wetted perimeter. Uniformity of iron corrosion on the pipe interior is indicative of lake level at full pond elevation (440 ft) and prolonged submergence.

Option No. 2 is recommended to rehabilitate the drainage facility addressing the immediate safety and economic loss risks.
