## **Additional Public Comment**

**From:** [Carlo Mondavi](#)  
**To:** [Ringel, Matthew](#)  
**Subject:** Vida Valiente | Show of Support | Hearing December 6th  
**Date:** Wednesday, November 29, 2023 7:00:00 AM

## Comments on Vida Valiente Winery Use Permit

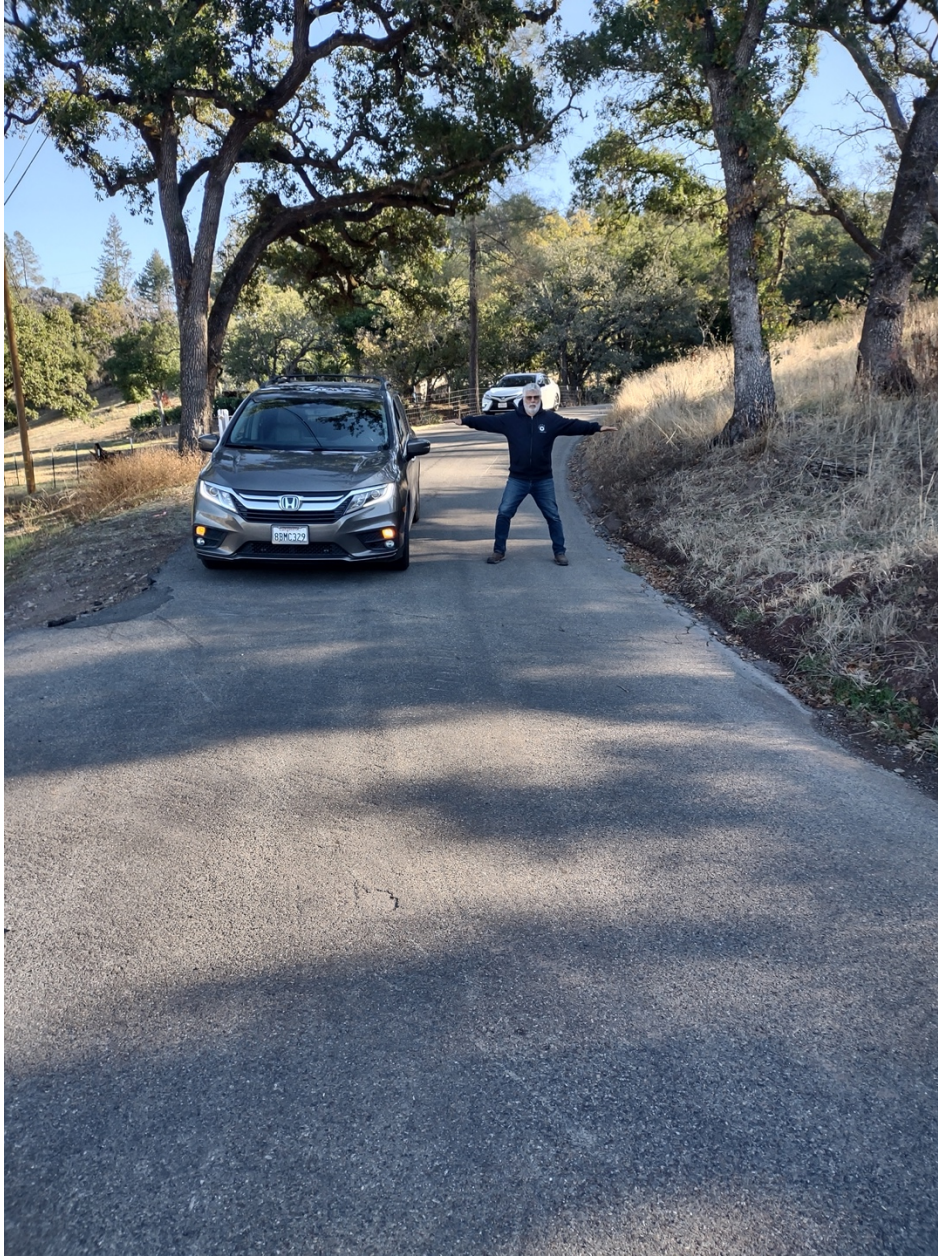
North end on a significant slope and sharp sweeping turn toward Silverado Trail.

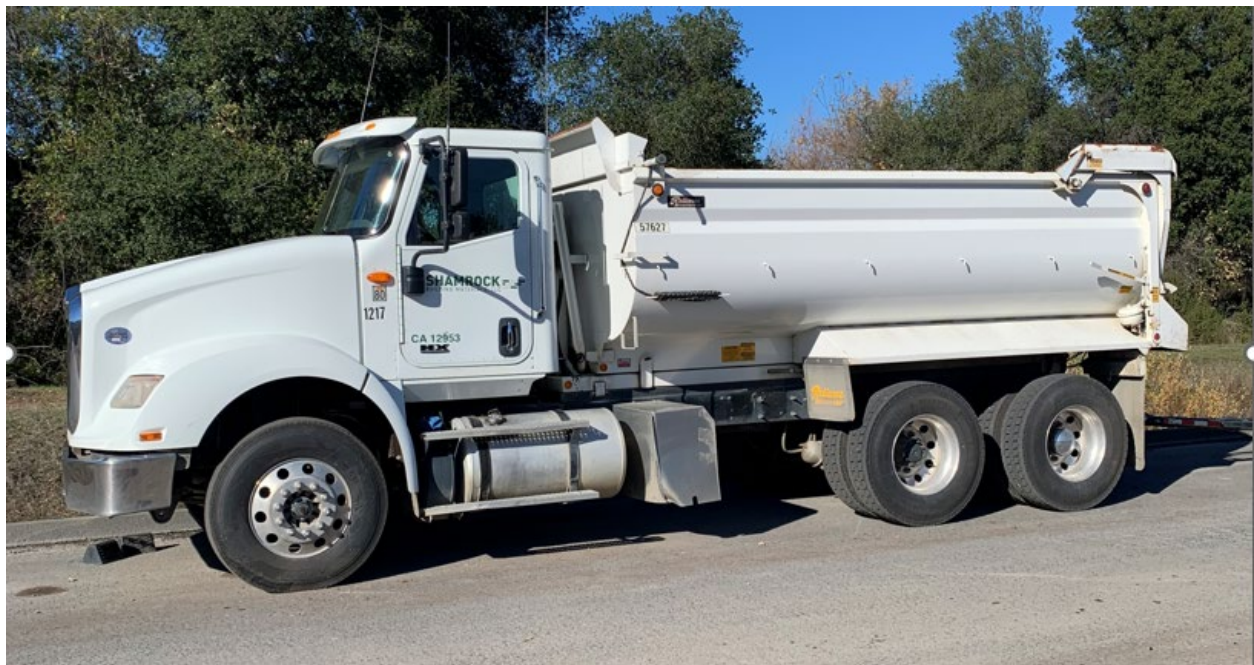
The dump truck above is a 12 yard "transfer" truck, often connected to trailer of a similar size for the transportation of 24 yards or more per trip. This truck is about 8'-6" wide but other models are 9' wide or larger. Applicants indicate that they might employ trucks of this size for cave spoils removal. This will obviously result in fewer total trips but will undoubtedly have negative impacts including longer idling/load time, greater disruption of traffic on Crystal Springs Road, and, as I discussed in detail in Item 8 of my comments dated December 1, 2023, the weight of a truck of this size might trigger a failure of the primitive retaining wall at the narrow section of Crystal Springs Road in the 600 block directly below my property.

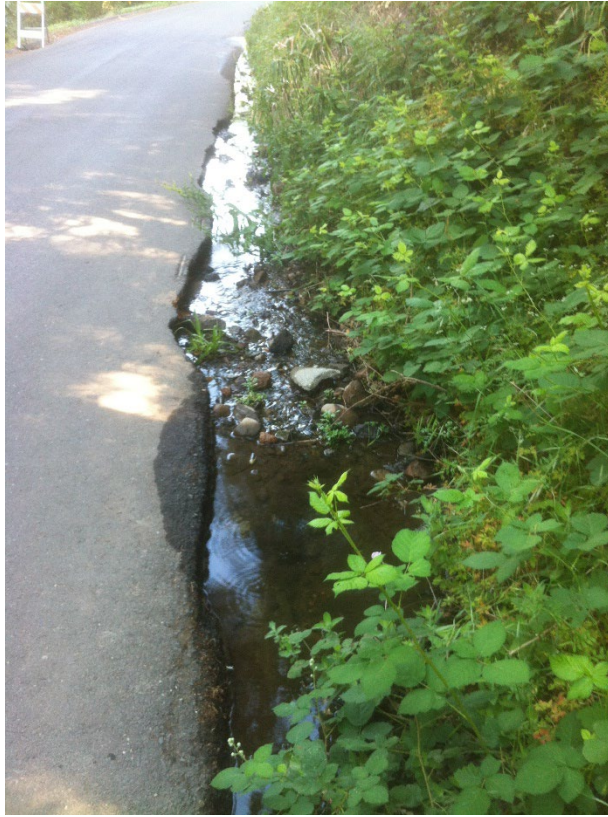
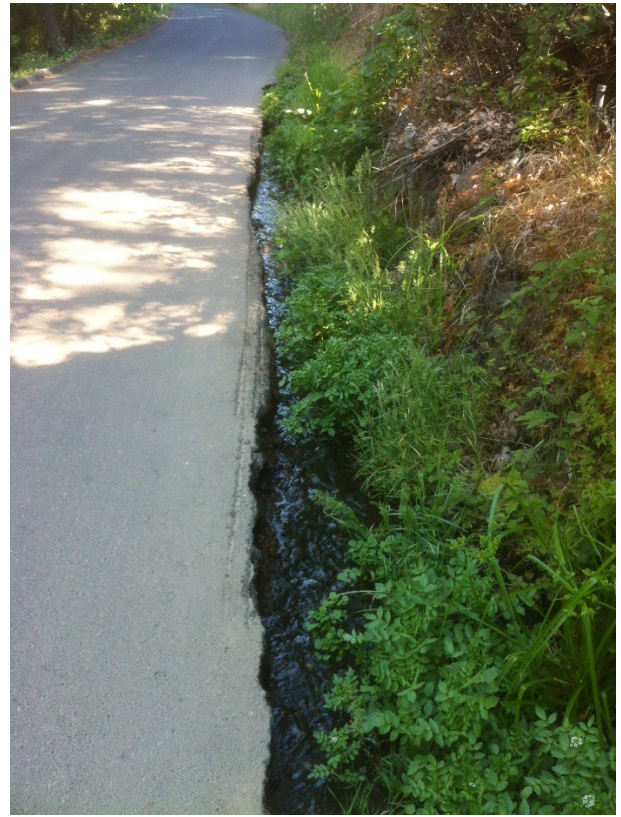
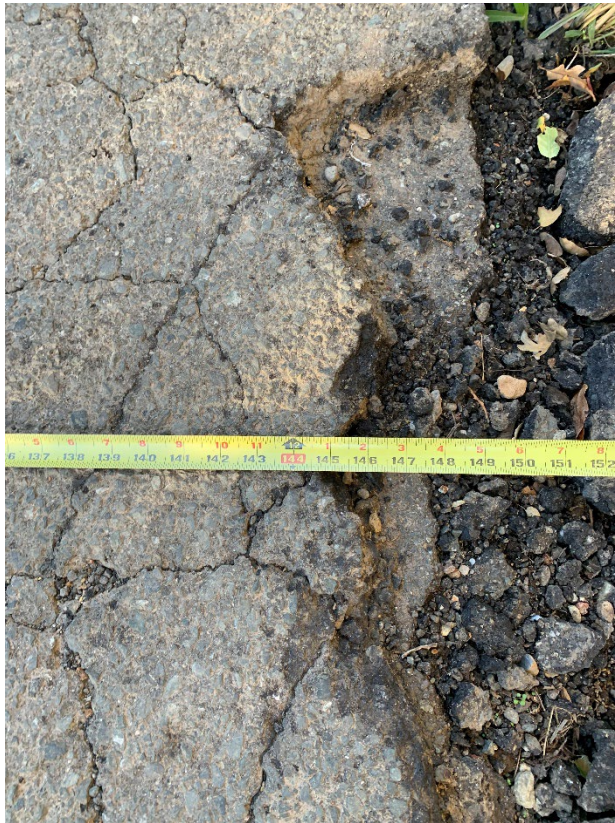
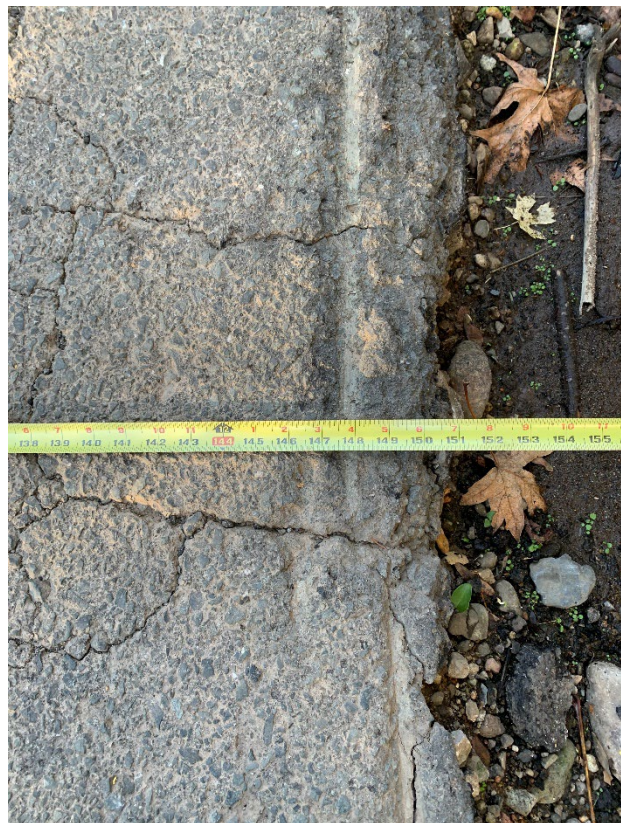
Addendum to comments by Larry Vermeulen submitted December 1, 2023  
600 block of Crystal Springs Road showing typical road width of 12' and 12'-6"

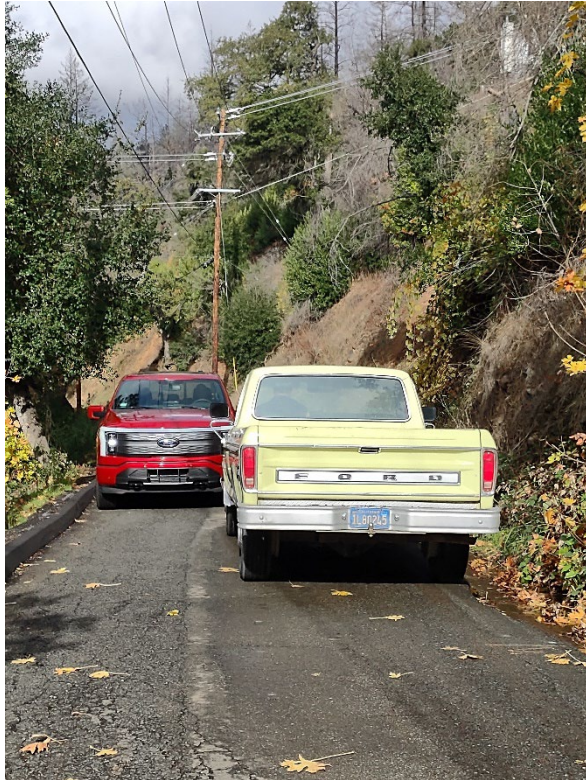
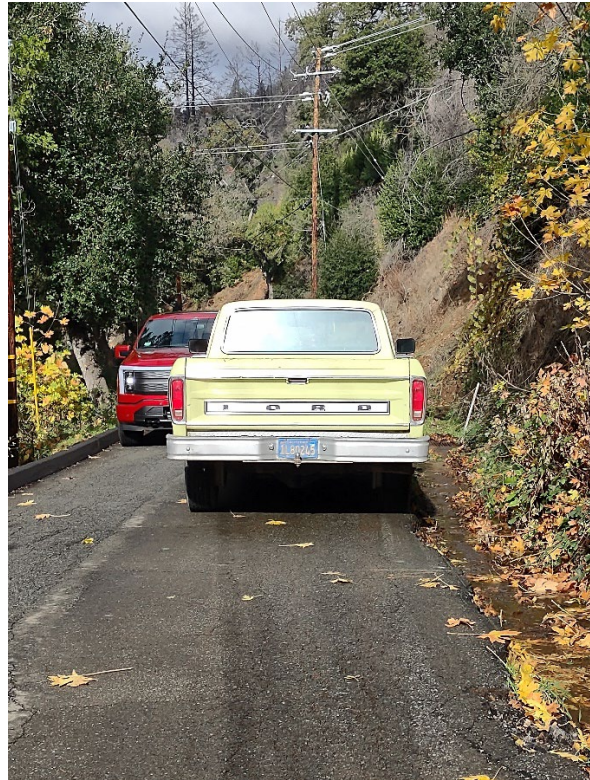
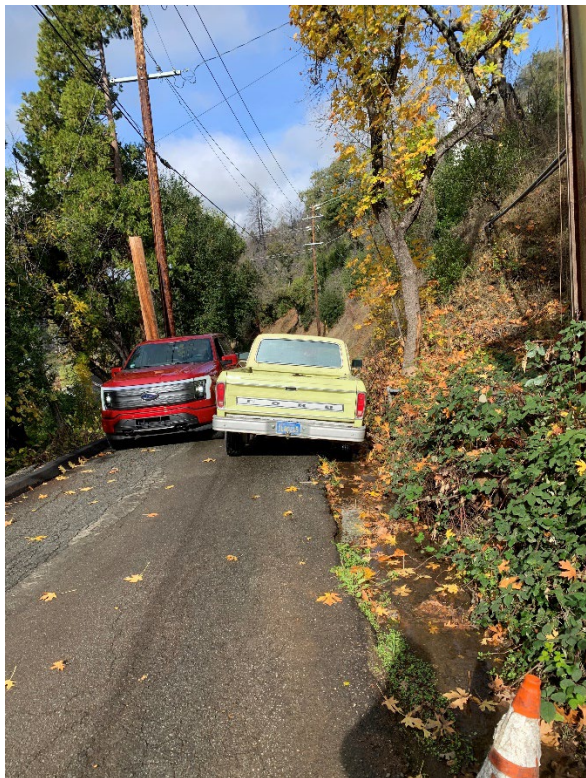
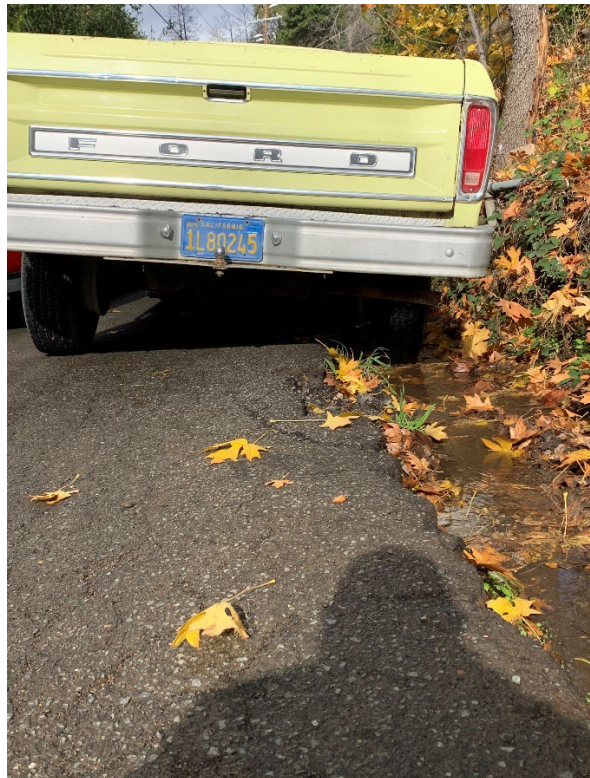
Two standard-sized pickup trucks trying to pass one-another in the 600 block of  
Crystal Springs Road where the pavement is only 12 feet wide

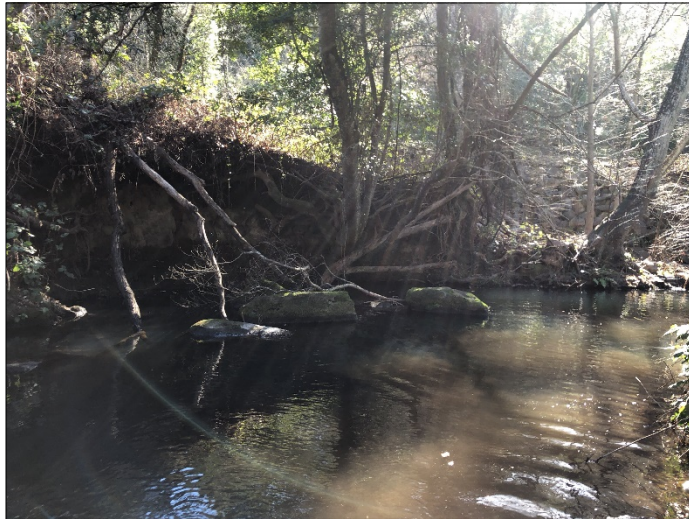
**Examples of extensive, deep pool habitat in Bell Creek**

juvenile steelhead rearing (Flosi *et al.*, 1998). The 2018 habitat inventory results suggest a considerable change in habitat type proportions, with pools accounting for 50% of the surveyed channel length while riffles and flatwater habitats accounted for 24% and 26%, respectively. On average, these pools were also deeper, with 24 (62%) of the 39 pools identified having a maximum residual depth greater than 2 feet, and 11 (28%) with a maximum residual

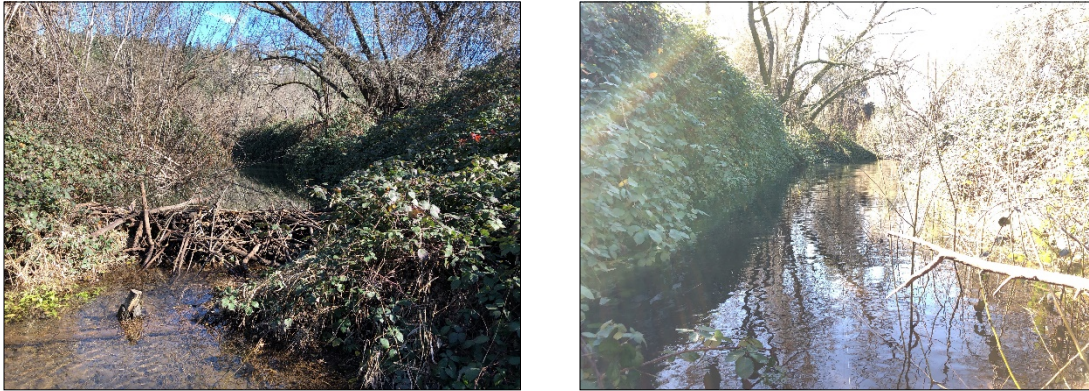
**Beaver dam (left) and upstream pool habitat (right) in Bell Creek adjacent to vineyards**

- (2) More importantly, however, at least three beaver dams were observed in Bell Creek in 2018; one immediately upstream of its confluence with the Napa River and two within the alluvial valley reach of Bell Creek bordered by vineyards. While the lowermost dam had limited hydraulic effect on Bell Creek, the two dams adjacent to the vineyards impounded a total of approximately 720 ft of channel (i.e., almost 10% of the total surveyed length of 7,502 ft), creating extensive pool habitat with average depths exceeding 3 ft and maximum depth exceeding 4 ft. In addition to expanding available pool habitat, the beaver impoundments are assumed to have drowned-out flatwater and riffle habitat within this reach, thereby shifting habitat type proportions. Excluding this 720-ft reach from the analysis reduces the 2018 pool habitat proportion from 50% to 44%. Beaver dams are widely recognized as providing high quality rearing habitat for juvenile salmonids and can significantly increase the density, survival, and production of juvenile steelhead (Bouwes *et al.* 2016). NCRCD (2005) make no mention of beaver dams in Bell Creek or any other central Napa River watershed stream assessed in 2004, and their current presence likely constitutes a significant natural habitat improvement.

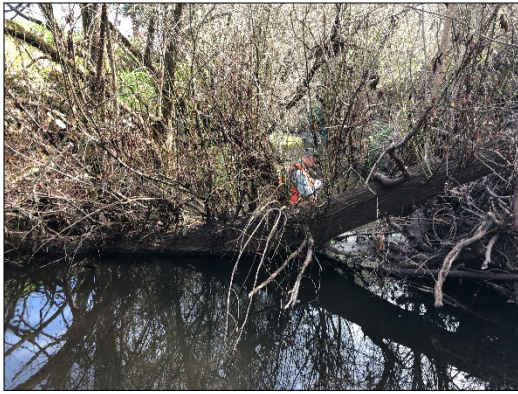
**Pool scour and cover provided by live hardwood**

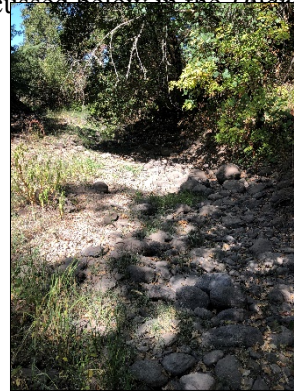
**Dry channel reach**
