## Additional Public Comment

Comments on Vida Valiente Winery Use Permit

Addendum to comments by Larry Vermeulen submitted December 1, 2023  
600 block of Crystal Springs Road showing typical road width of 12' and 12'-6"

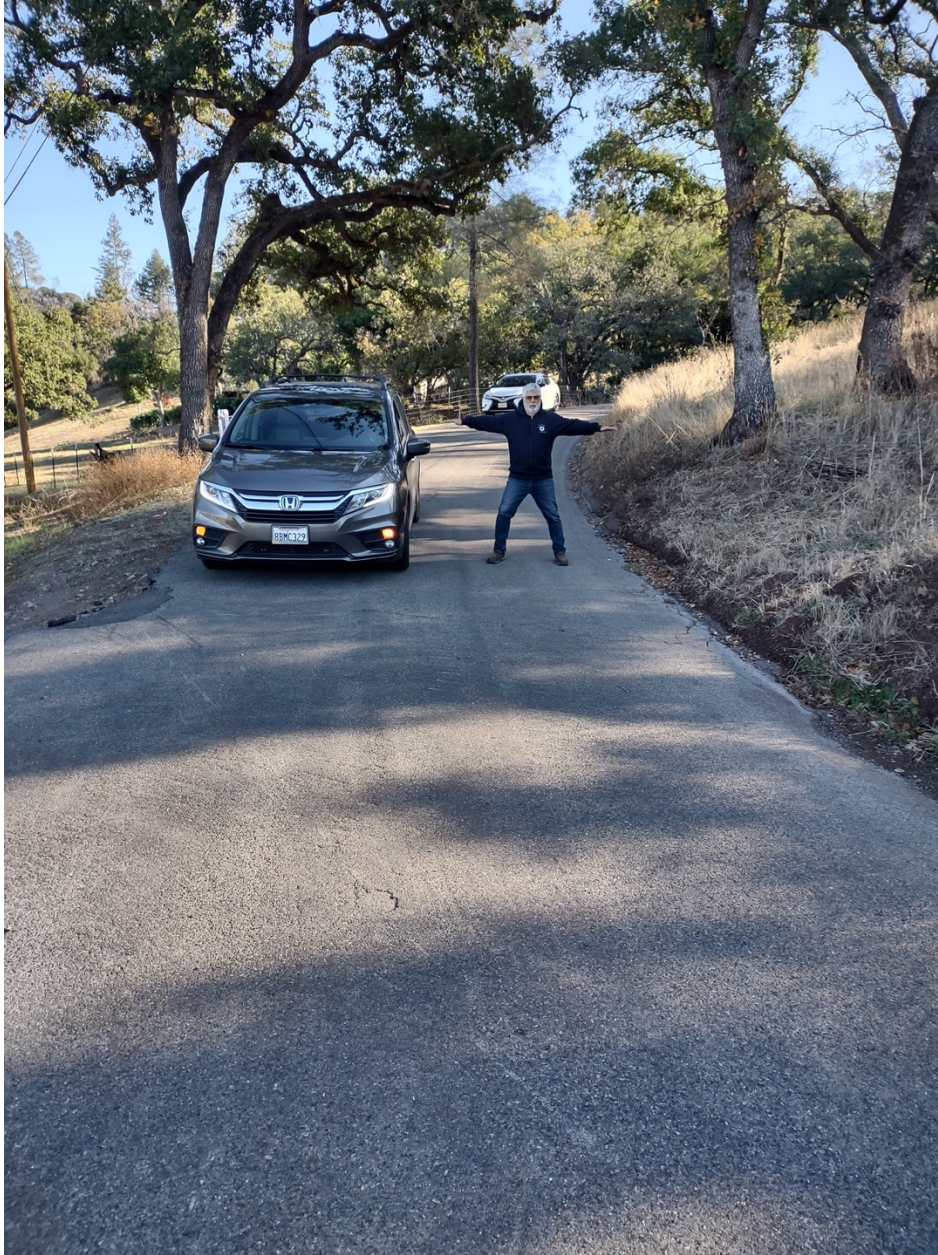
North end on a significant slope and sharp sweeping turn toward Silverado Trail.

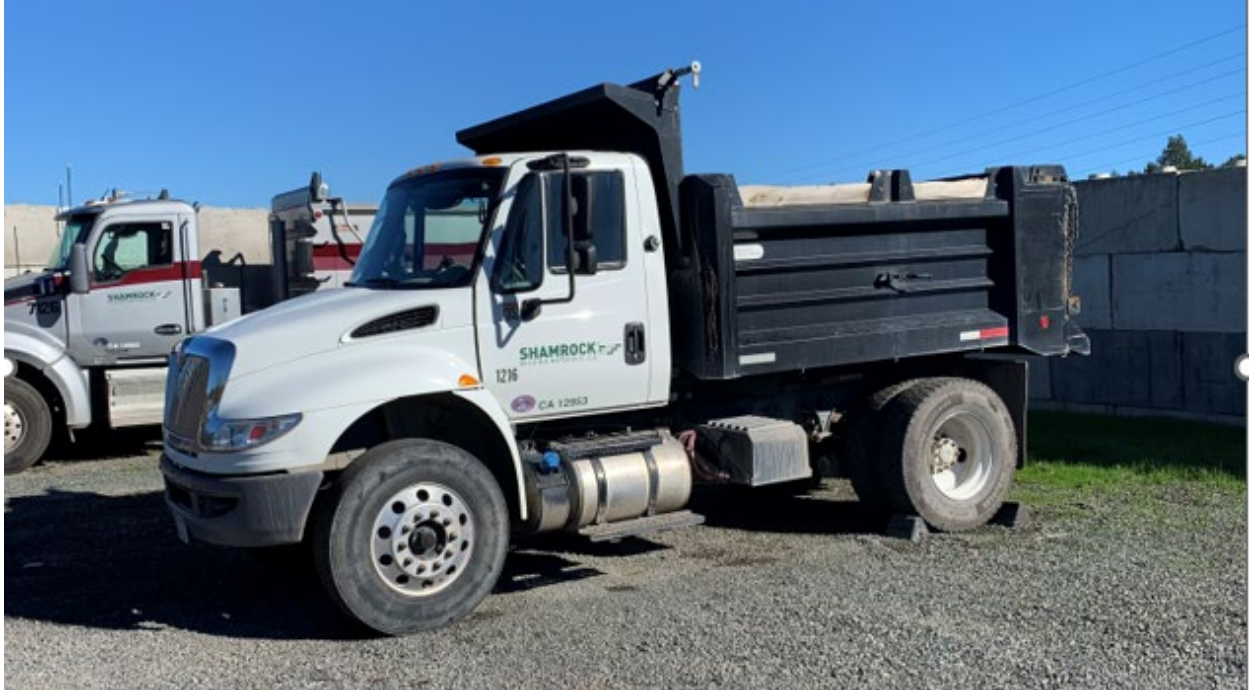
Above is pictured a typical 8-yard “bobtail” dump truck. This truck will carry 7 to 8 cubic yards of cave spoils. It is a little over 8 feet wide. This is considered a “small” dump truck in the industry and is favored for its maneuverability. This truck is about 8’-6” wide. By comparison, a standard-sized pickup is about 6’-6” wide.

Applicants estimate that 19,400 cubic yards of cave spoils will be generated and will need to be disposed of off-site. They make no calculation for “fluff”, (the property of soils to expand considerably when excavated). Industry-standard practice is to assume a 50% “fluff” factor, so the 19,400 cu yards of compacted soils will likely result in a minimum of 29,100 cubic yards of materials to be trucked off-site.

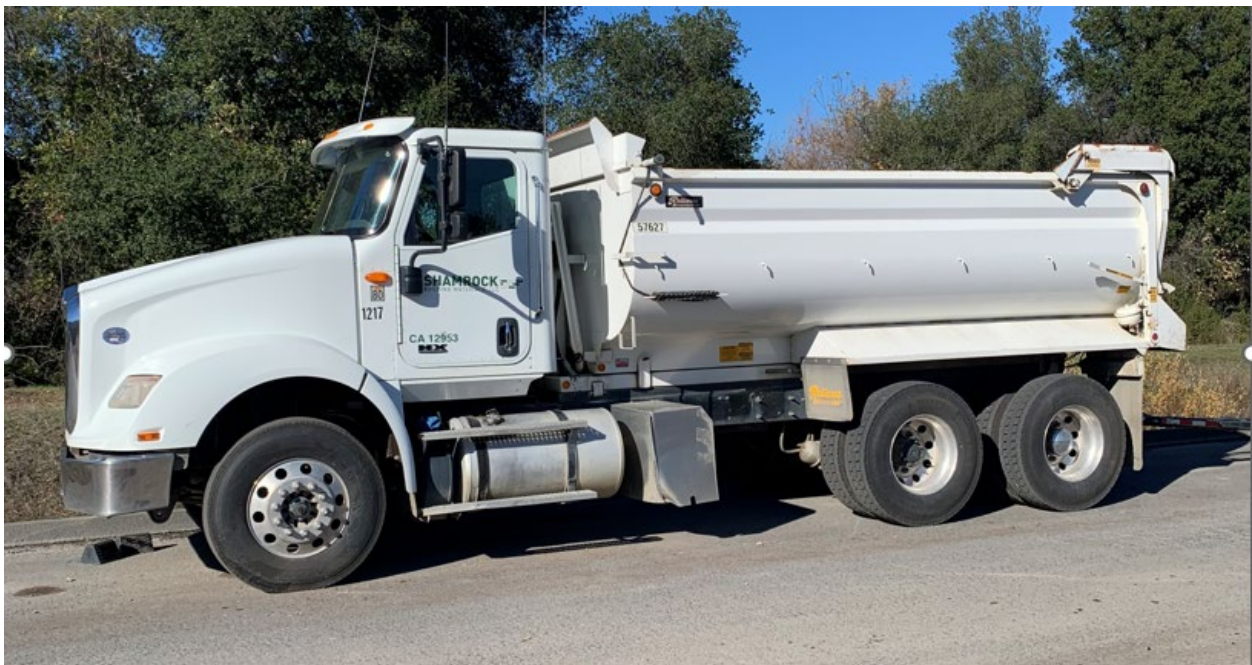
The dump truck above is a 12 yard “transfer” truck, often connected to trailer of a similar size for the transportation of 24 yards or more per trip. This truck is about 8’-6” wide but other models are 9’ wide or larger. Applicants indicate that they might employ trucks of this size for cave spoils removal. This will obviously result in fewer total trips but will undoubtedly have negative impacts including longer idling/load time, greater disruption of traffic on Crystal Springs Road, and, as I discussed in detail in Item 8 of my comments dated December 1, 2023, the weight of a truck of this size might trigger a failure of the primitive retaining wall at the narrow section of Crystal Springs Road in the 600 block directly below my property.

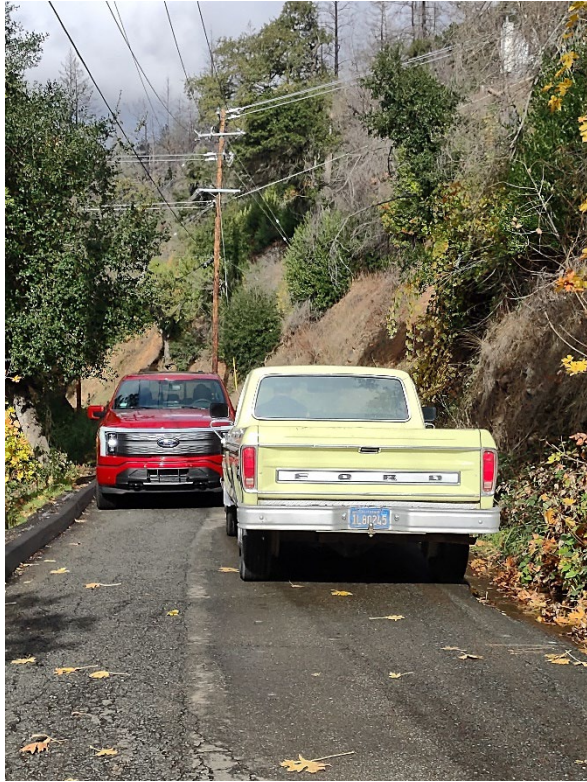
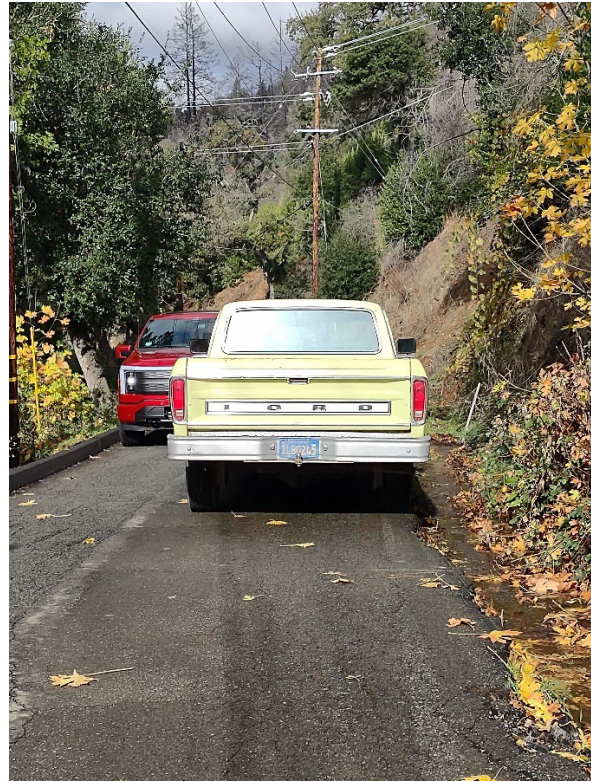
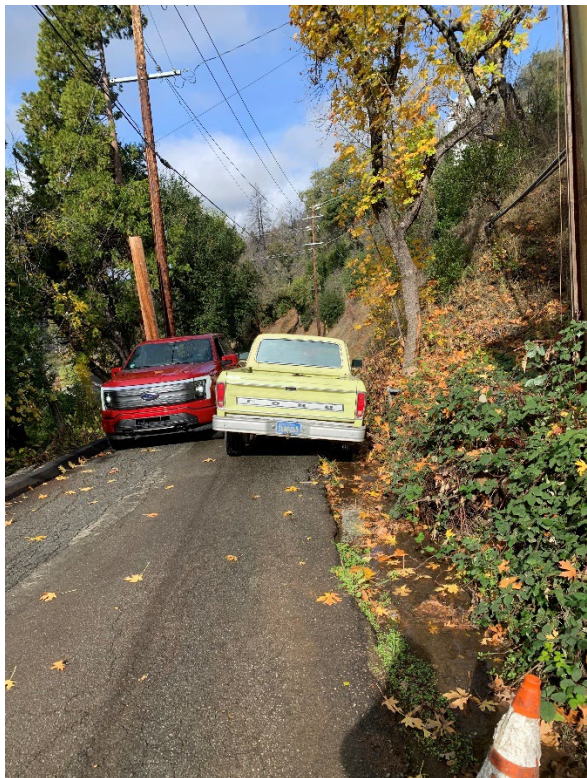
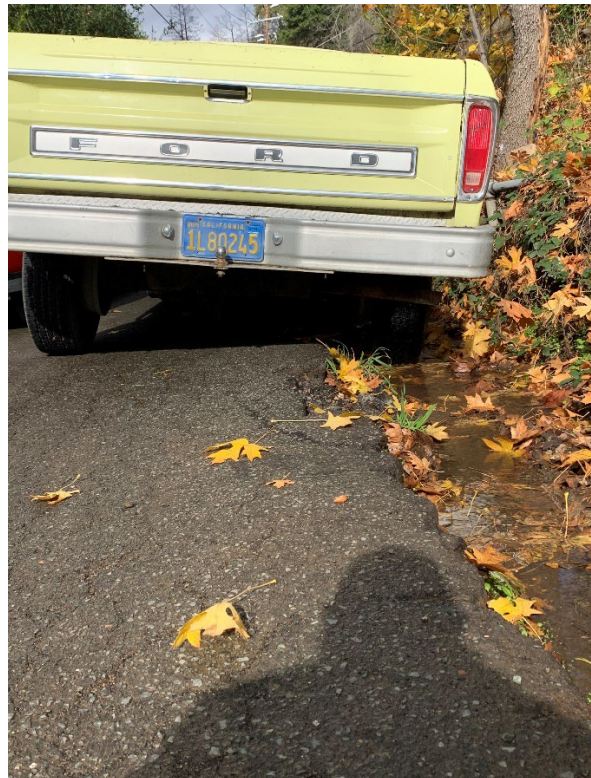
Addendum to comments by Larry Vermeulen submitted December 1, 2023  
Two standard-sized pickup trucks trying to pass one-another in the 600 block of  
Crystal Springs Road where the pavement is only 12 feet wide

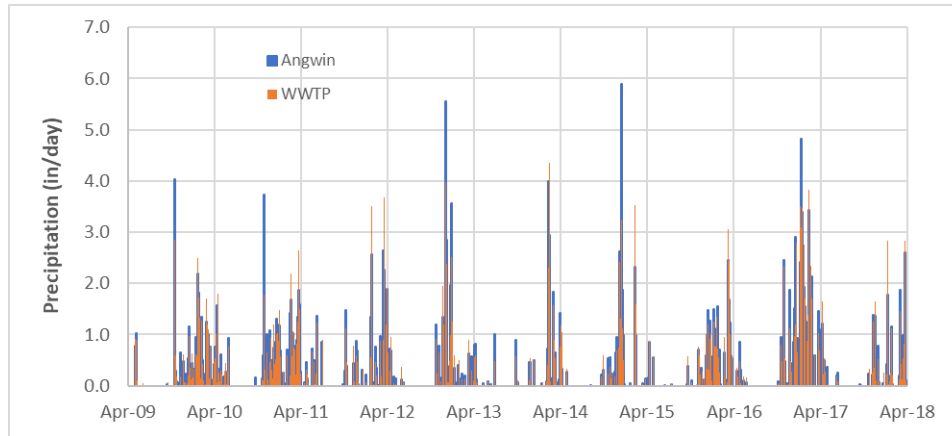
**Figure 4: Precipitation data at Angwin and the Water Treatment Plant used in the hydrologic analysis.**

Watershed surface areas upstream of the reservoir, between the reservoir and the upper (Terroir) evaluation site, and between the upper (Terroir) and lower (Vineyard) evaluation sites were delineated from available LiDAR topographic data (Figure 1). Two precipitation records are available, one at Angwin, located about 0.8 miles east of the eastern edge of the watershed, and one at the water treatment plant located just below the reservoir (Figure 4). The mean annual precipitation at each station was compared to the mean annual precipitation variations across the watershed as represented by mean annual precipitation from PRISM (2010).

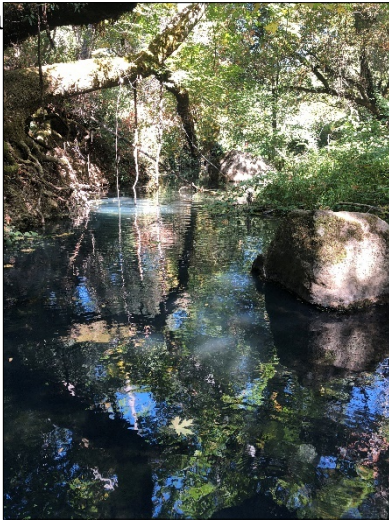
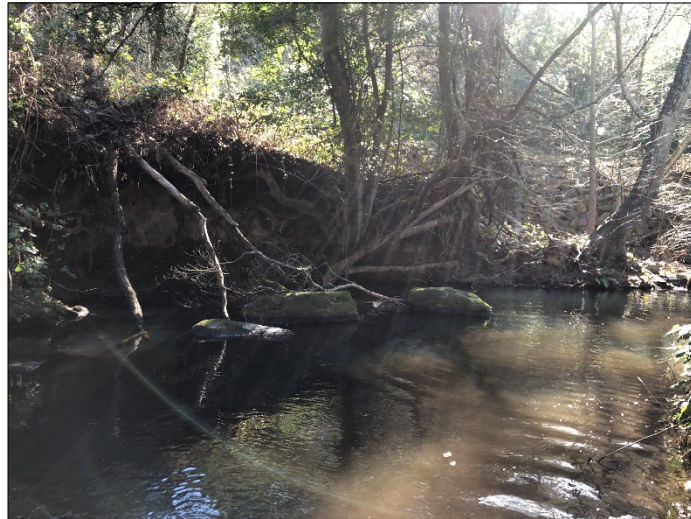
#### **Examples of extensive, deep pool habitat in Bell Creek**

juvenile steelhead rearing (Flosi *et al.*, 1998). The 2018 habitat inventory results suggest a considerable change in habitat type proportions, with pools accounting for 50% of the surveyed channel length while riffles and flatwater habitats accounted for 24% and 26%, respectively. On average, these pools were also deeper, with 24 (62%) of the 39 pools identified having a maximum residual depth greater than 2 feet, and 11 (28%) with a maximum residual

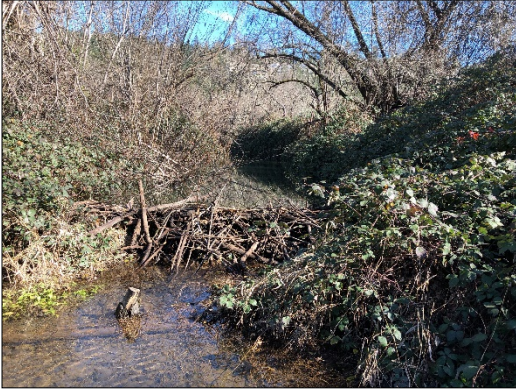
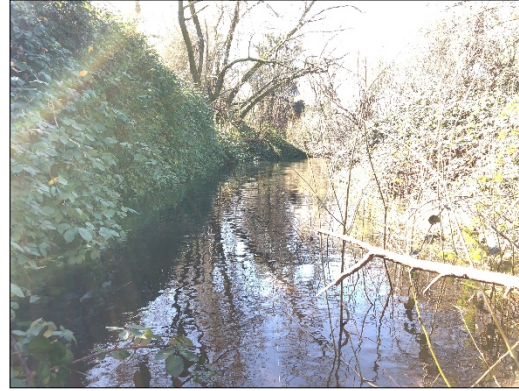
**Beaver dam (left) and upstream pool habitat (right) in Bell Creek adjacent to vineyards**

- (2) More importantly, however, at least three beaver dams were observed in Bell Creek in 2018; one immediately upstream of its confluence with the Napa River and two within the alluvial valley reach of Bell Creek bordered by vineyards. While the lowermost dam had limited hydraulic effect on Bell Creek, the two dams adjacent to the vineyards impounded a total of approximately 720 ft of channel (i.e., almost 10% of the total surveyed length of 7,502 ft), creating extensive pool habitat with average depths exceeding 3 ft and maximum depth exceeding 4 ft. In addition to expanding available pool habitat, the beaver impoundments are assumed to have drowned-out flatwater and riffle habitat within this reach, thereby shifting habitat type proportions. Excluding this 720-ft reach from the analysis reduces the 2018 pool habitat proportion from 50% to 44%. Beaver dams are widely recognized as providing high quality rearing habitat for juvenile salmonids and can significantly increase the density, survival, and production of juvenile steelhead (Bouwes *et al.* 2016). NCRCD (2005) make no mention of beaver dams in Bell Creek or any other central Napa River watershed stream assessed in 2004, and their current presence likely constitutes a significant natural habitat improvement.

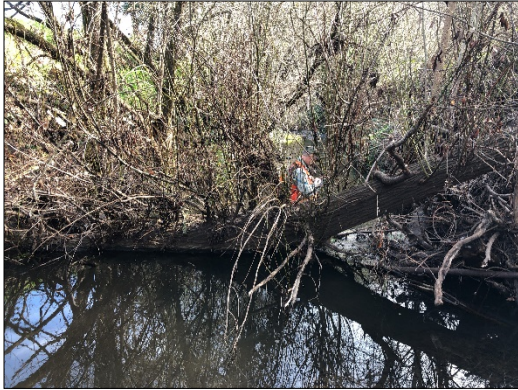
**Pool scour and cover provided by live hardwood**

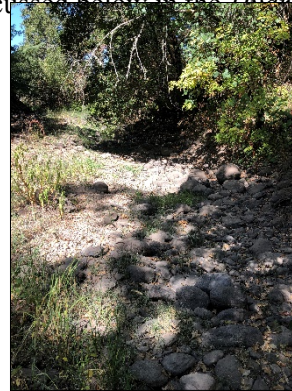
**Dry channel reach**

dry reach at a time when all reservoir inflows were being bypassed, and (3) the fact the USGS topographic map for the St. Helena quadrangle, which is based on aerial photographs taken in 1957 prior to the construction of Bell Canyon Reservoir, depicts Bell Creek as an intermittent stream, it appears reasonable to assume that dry channel reaches periodically occur naturally in Bell Creek during the baseflow season of some years. Surface water-groundwater interactions in the Bell Creek watershed are further discussed below in the *Hydrology* section

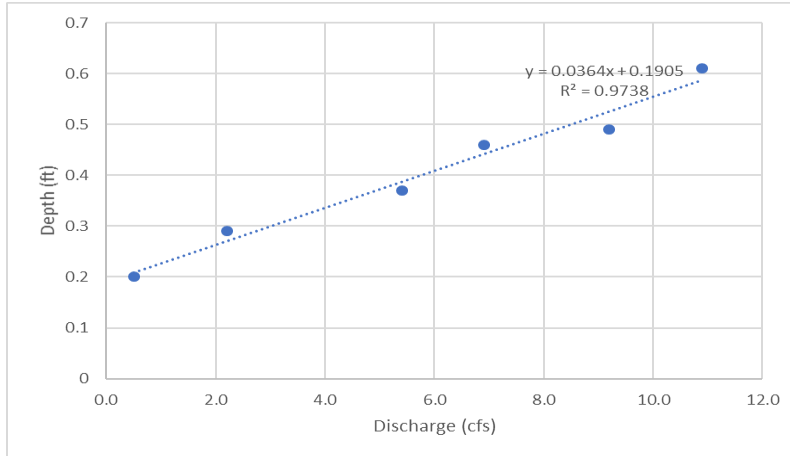
**Figure 10: Riffle depth-to-discharge relationship for Transect 1 at the Terroir Riffle.**

Riffle	Adult Passage Flow (cfs)	Smolt Passage Flow (cfs)
Terroir Transect 1	10.5	5.6
Terroir Transect 2, w/o Outlier	9.9	5.9
Terroir Transect 2, w/ Outlier	9.4	5.5
Vineyard	10.2	5.1

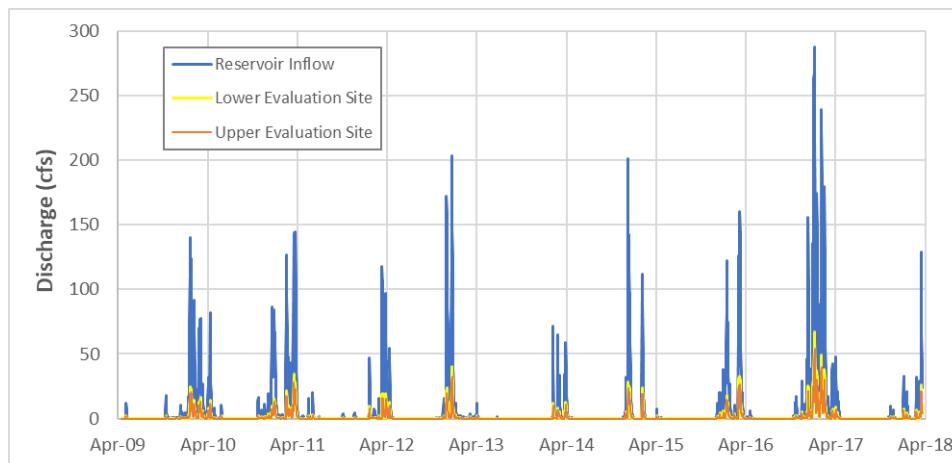
**Figure 13: Total reservoir inflow and additional flow contributions to the Terroir (upper) and Vineyard (lower) evaluation sites as simulated with the hydrologic model.**

The simulated reservoir inflows and additional flow contributions to the upper (Terroir) and lower (Vineyard) evaluation sites for the April 2009 to March 2018 period are shown in **Figure 13**. Although there is significant scatter in the data, the additional flow contributions to the downstream sites are well-described using linear relationships (**Figure 14**). The regressions indicate that after adjusting for a small negative y-intercept (representing the minimum reservoir inflow above which additional flow is generated at the downstream sites), additional flow contributions to the upper (Terroir) and lower (Vineyard) evaluation sites are approximately 15.3% and 19.2% of the total reservoir inflow respectively (**Figure 13**). The additional drainage areas contributing to the upper and lower sites are approximately 17.2% and 21.4% of the reservoir inflow drainage area. The percentages arrived at by regression of the simulation flow data are similar but somewhat lower than the relative drainage areas would suggest, which intuitively makes sense since rainfall rates are moderately higher in the reservoir inflow drainage area than in the downstream drainage areas. The equations presented in **Figures 14** represent a simple means of approximating the additional flow contributions to the upper and lower evaluation sites for the purposes of adjusting bypasses to meet downstream targets at the evaluation sites. For example, the model predicts that when reservoir inflow is 11.0 cfs, the mean predicted stream flow accretion between the reservoir and the Terroir and Vineyard sites is 1.65 cfs and 2.03 cfs, respectively.

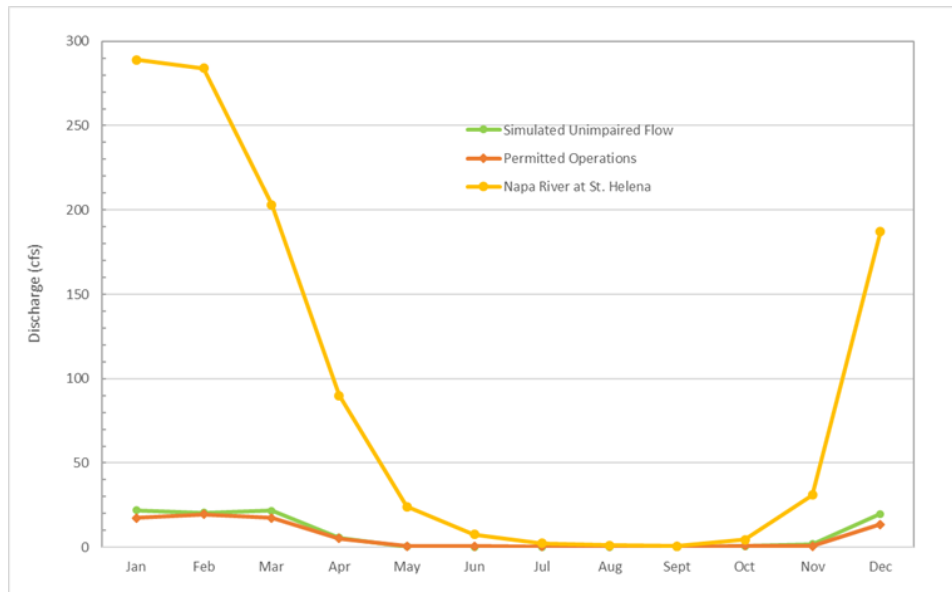
NOTE: Summer mean monthly discharges of 0.4 cfs reported for the permitted operations represent an average of summer bypass flow releases made by the City in accordance with past accounting methods and likely represent releases made in excess of those required under the terms of its permits (i.e., exceeding actual inflows).

**Figure 15. Mean monthly mean discharges for simulated unimpaired and permitted bypass releases at Bell Canyon Reservoir conditions vs. mainstem Napa River at St. Helena, WY 2010-2018.**

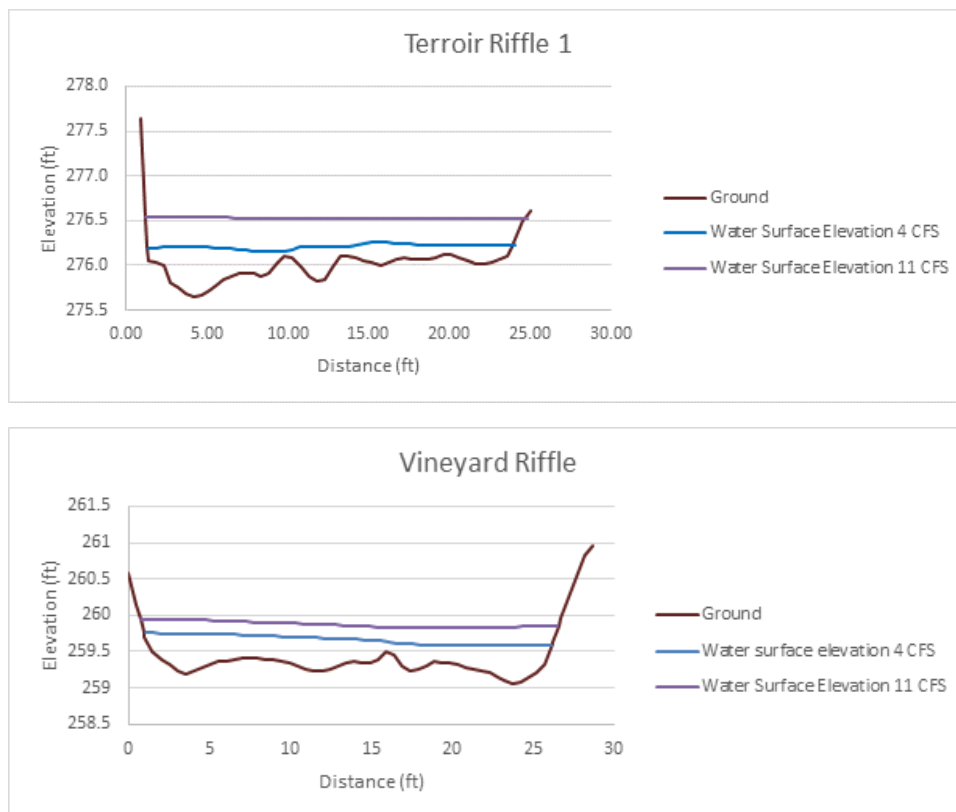
**Figure 27. Surface water elevations at two evaluation sites on Bell Creek at discharges of 11 cfs and 4 cfs.**

The proposed FBP regime also ensures that appropriate steelhead smolt out-migration flows are maintained downstream of the reservoir at all times when such conditions would naturally be present. After the April 15 end of the diversion season, all inflows will be bypassed and fish habitat conditions in Bell Creek below the reservoir will be maintained consistent with unimpaired conditions.
