Water Availability Analysis  
March 5, 2021 – Tier I & II WAA  
October 4, 2022 – Tier I-III Addendum

**Vida Valiente Winery**  
**Groundwater Use Estimate**

This Memorandum presents the key RCS findings, conclusions, and preliminary recommendations regarding the Water Availability Analysis (WAA) for the proposed new winery project for the Vida Valiente property (subject property) in Napa County, California. This document was prepared for the property owner to provide hydrogeologic analyses in conformance with Napa County Tier 1 and Tier 2 WAA requirements, as described in the Napa County WAA Guidelines Document (WAA, 2015).

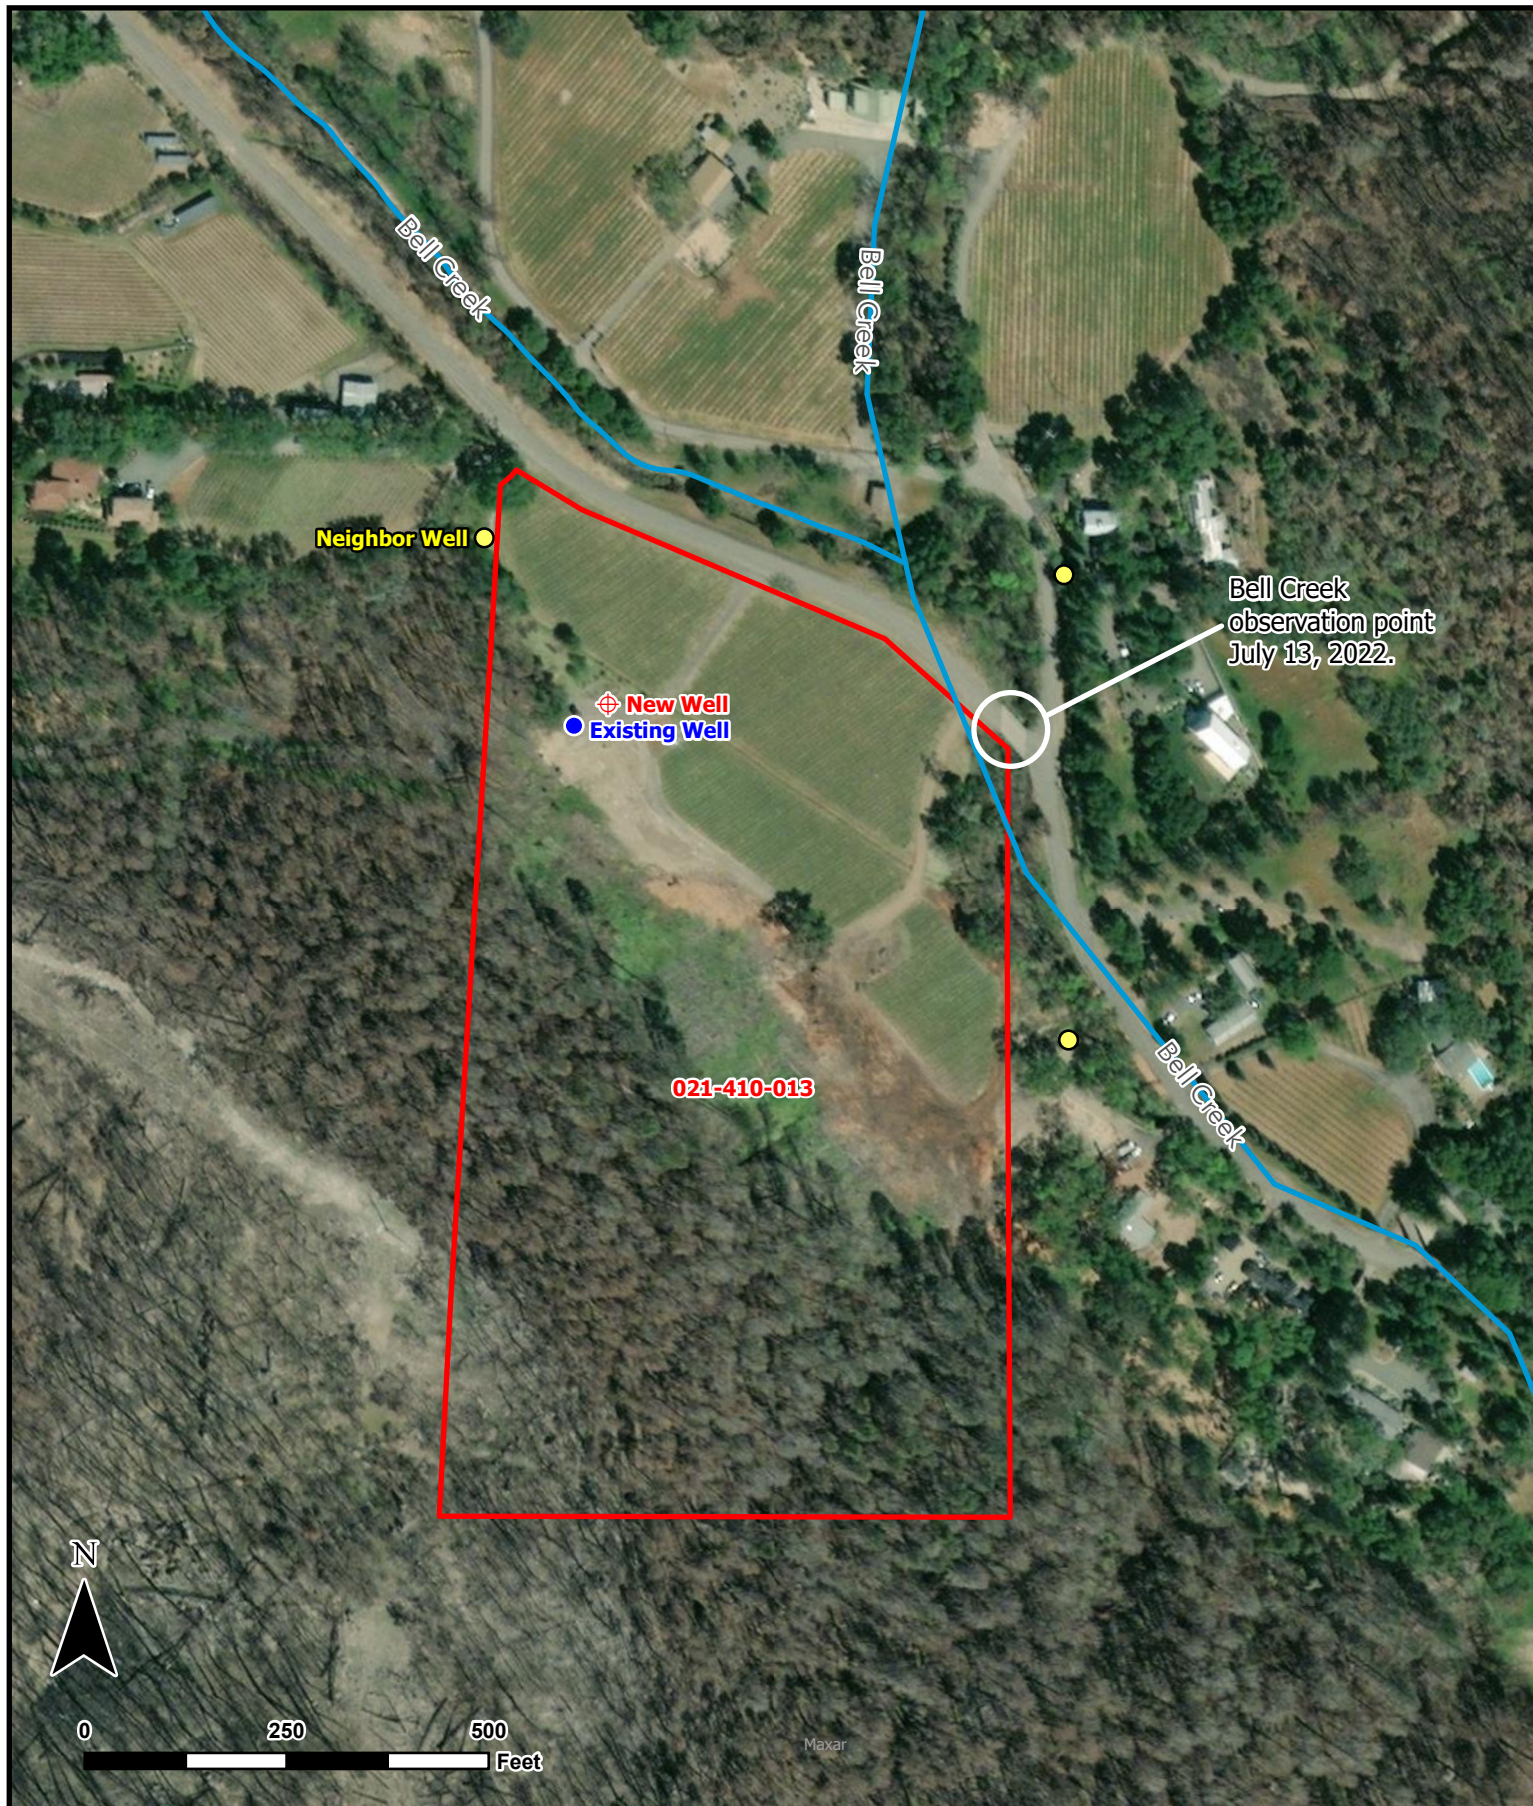
**FIGURE 2**  
**AERIAL PHOTOGRAPH**  
**MAP**

During a site visit to the property on June 2, 2020, an RCS geologist noted that Bell Creek was observed to be flowing in the portion of the Creek north of the subject property (north of Crystal Springs Road). Later, on July 13, 2022, the pumper from RWTS who was operating the New Well for the Tier 2 WAA aquifer test noted that Bell Creek was flowing at the bridge over Bell Creek at Crystal Springs road; the location of that observation is shown on Figure 2.

<sup>2</sup> It should be noted that the Bell Creek alignment from the County GIS data does not quite match the location of the creek on the Figure 1 topographic map, or the Figure 2 aerial photograph. In reality, Bell Creek is not found within the boundaries of the subject property.
