**Water Availability Analysis  
March 5, 2021 – Tier I & II WAA  
October 4, 2022 – Tier I-III Addendum**

**Vida Valiente Winery  
Groundwater Use Estimate**

This Memorandum presents the key RCS findings, conclusions, and preliminary recommendations regarding the Water Availability Analysis (WAA) for the proposed new winery project for the Vida Valiente property (subject property) in Napa County, California. This document was prepared for the property owner to provide hydrogeologic analyses in conformance with Napa County Tier 1 and Tier 2 WAA requirements, as described in the Napa County WAA Guidelines Document (WAA, 2015).

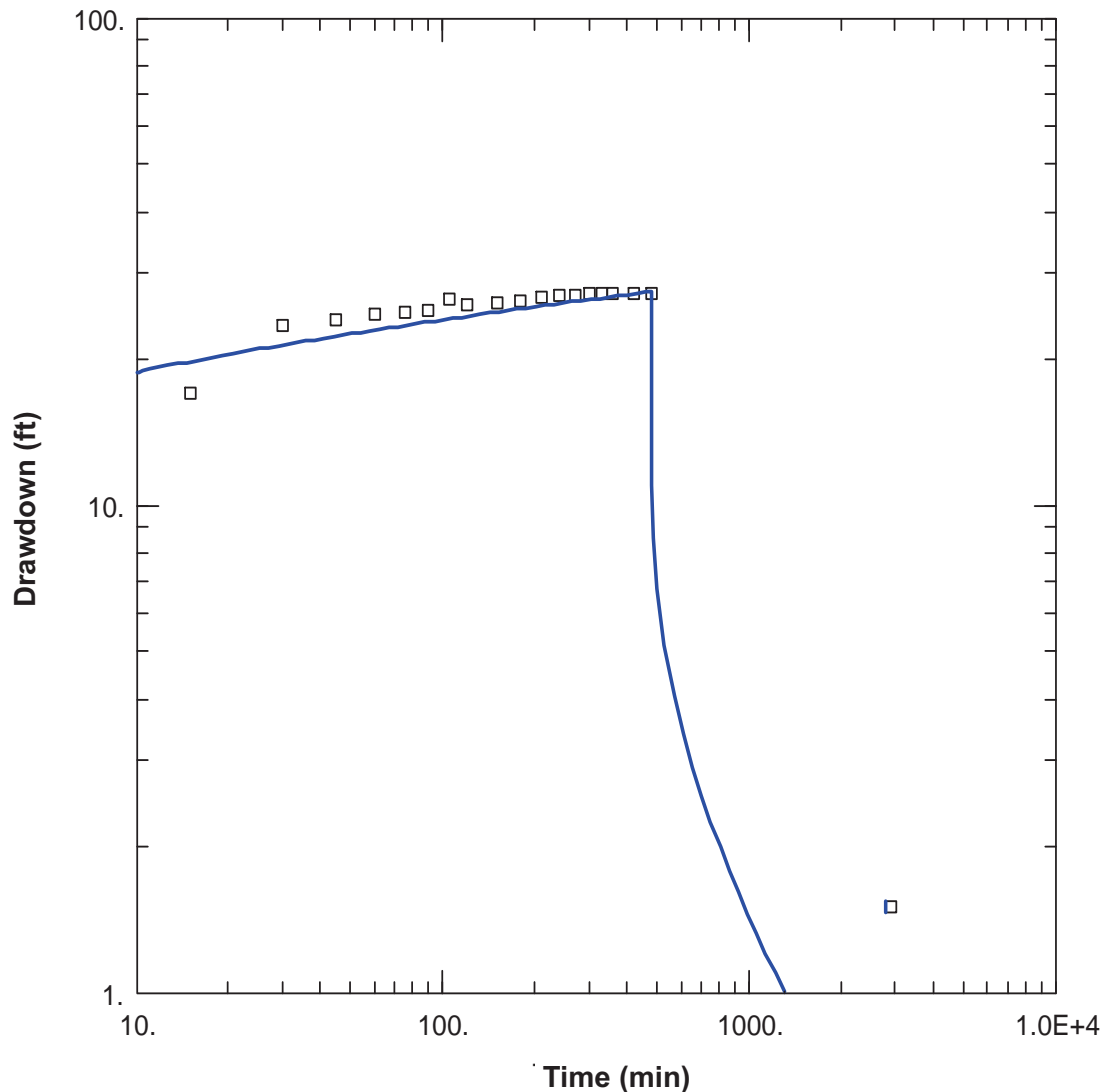
**Figure 5A**  
**Constant Rate Pumping Test Analysis**  
**Theis/Hantush Confined Aquifer Solution**  
**Existing Well**

- Theis/Hantush – Figure 5A, “Constant Rate Pumping Test Analysis, Theis/Hantush Solution, Confined Aquifer, Existing Well.” – As shown on the figure, the curve for the confined aquifer solution has been “best fit” to the later-time water level drawdown data observed in the Existing Well. A transmissivity value of approximately 1,836 gpd/ft is calculated for these data.

Numerous analytical solutions were applied to the Existing Well pumping test data using the software in an attempt to determine transmissivity values using an automatic curve fitting procedure. The solutions utilized consisted of unconfined, confined, semi-confined, and/or fractured aquifer solutions; several variations of these solutions were evaluated by RCS. Certain assumptions are made about the aquifer when applying these solutions. In general, for the solutions listed below, key assumptions for use include: that the aquifer has an infinite areal (lateral) extent; that the aquifer is isotropic (the same in all directions); that the pumping well fully and/or partially penetrates the aquifer system(s); and that groundwater is instantaneously released from storage with the decline of hydraulic head. Also, for the purposes of this evaluation, the conservative assumption is made that the saturated aquifer thickness at the Existing/Proposed New Well was approximately 127 ft at the date of the pumping test. This saturated aquifer thickness was determined by calculating the vertical distance between the static water level in the Existing Well (approximately 45 ft brp on April 10, 2019) and the bottom of the well casing in this Existing Well (at a depth of approximately 172 ft bgs; see Table 1). In reality, the thickness of the saturated volcanic materials beneath this location on the property is likely greater.

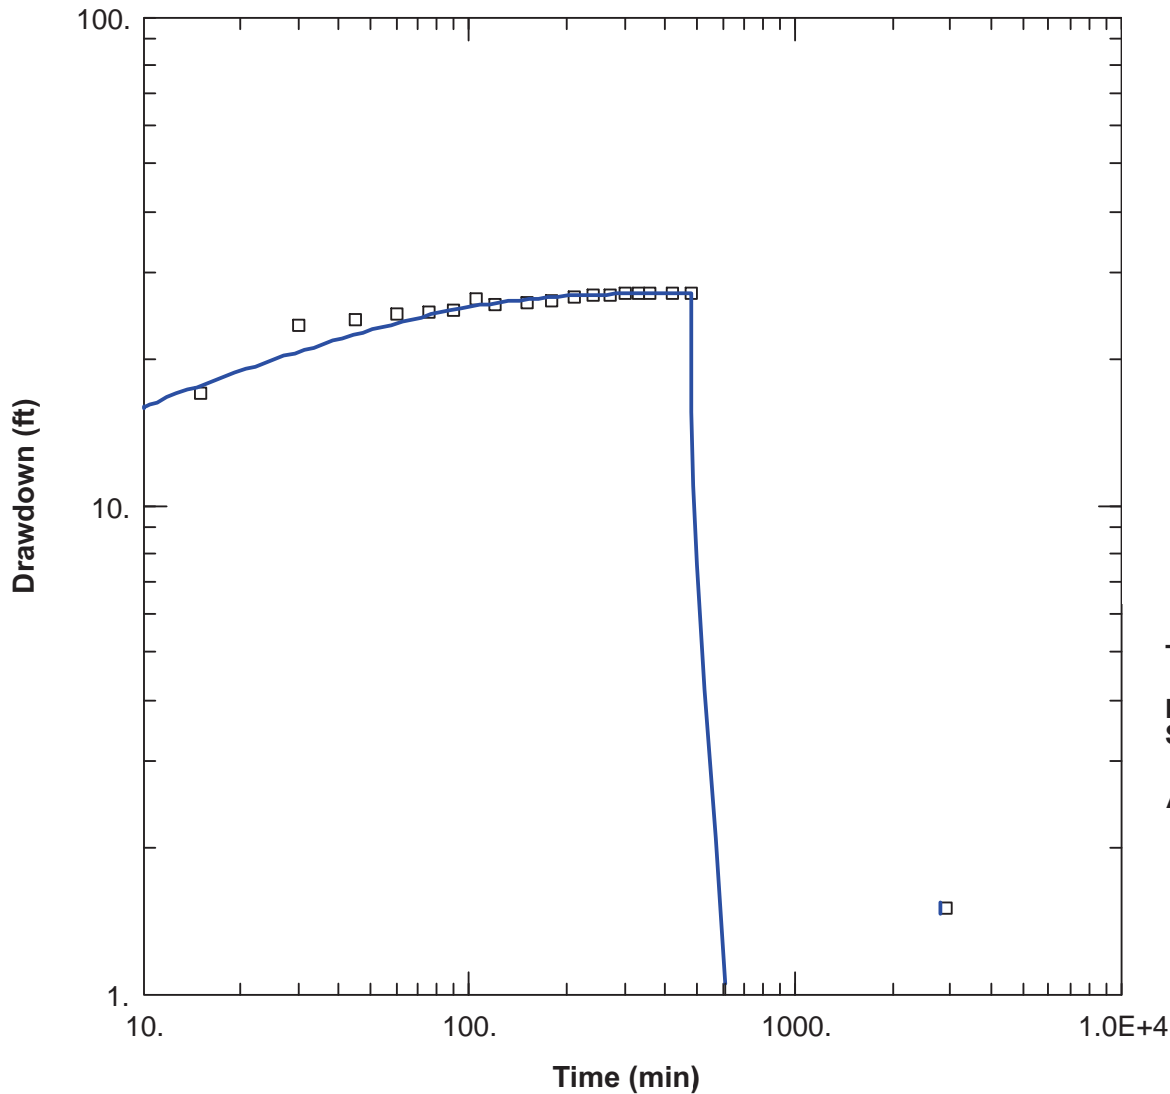
**Figure 5B**  
**Constant Rate Pumping Test Analysis**  
**Moench Confined Aquifer Solution**  
**Existing Well**

- Moench – Figure 5B, “Constant Rate Pumping Test Analysis, Moench, Leaky Aquifer, Existing Well.” As shown on the figure, the curve for the leaky aquifer solution has been reasonably matched to most of the later-time portion of the water level drawdown data collected during the pumping period in the Existing Well. A transmissivity value of approximately 259 gpd/ft is calculated for these data.

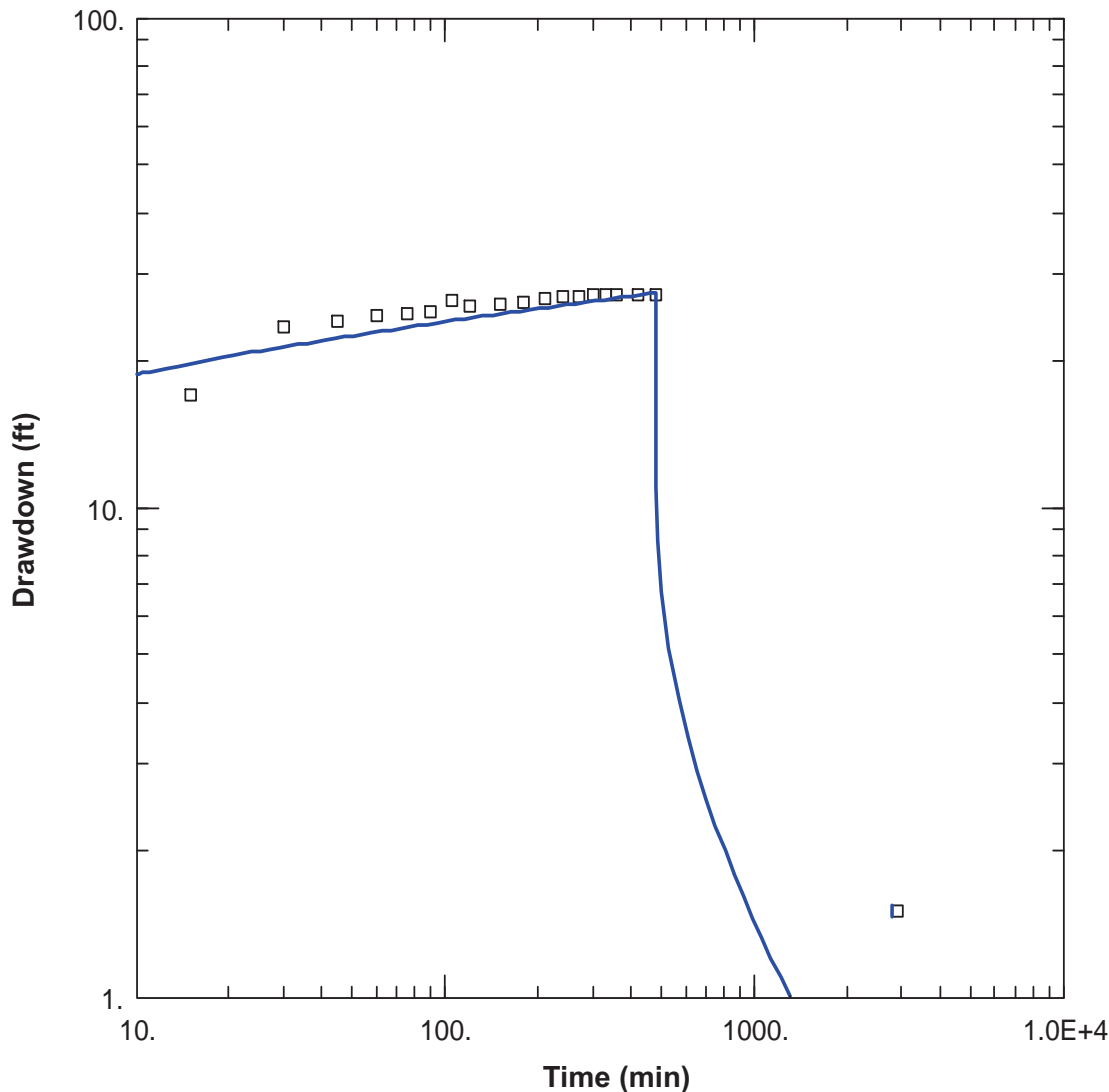
**Figure 5C**  
**Constant Rate Pumping Test Analysis**  
**Gringarten-Witherspoon Fractured Aquifer Solution**  
**Existing Well**

- Gringarten-Witherspoon – Figure 5C, “Constant Rate Pumping Test Analysis, Gringarten-Witherspoon, Fractured Aquifer, Existing Well.” – As shown on the figure, the curve for the fractured aquifer solution has been reasonably fit to the latter portion of the water level drawdown data acquired during the pumping test of the Existing Well. A transmissivity value of approximately 2,182 gpd/ft is calculated for these data.

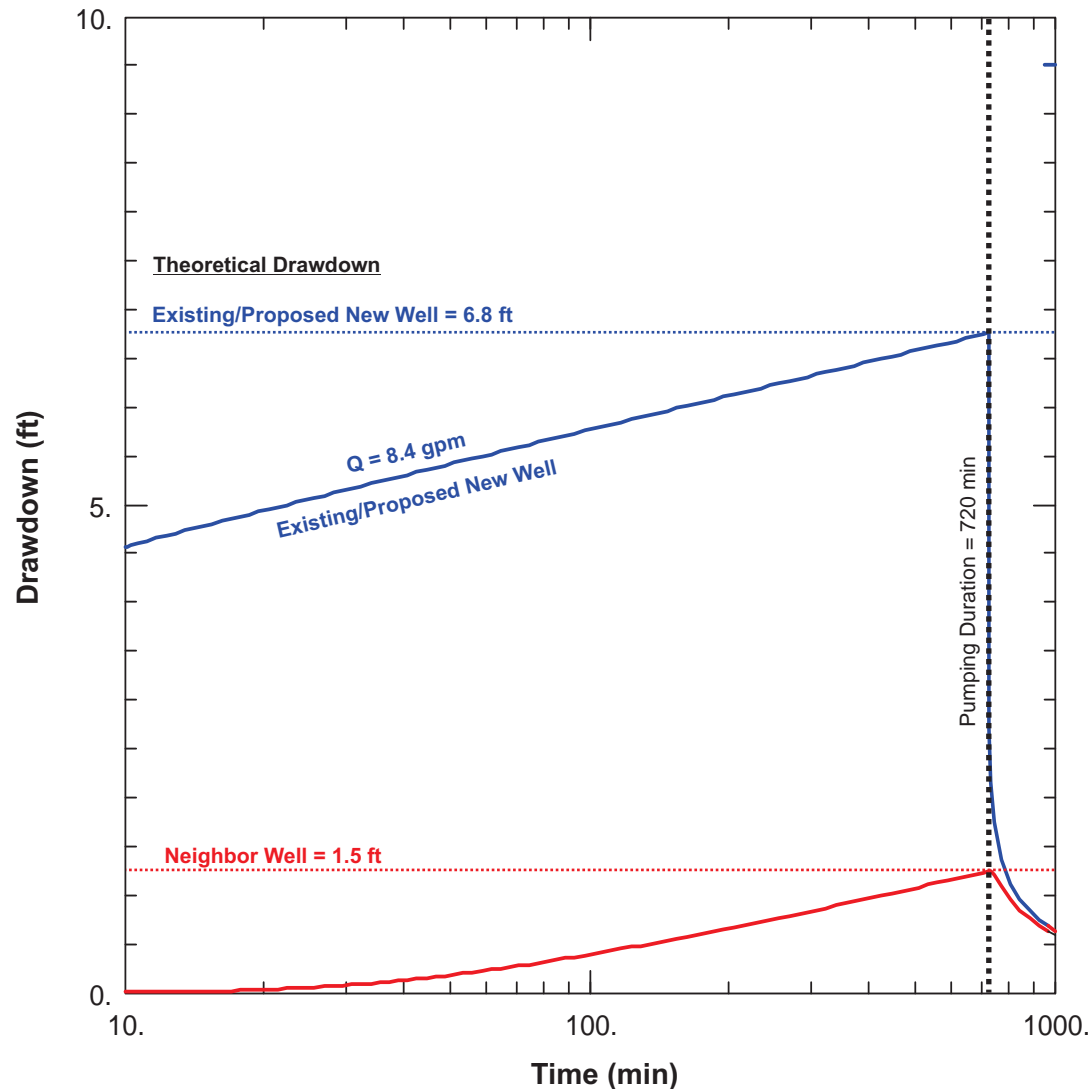
**Figure 6B**  
**Theoretical Drawdown Calculations**  
**in the Observation Well**  
**12 Hours/8.4 gpm/T=1,925 gpd/ft**

Once the transmissivity value was better calibrated to the drawdown values actually observed in the field in the Existing Well, the predictive water level drawdown simulation was performed. Data derived using the Existing Well data were applied to the proposed New Well (the pumping well), and simulations included the offsite Neighbor Well (the observation well). Figure 6B, “Theoretical Drawdown Calculations, Predictive Simulation” has been prepared to show the theoretically-calculated water level drawdown values in the proposed New Well (the pumping well) and also in the Neighbor Well (the observation well) that might occur after pumping the New Well for the assumed continuous period of 12 hours and at a constant pumping rate of 8.4 gpm (the rate necessary to meet the MDD for the project).

To better calibrate the software to the actual drawdown values that were recorded by RWTS pumper in the Existing Well during the 8-hour pumping test, adjustments were made to the assumed transmissivity value used in the AQTESOLV simulation. After an iterative process, a transmissivity value of 1,925 gpd/ft was found to provide drawdown values that were more comparable to those that were actually monitored in the field during the test of the Existing Well. This transmissivity value of 1,925 gpd/ft yielded a theoretical water level drawdown value of approximately 27.4 ft in the Existing Well, which is similar to the drawdown actually observed during testing of the Existing Well (27.3 ft). Figure 6A, “Transmissivity Calibration, the Existing Well” illustrates the theoretical amounts of water level drawdown that were calculated to occur after 8 hours of continuous pumping of the Existing Well at a constant rate of 35 gpm, based on a transmissivity of 1,925 gpd/ft and a storativity of  $3.9 \times 10^{-4}$ .

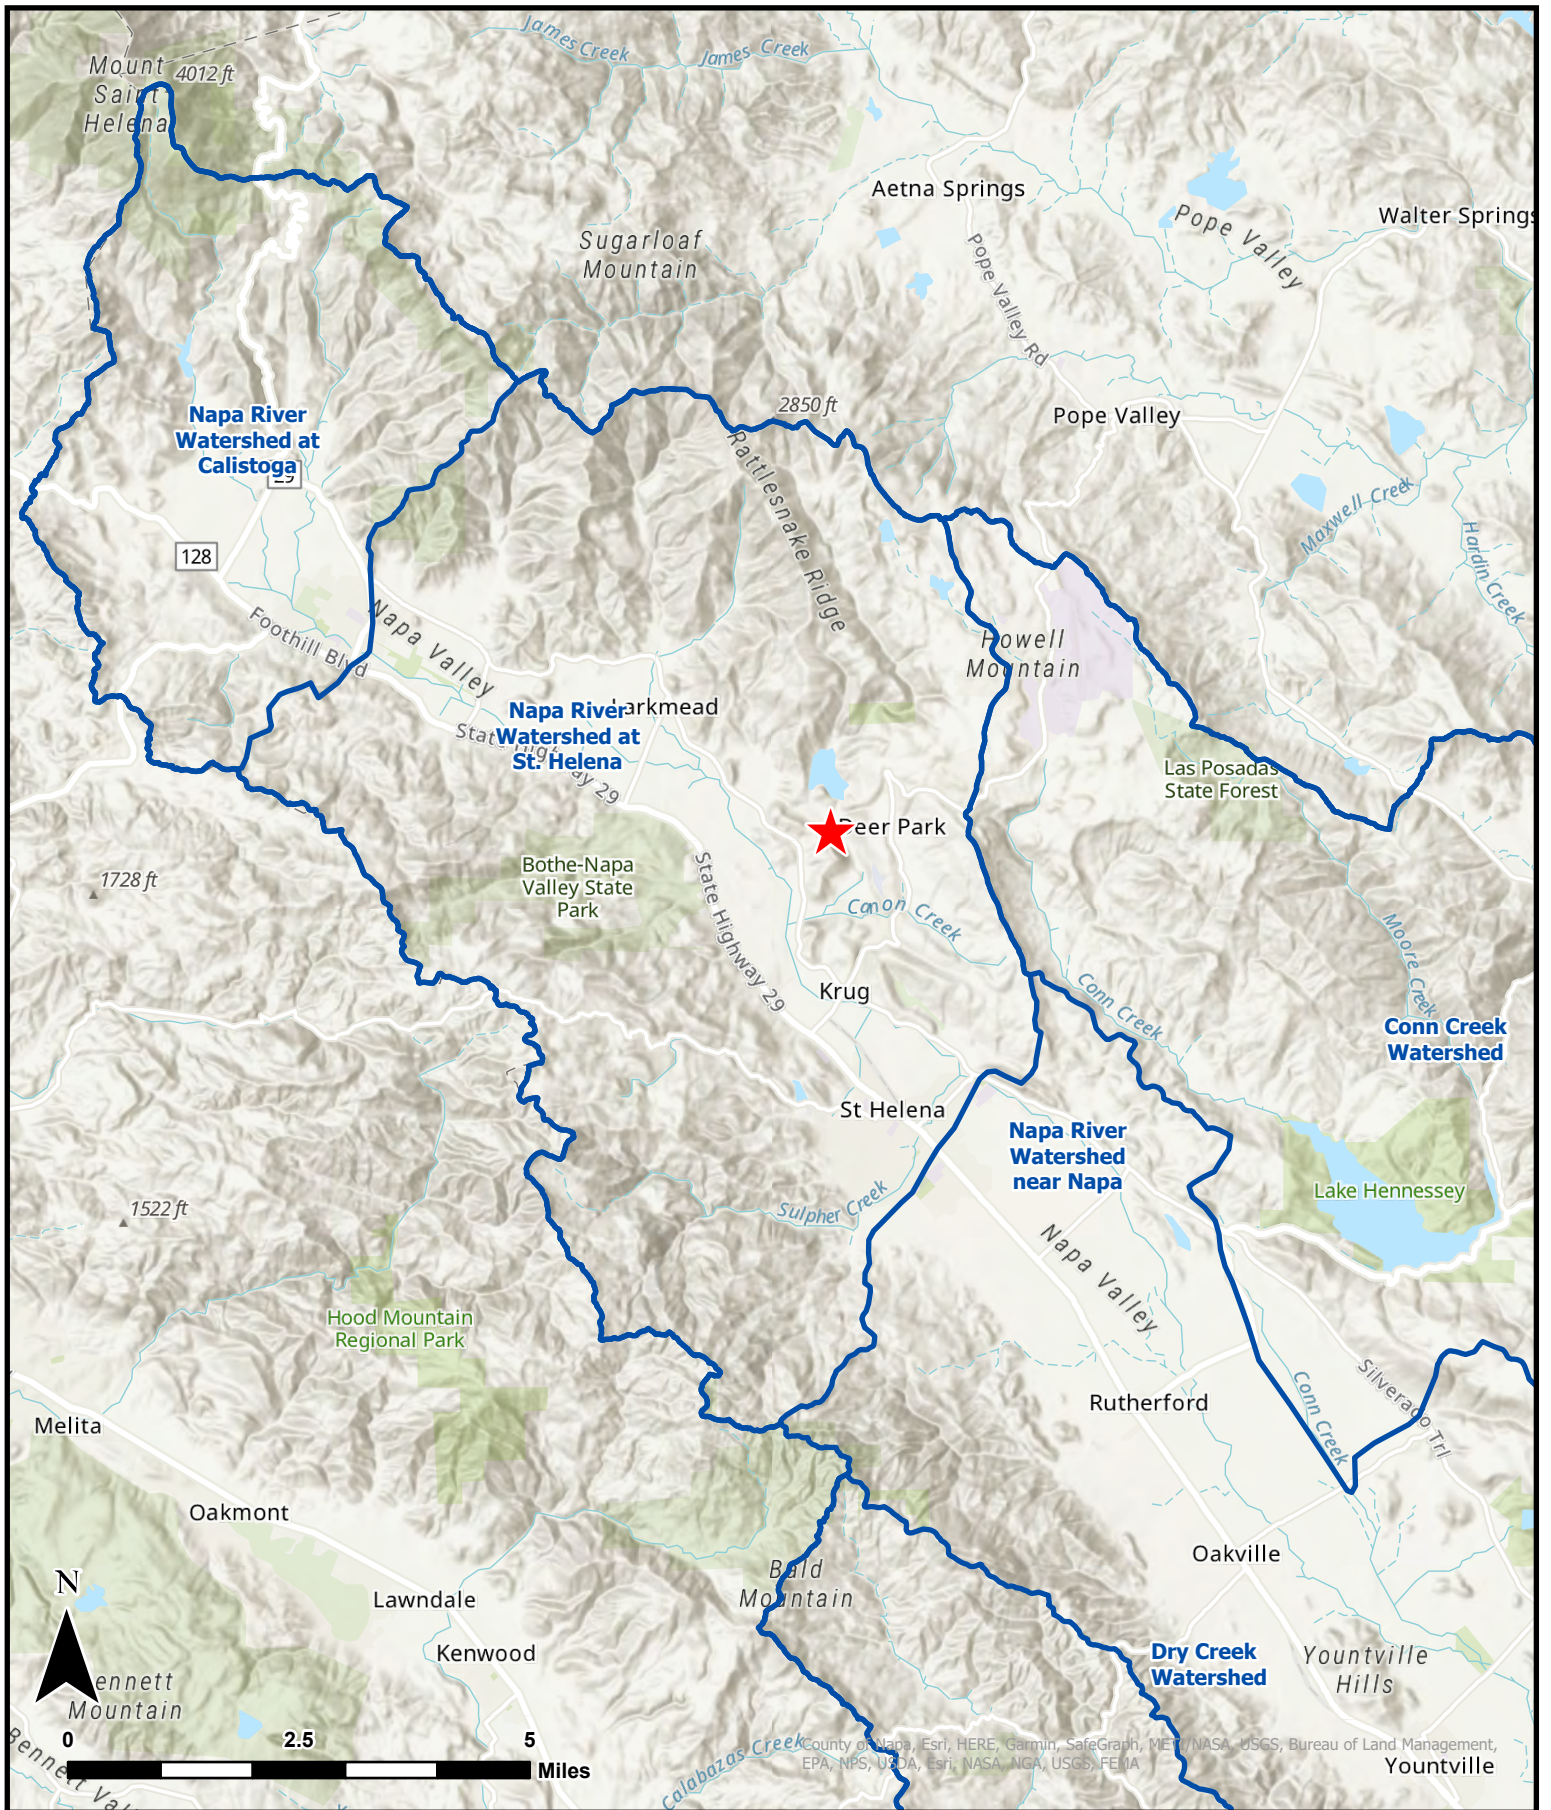
In this scenario, the offsite water level observation well (the Neighbor Well) is assumed to be not pumping during the New Well pumping period. As shown on Figure 6B, the results of the predictive simulation for theoretical water level drawdown values during future pumping of the New Well are presented as follows:

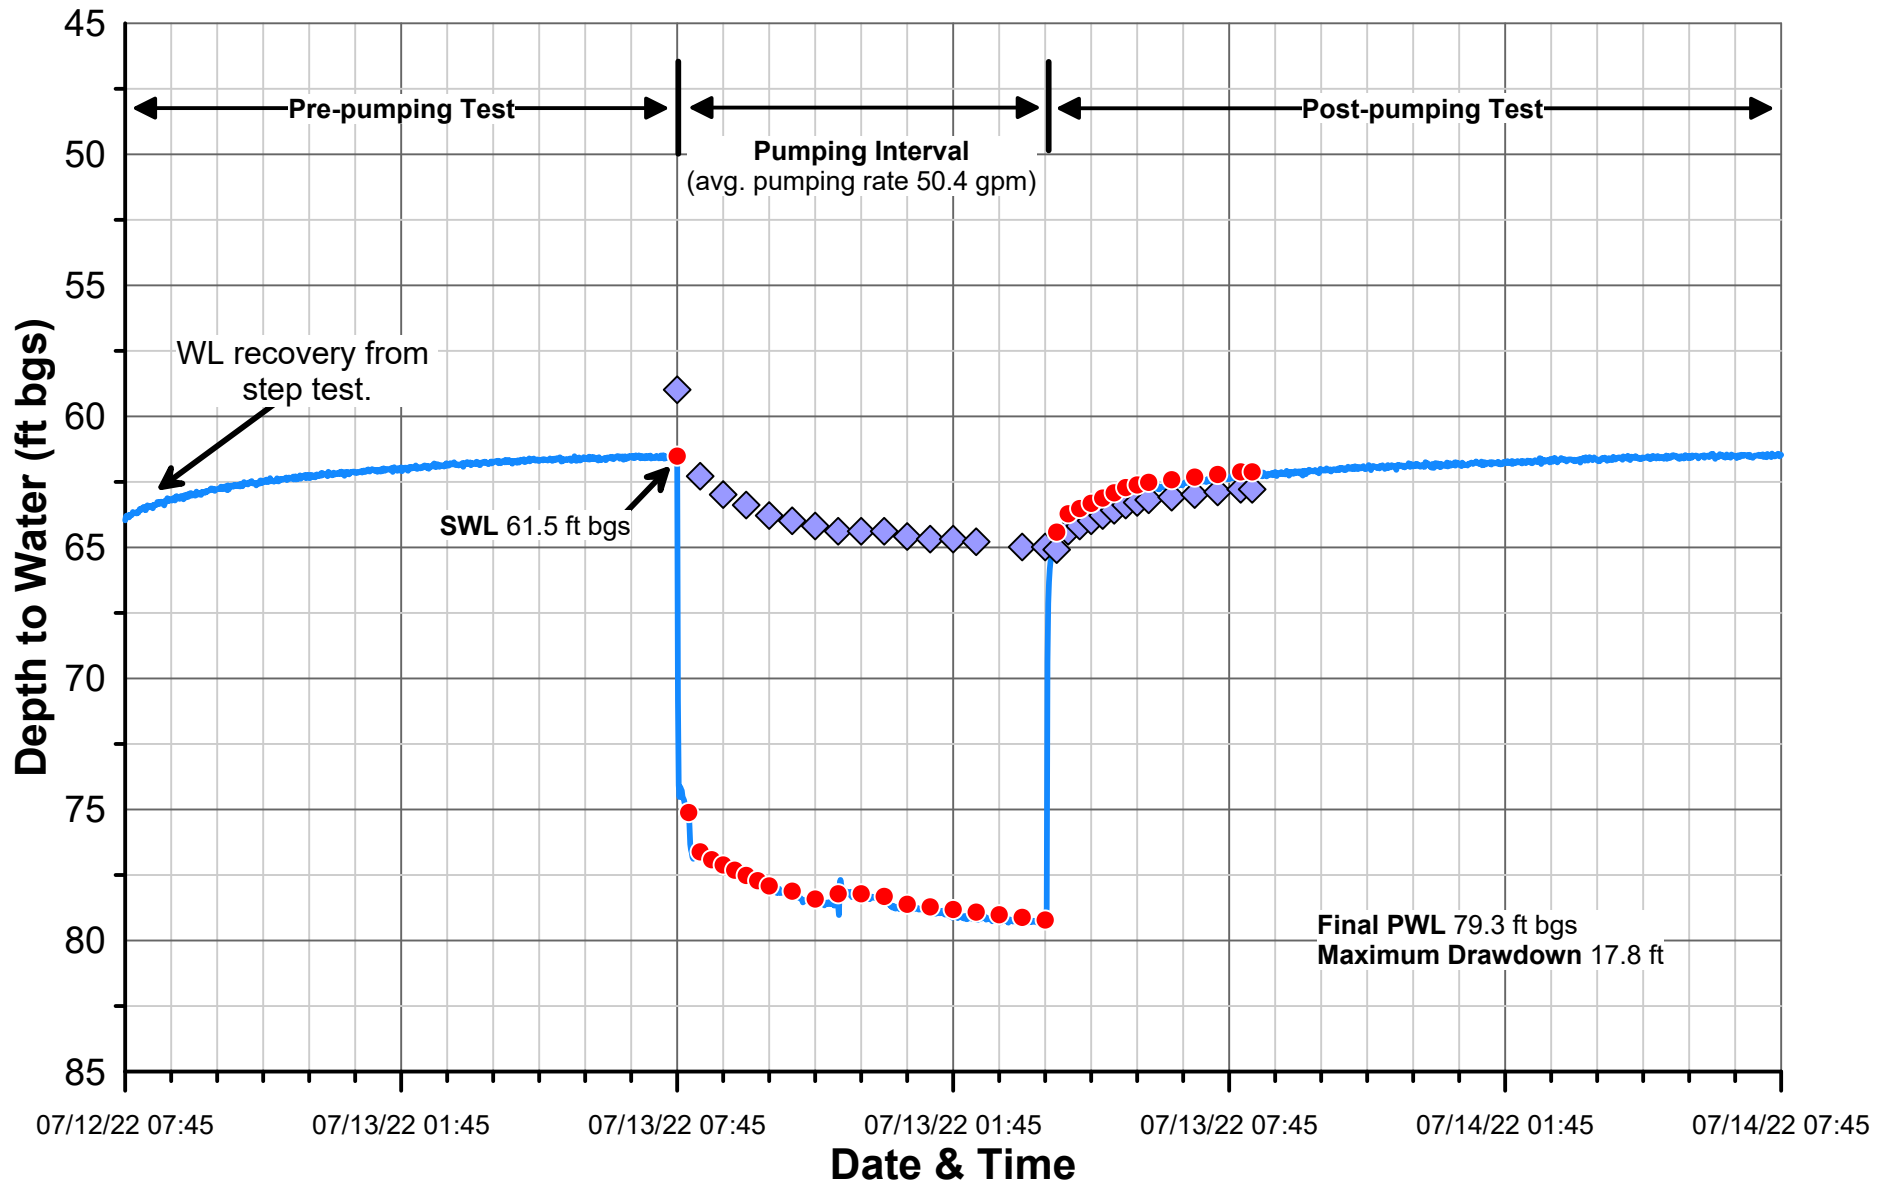
**FIGURE 3  
WATER LEVELS DURING  
CONSTANT RATE PUMPING TEST  
NEW WELL**

- New Well Manual WL Measurements
- ◆ Existing Well Manual WL Measurements
- New Well Transducer WL Measurements

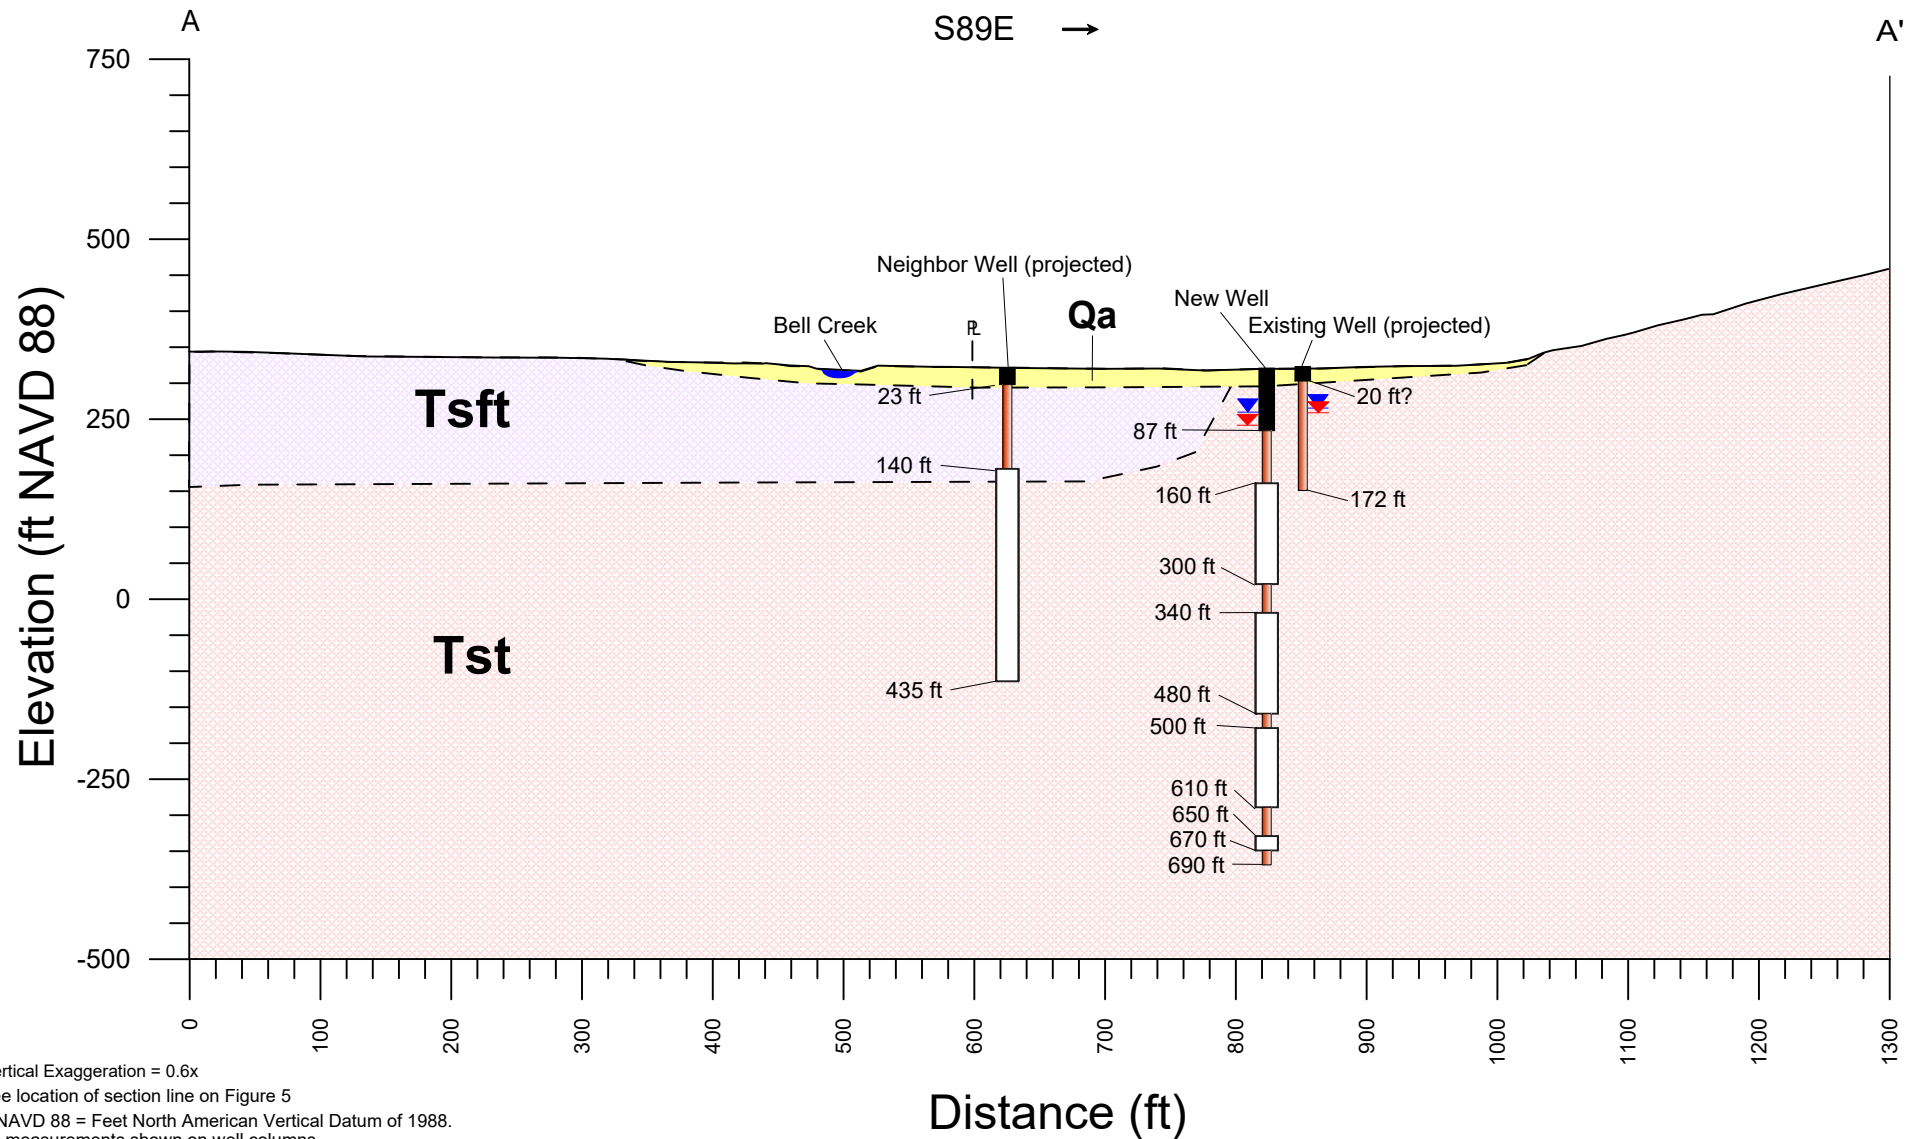
**FIGURE 6  
CROSS SECTION A-A'**

- Cement Seal
- Blank Casing
- Perforated Interval
- ▼ Static Water Level (July 2022)
- ▼ Pumping Water Level (July 2022)  
 \*\*Pumping water level" for Existing Well is actually a non-pumping measurement collected during constant rate test on New Well.
- RL Property Line
- Qa Alluvium(Holocene and late Pleistocene)
- Tsft Tuff (Pliocene)
- Tst Pumiceous ash-flow tuff (Pliocene)

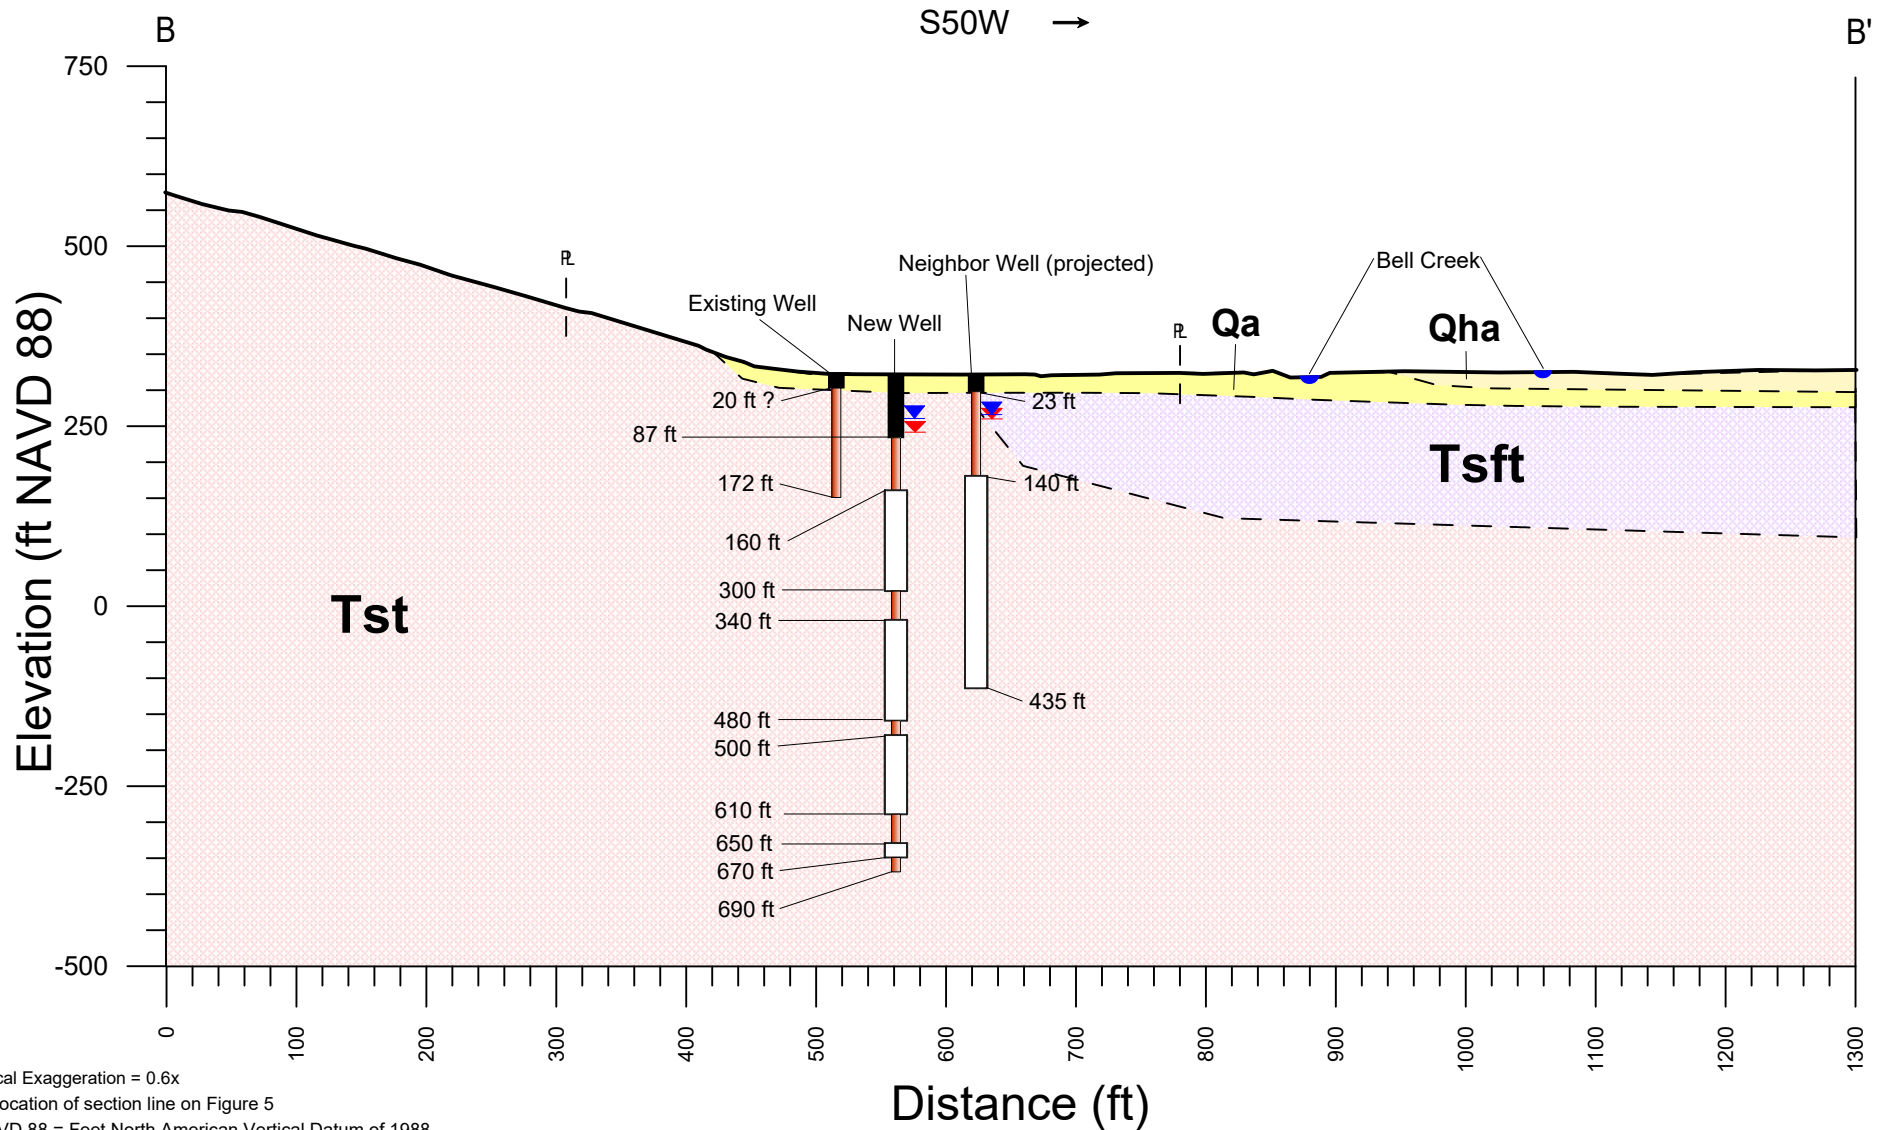
Vertical Exaggeration = 0.6x  
 See location of section line on Figure 5  
 ft NAVD 88 = Feet North American Vertical Datum of 1988.  
 All measurements shown on well columns  
 are below ground surface.
