Water Availability Analysis
March 5, 2021 – Tier I & II WAA
October 4, 2022 – Tier I-III Addendum

Vida Valiente Winery
Groundwater Use Estimate

MEMORANDUM

This Memorandum presents the key RCS findings, conclusions, and preliminary recommendations regarding the Water Availability Analysis (WAA) for the proposed new winery project for the Vida Valiente property (subject property) in Napa County, California. This document was prepared for the property owner to provide hydrogeologic analyses in conformance with Napa County Tier 1 and Tier 2 WAA requirements, as described in the Napa County WAA Guidelines Document (WAA, 2015).

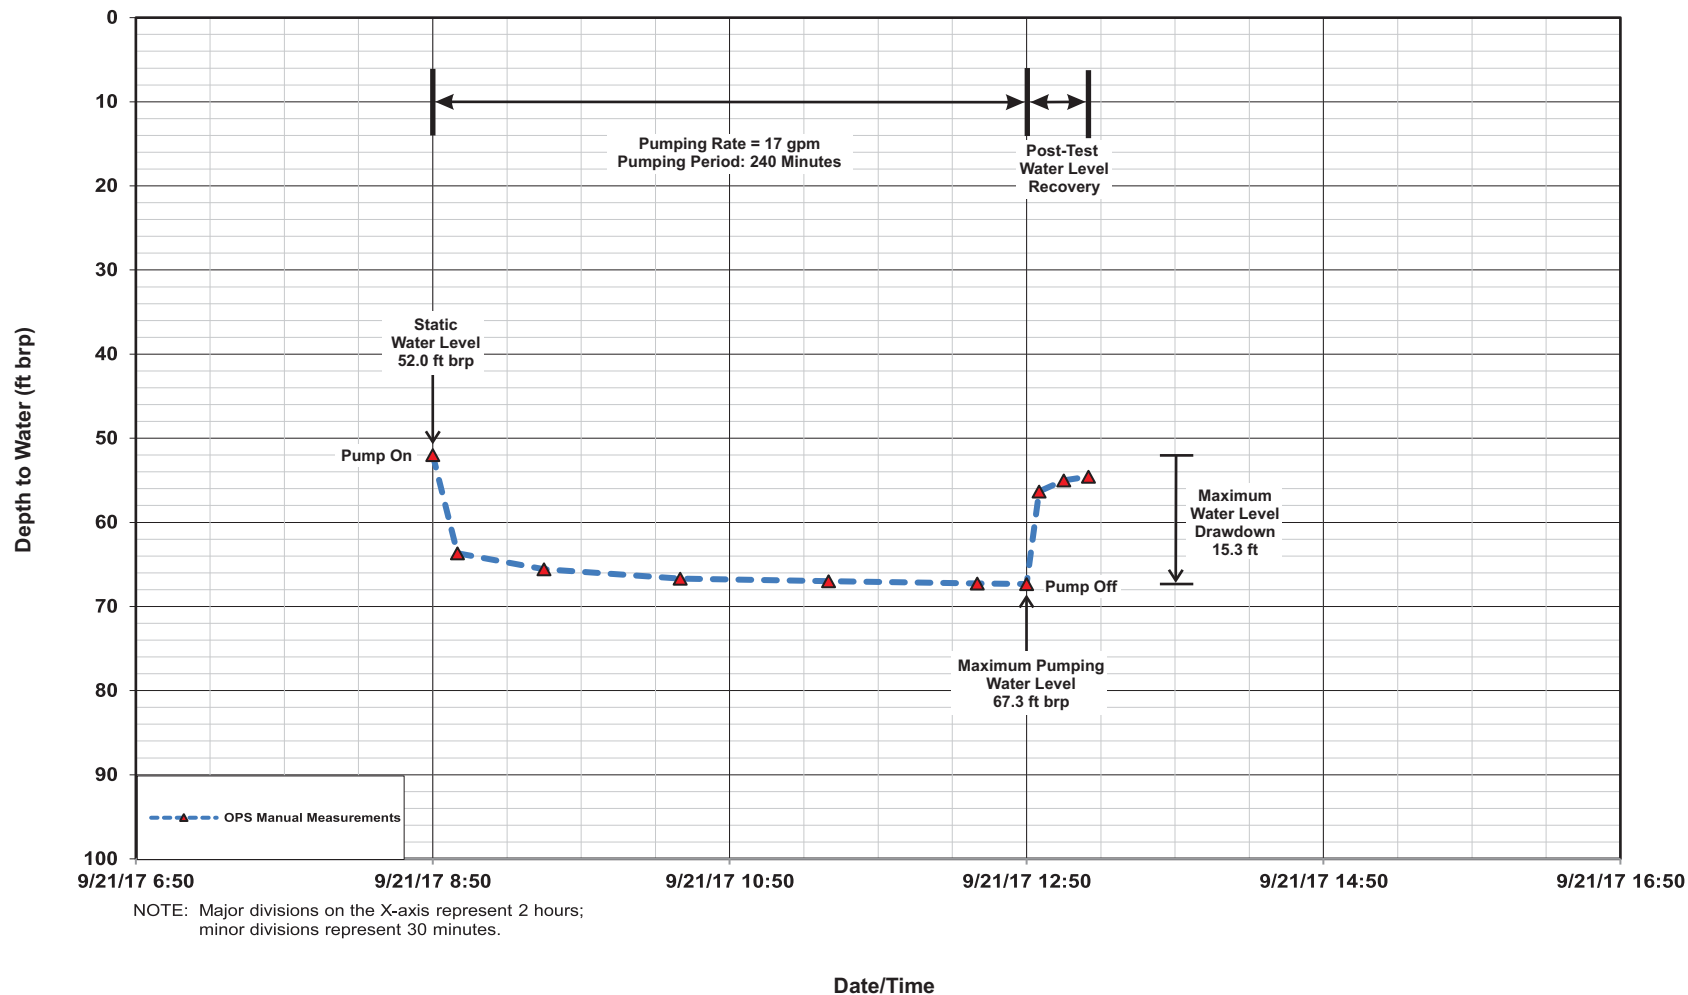
FIGURE 3A
WATER LEVEL DATA DURING SEPTEMBER 2017
CONSTANT RATE PUMPING TEST
EXISTING WELL
VIDA VALIENTE WINERY

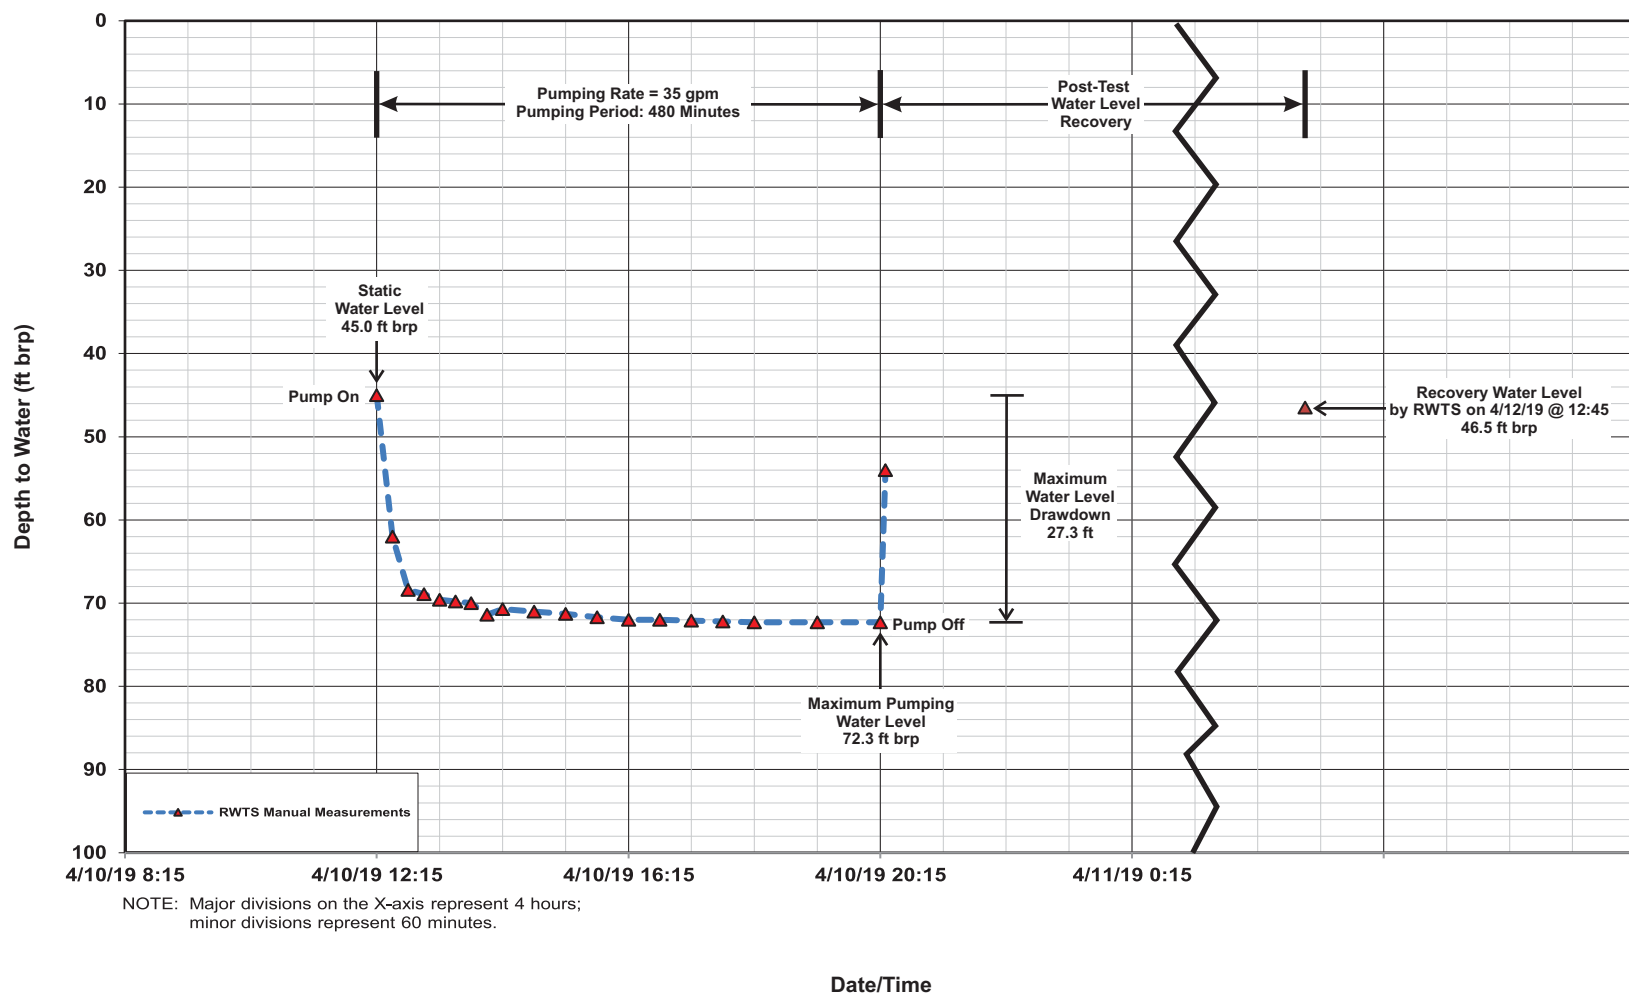
FIGURE 3B
WATER LEVEL DATA DURING APRIL 2019
CONSTANT RATE PUMPING TEST
EXISTING WELL
VIDA VALIENTE WINERY

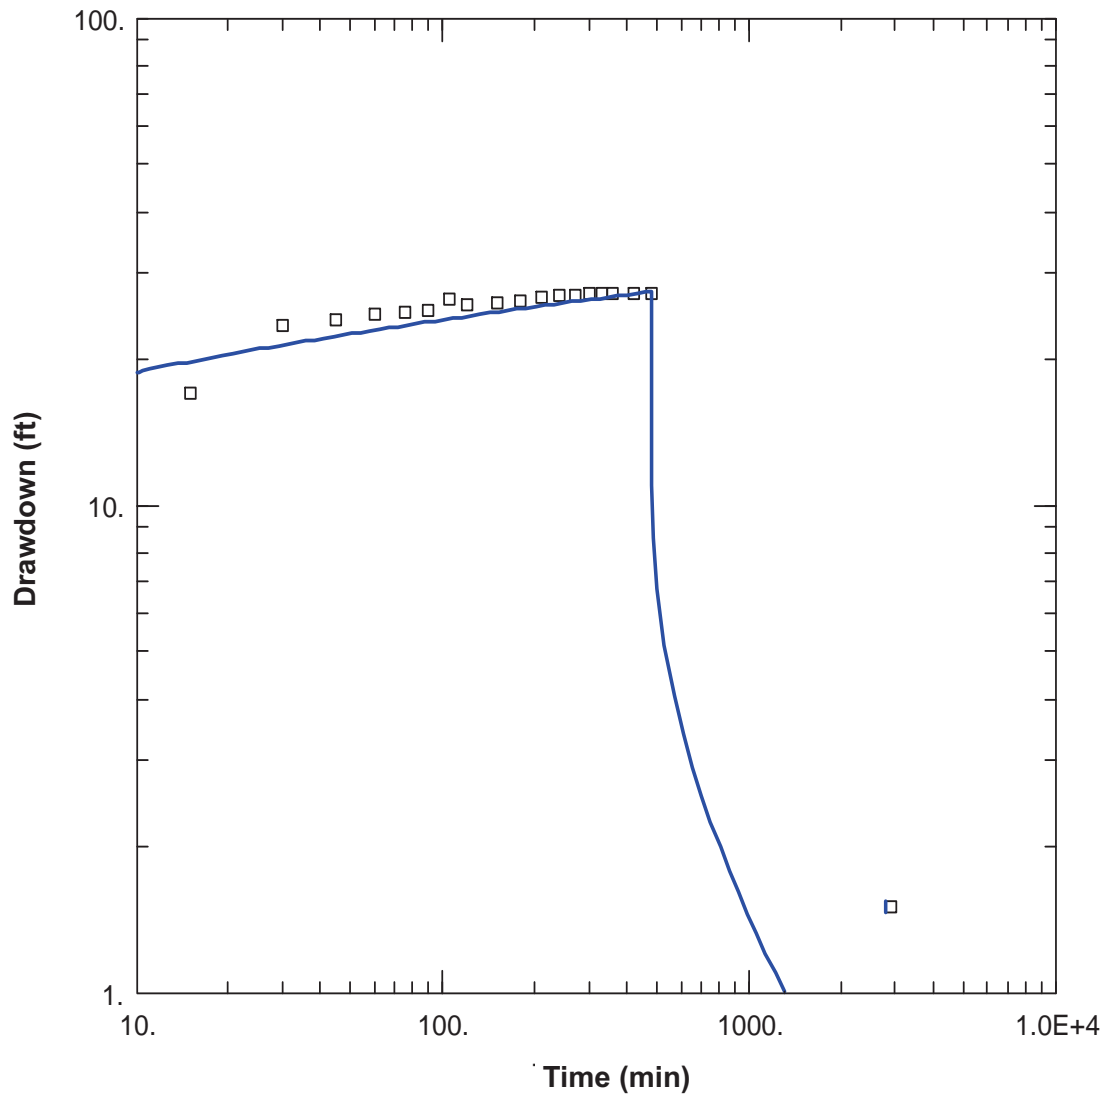
- Theis/Hantush – Figure 5A, “Constant Rate Pumping Test Analysis, Theis/Hantush Solution, Confined Aquifer, Existing Well.” – As shown on the figure, the curve for the confined aquifer solution has been “best fit” to the later-time water level drawdown data observed in the Existing Well. A transmissivity value of approximately 1,836 gpd/ft is calculated for these data.

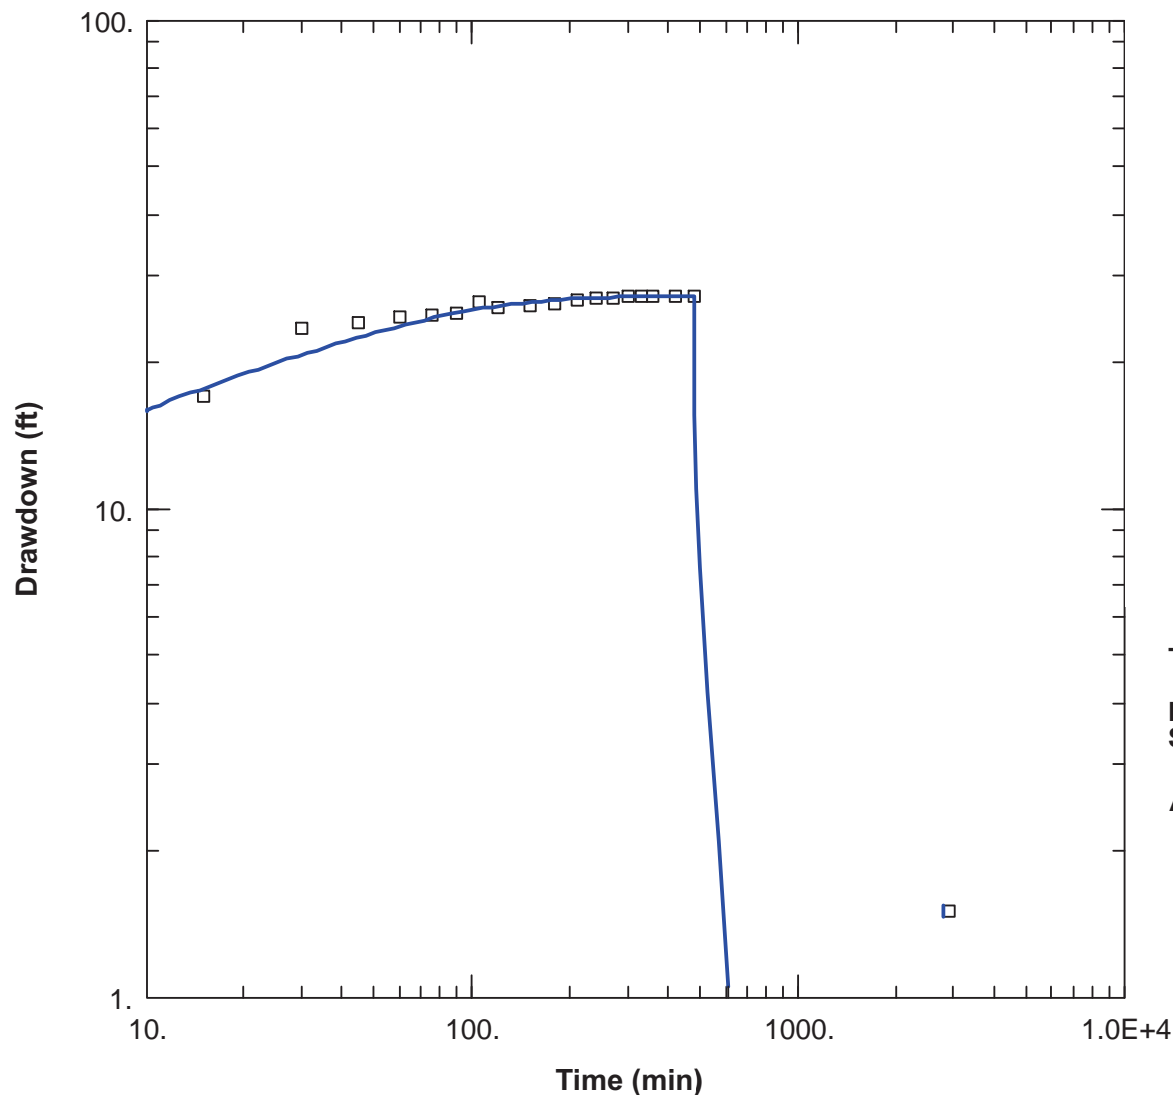
- Moench – Figure 5B, “Constant Rate Pumping Test Analysis, Moench, Leaky Aquifer, Existing Well.” As shown on the figure, the curve for the leaky aquifer solution has been reasonably matched to most of the later-time portion of the water level drawdown data collected during the pumping period in the Existing Well. A transmissivity value of approximately 259 gpd/ft is calculated for these data.

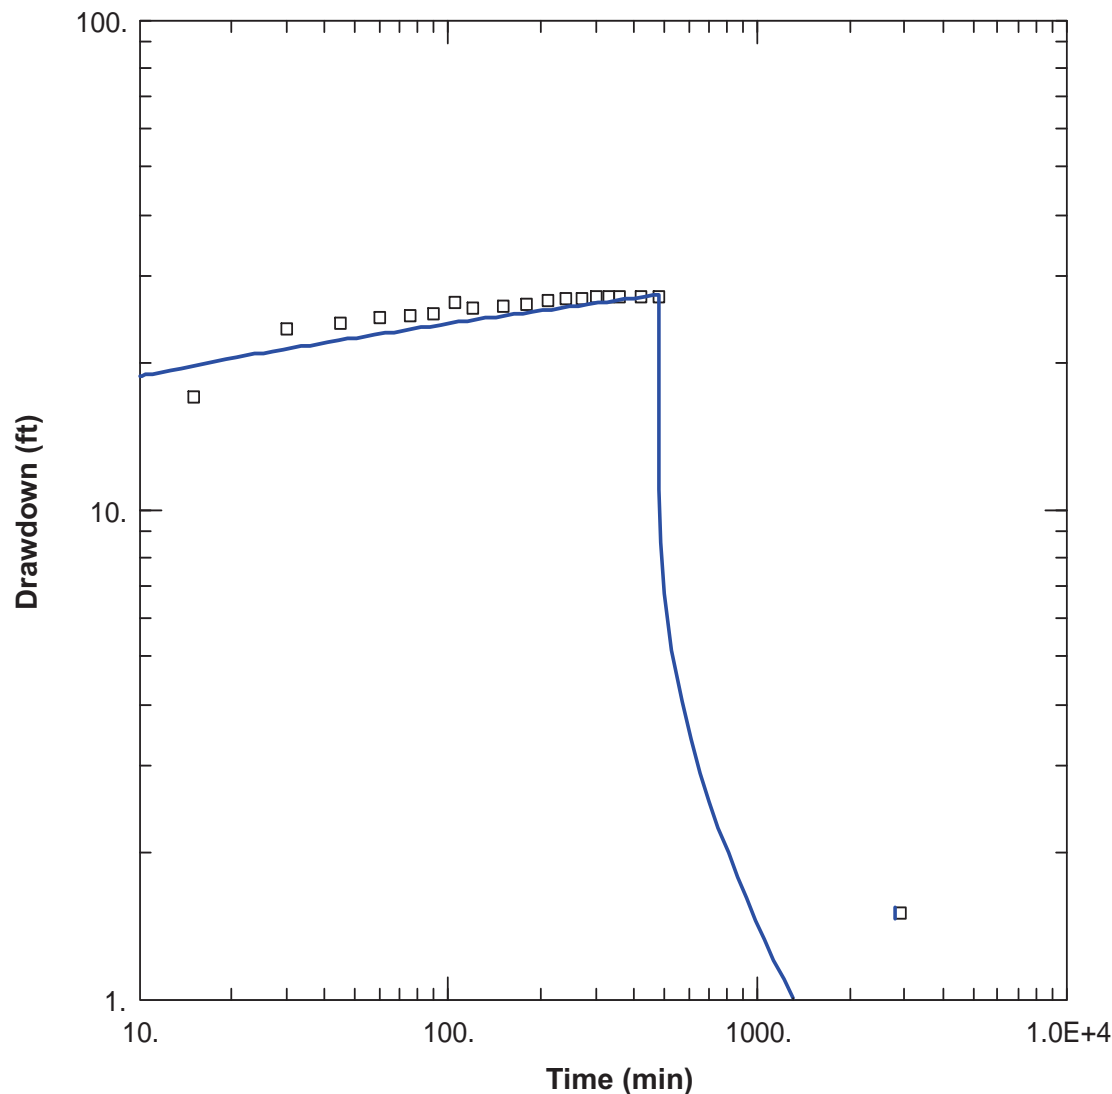
- Gringarten-Witherspoon – Figure 5C, “Constant Rate Pumping Test Analysis, Gringarten-Witherspoon, Fractured Aquifer, Existing Well.” – As shown on the figure, the curve for the fractured aquifer solution has been reasonably fit to the latter portion of the water level drawdown data acquired during the pumping test of the Existing Well. A transmissivity value of approximately 2,182 gpd/ft is calculated for these data.

Figure 5C
Constant Rate Pumping Test Analysis
Gringarten-Witherspoon Fractured Aquifer Solution
Existing Well

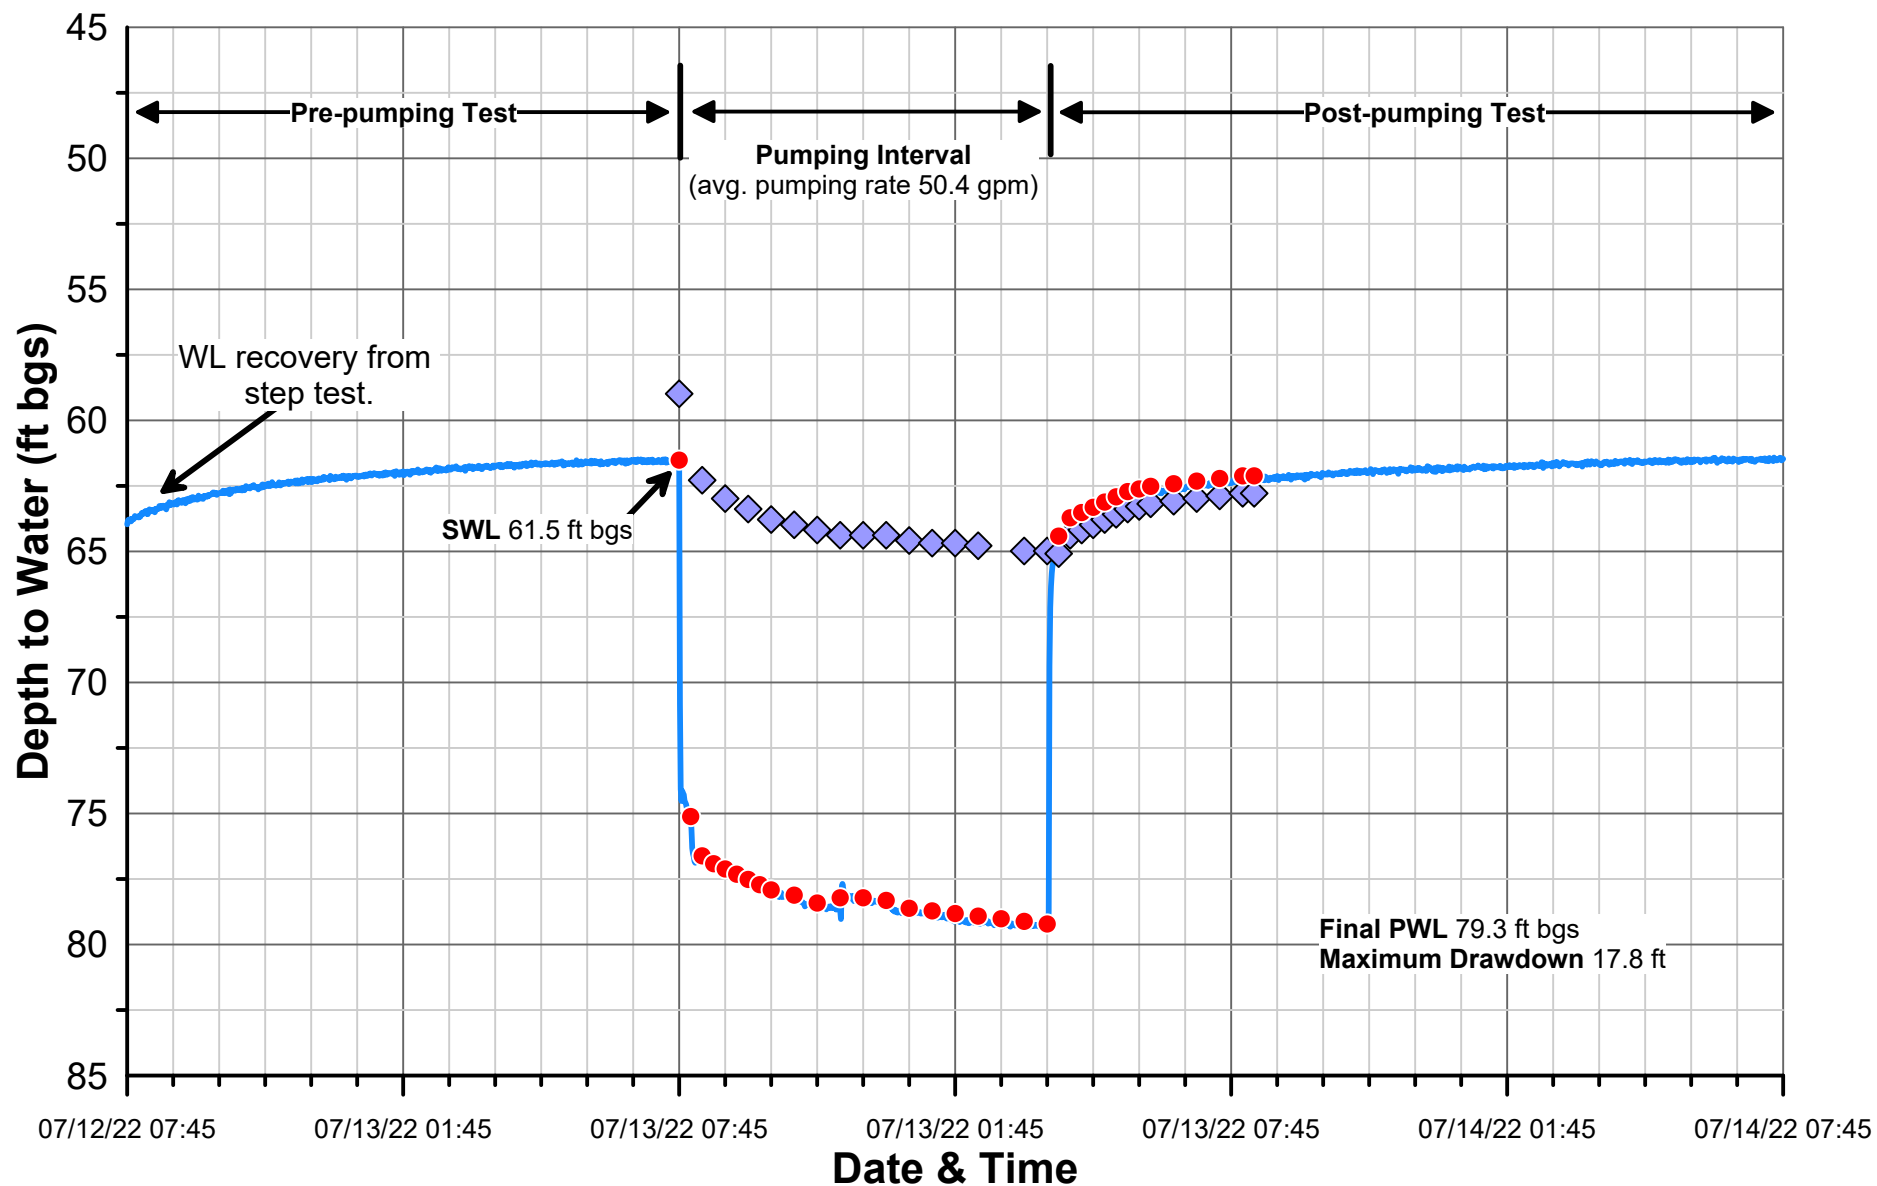
FIGURE 3
WATER LEVELS DURING
CONSTANT RATE PUMPING TEST
NEW WELL

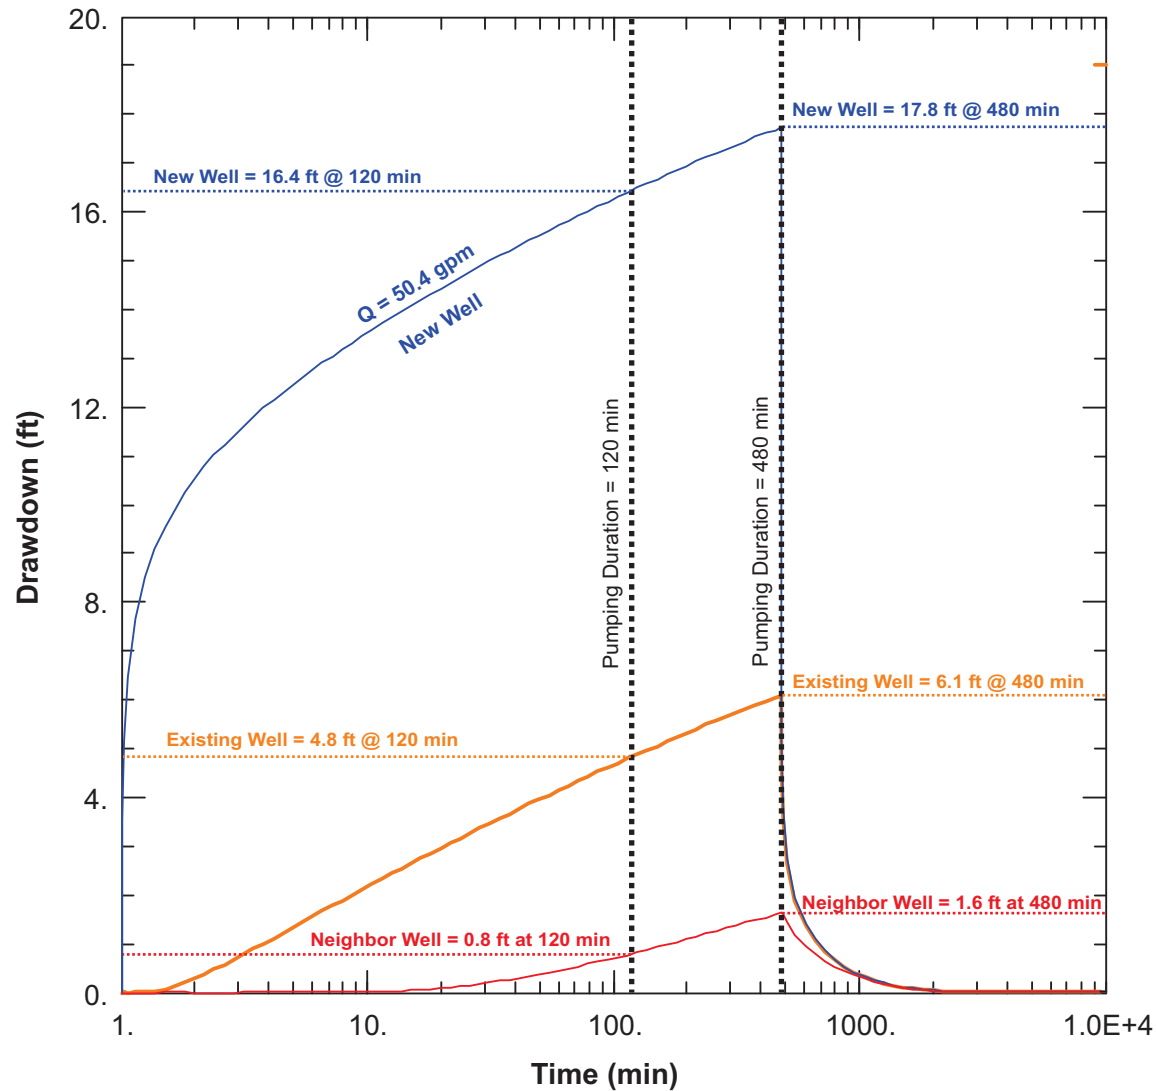
- Hantush (1960) Leaky Confined with Aquitard Storage - A T value of approximately 3,705 gpd/ft and a $S 5.2 \times 10^{-4}$ was calculated for these data. Curve-fitting for this solution was a very good match for the water level data for both the pumping well and the observation well.
- Theis (1935) Unconfined – A T value of approximately 4,360 gpd/ft and a S of 1.3×10^{-3} is calculated for these data. It should be noted that the Theis confined solution (not shown herein) produced similar results.

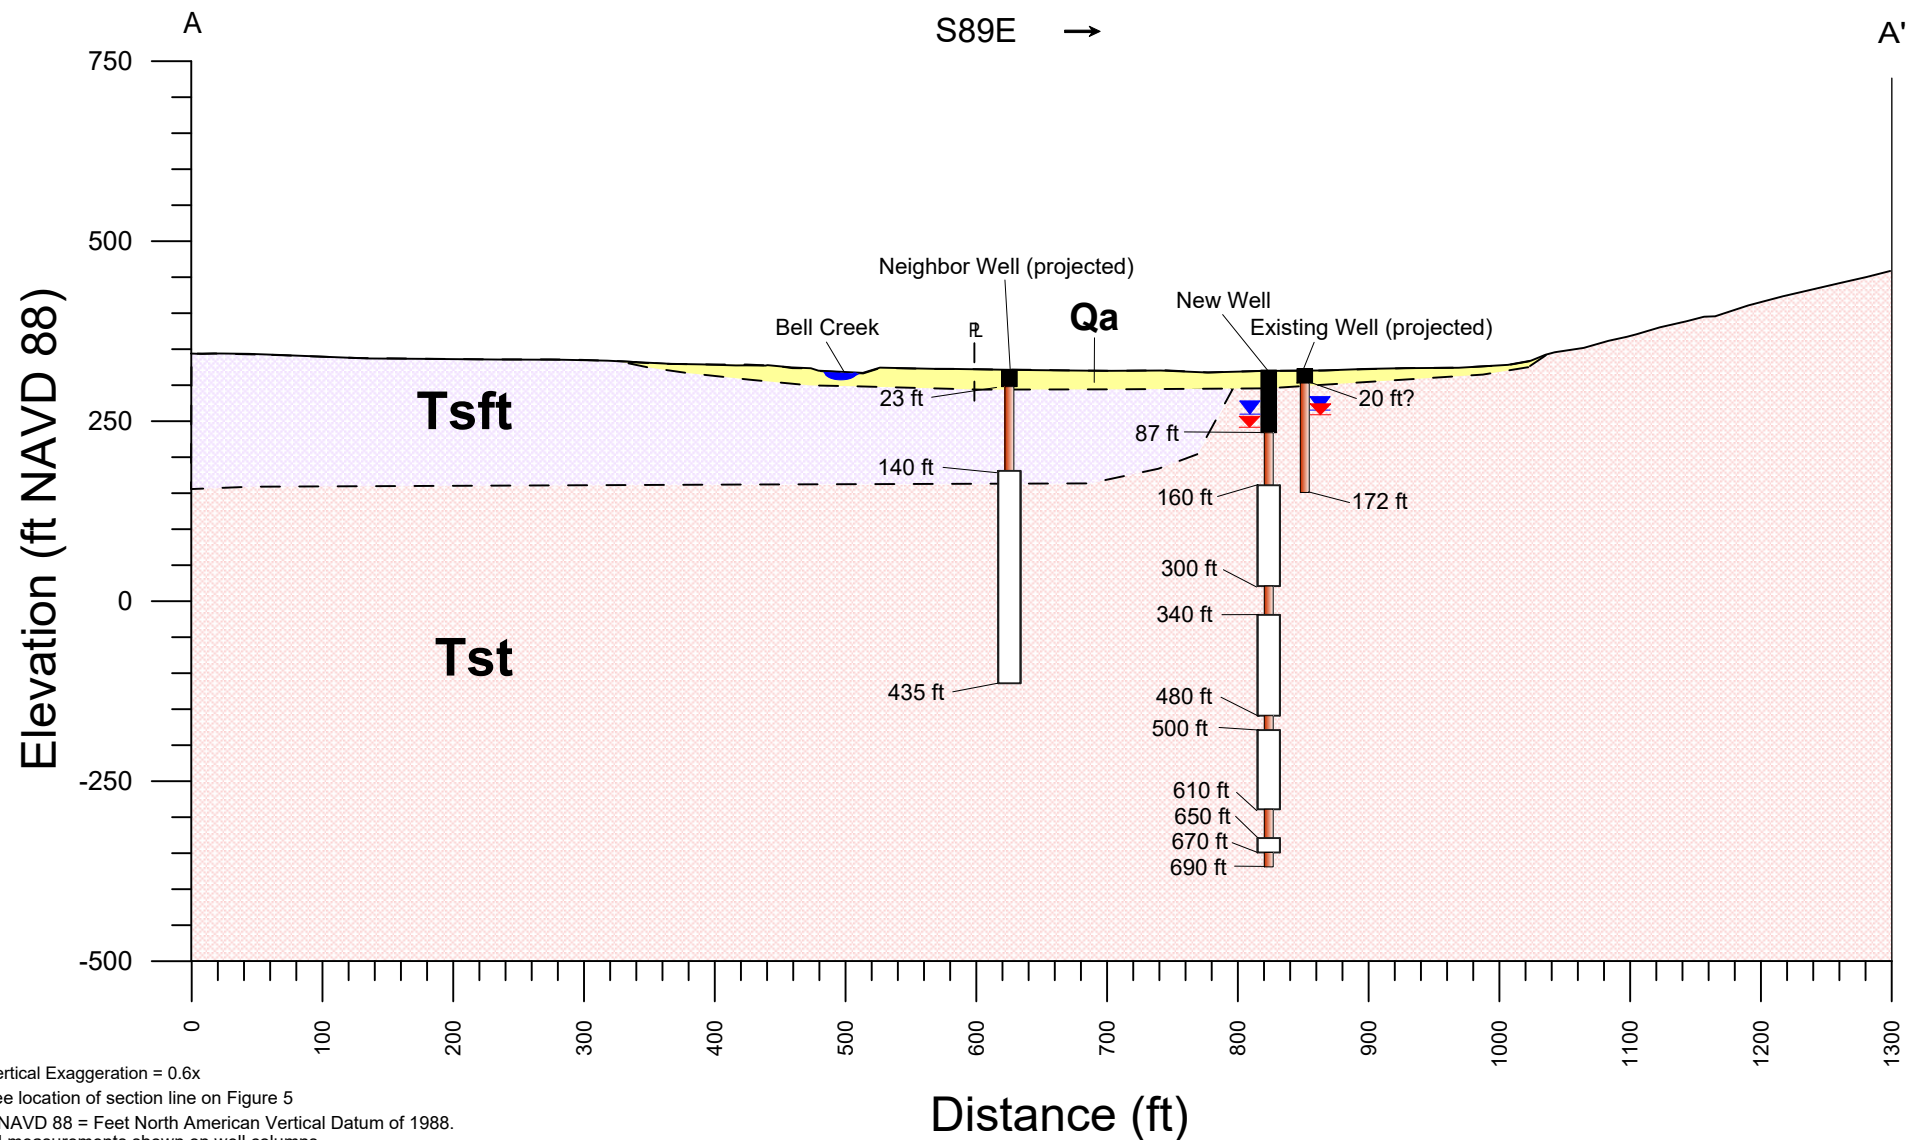
FIGURE 6
CROSS SECTION A-A'

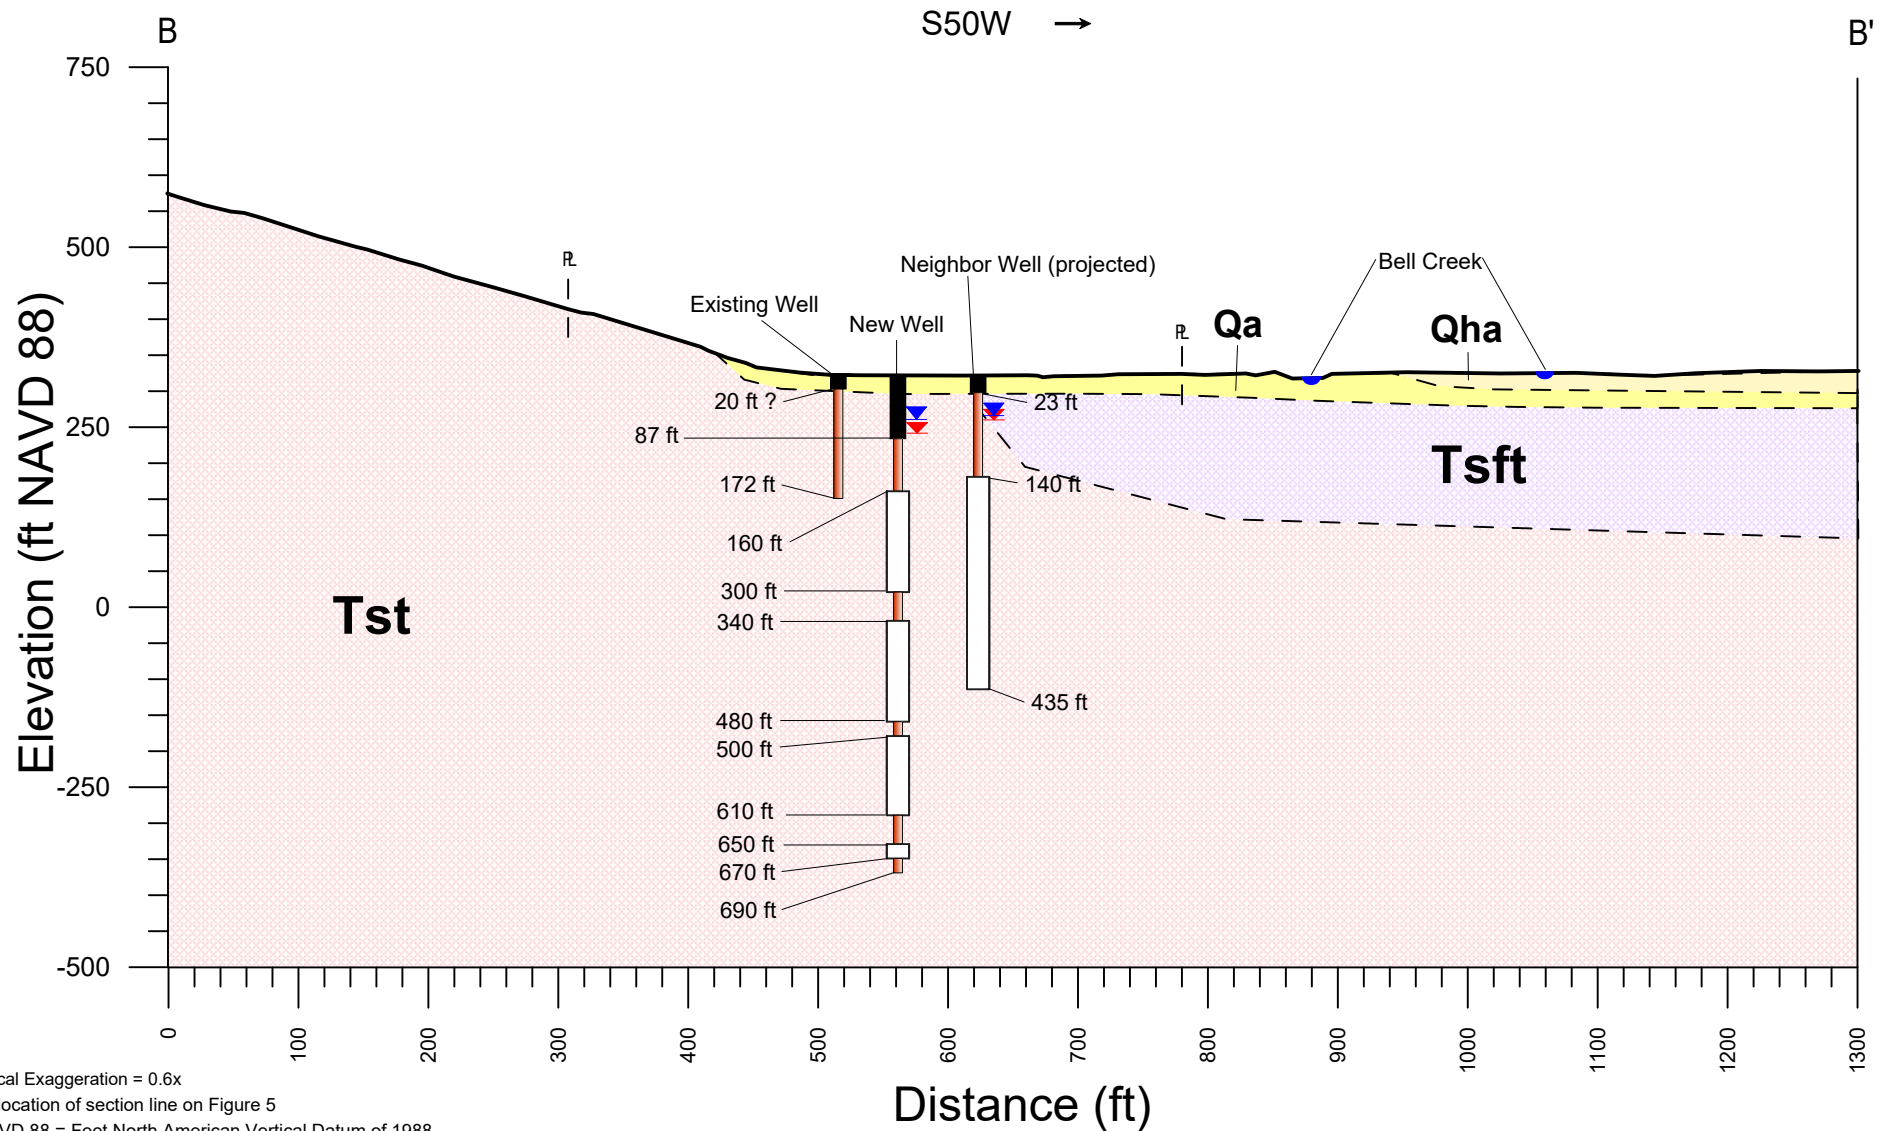
**FIGURE 7
CROSS SECTION B-B'**
