## Revised Noise Study

Silverado Resort & Spa Project  
Minor Modification to Non-Winery Use Permit  
P24-00141-MM  
Planning Commission Hearing – November 5, 2025

**Subject: The Grove at Silverado Resort – Noise Study**  
**Salter Project 24-0381**

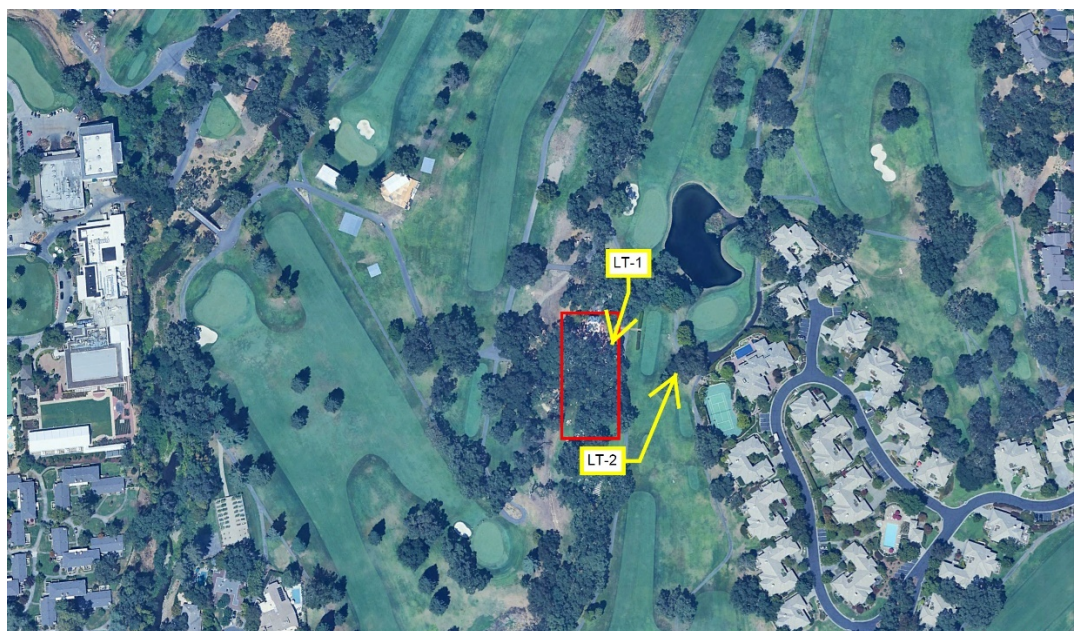
**Figure 1: Site Plan**

The existing event courtyard includes an outdoor stage and seating area. Measurement kit LT-1 was attached to the courtyard perimeter fence between the stage and residences to the east. The second measurement kit LT-2 was attached to a tree further east.

To the south of the courtyard and stage is an additional outdoor pavilion which includes a small platform stage and seating area along the dry creek bed.

Noise levels were collected between 28 August and 3 September 2024. Refer to **Figure 1** for measurement locations. During the long-term measurements three separate events took place in the courtyard event area between 5 and 10 PM on August 28<sup>th</sup> and 31<sup>st</sup>, and September 1<sup>st</sup>. The event types, headcount, and entertainment information is summarized below in addition to the maximum noise levels measured during those events at location LT-2.

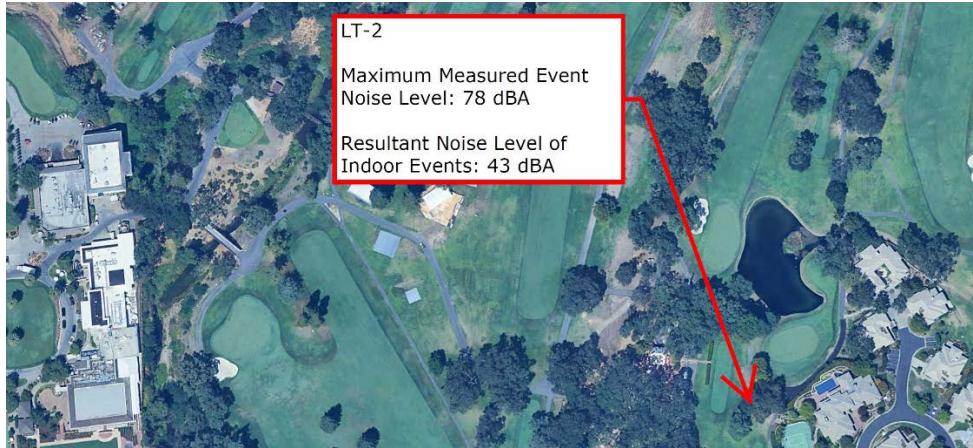
Figure 4: Resultant Noise at LT-2

Refer to **Figure 4** below. Noise of indoor events is projected to the property line assuming exterior doors and windows shut. At the nearest property line at the Grove community (near LT-2 in Figure 1), the measured event noise levels are expected to be reduced by approximately 35 dB based on the anticipated aggregate noise reduction of the exterior shell.

Based on our event noise measurements, noise projections, and the anticipated noise reduction of the Pavilion exterior shell, we conclude that the interior and exterior noise limits in the Napa County noise ordinance will be achieved during indoor events at the nearest residences (with Pavilion windows and doors closed).

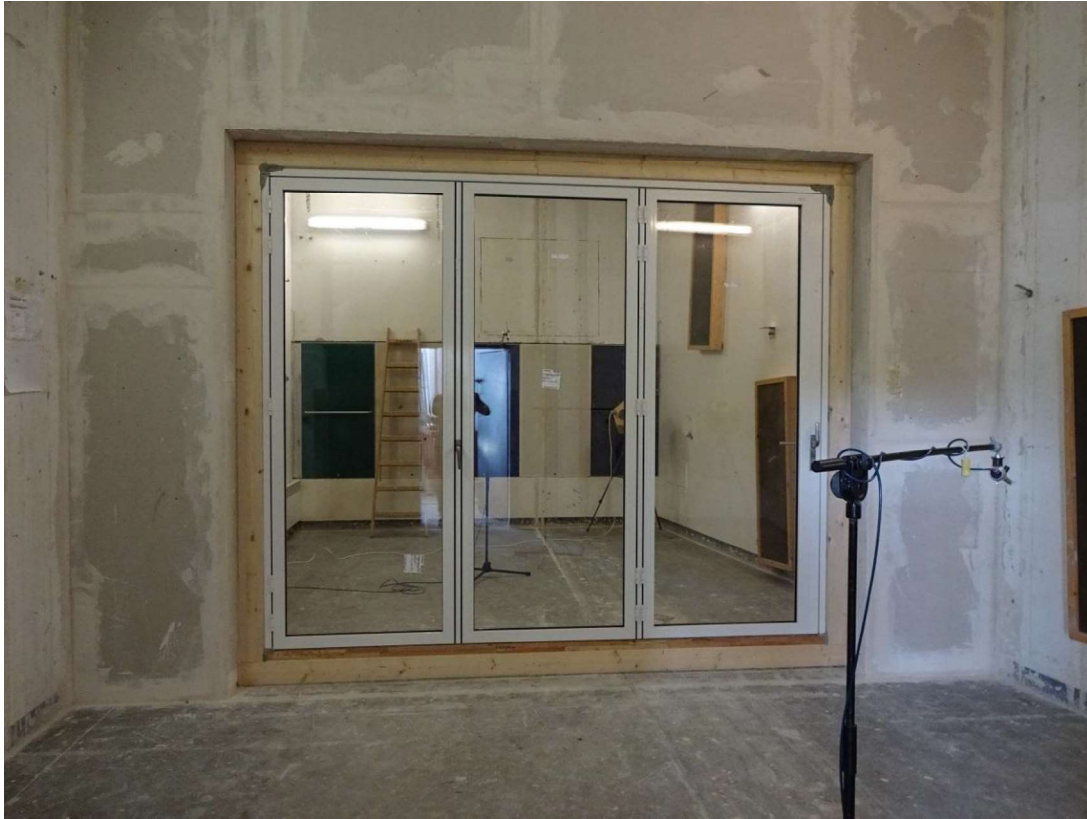
Photo 4: Folding glass wall Acoustic SL70, view transmission room

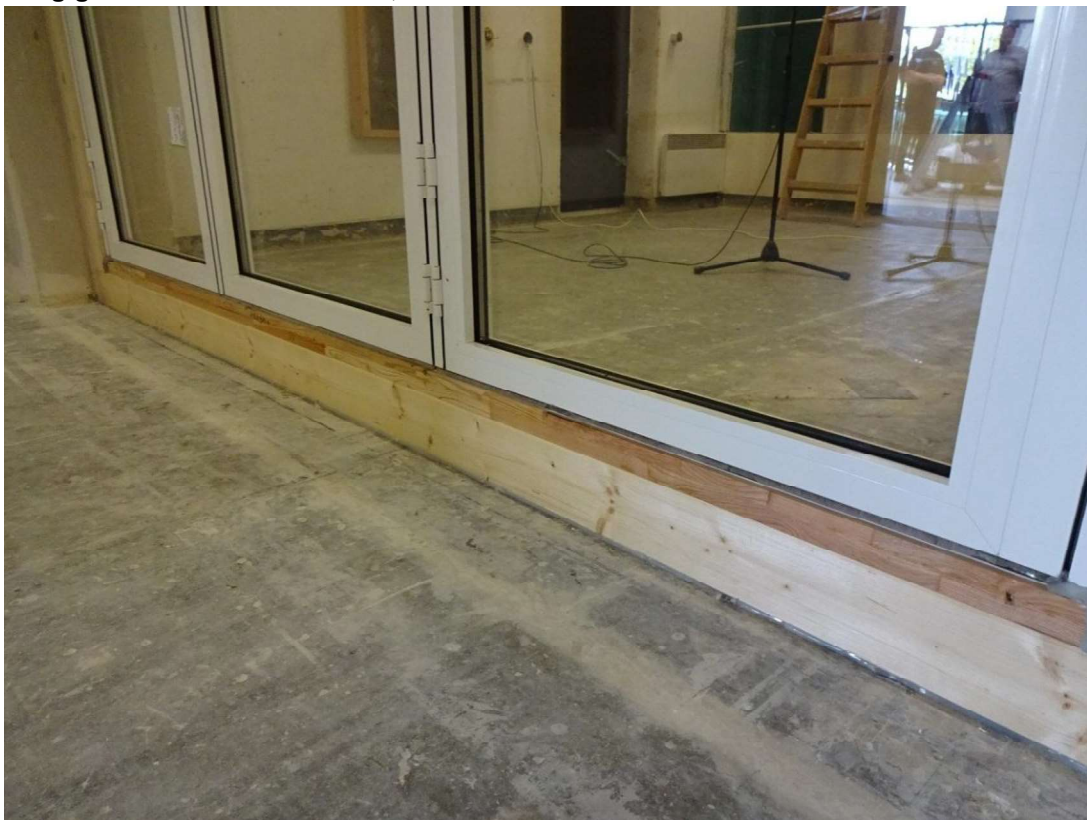
Photo 5: Folding glass wall Acoustic SL70, detail flush sill

All tests were carried out with a flush sill (type 5-60-23-x). In order to simulate a recessed or barrier-free installation (integrated in the floor) of the flush sill, it was covered with wooden strips (d = 25 mm) in the transmission and receiving room.

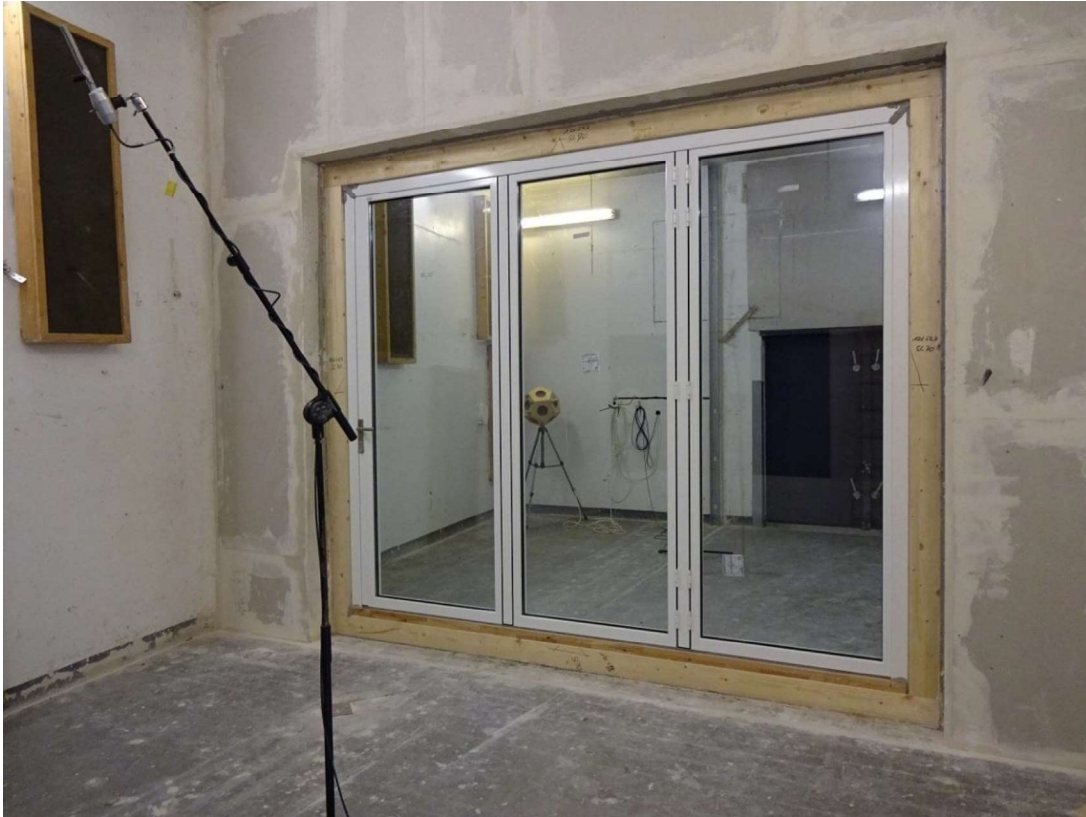
Photo 6: Folding glass wall Acoustic SL70, view receiving room

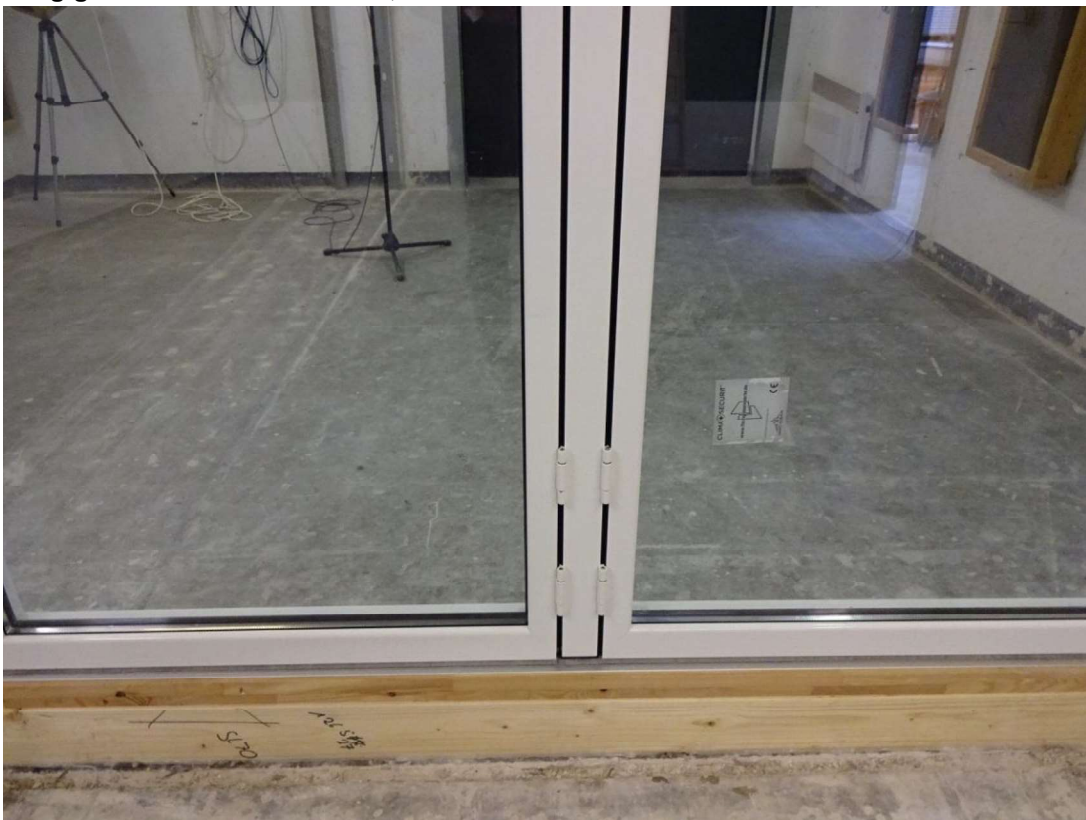
Photo 7: Folding glass wall Acoustic SL70, detail vertical mullion
